WASHINGTON SQUARE REHABILITATION STUDY

February 3, 1995

CONSERVATION TECHNOLOGY GROUP

WASHINGTON SQUARE REHABILITATION COMMITTEE
NEWPORT BEAUTIFICATION AND CONSERVATION COMMISSION

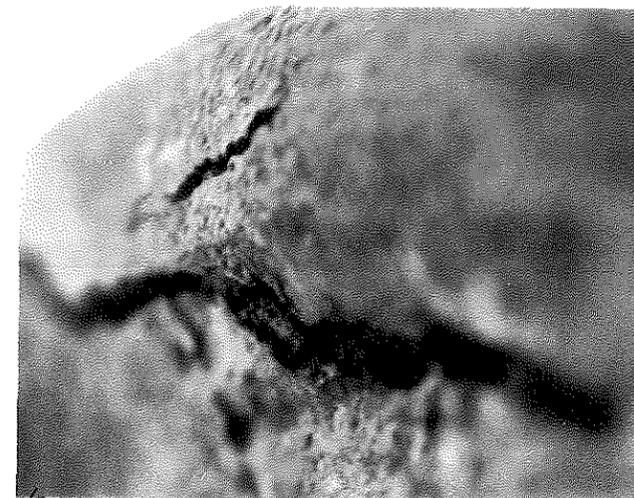
Casting flaws in right epaulet

Bronze surface characteristics were examined from a bucket lift. The surface is characterized by casting flaws² (see photo plate 5-3), deleterious corrosion patterns (see photo plate 5-4), and dirt³. Examination of the upper horizontal surfaces indicated heavy pitting; examination of the lower surfaces indicated nascent erosion channels. This pattern is typical of bronze monuments with poor resistance to natural elements. No evidence of a ferrous armature or other galvanically interactive material was discovered during examination.

2. Fissures and pitting resulting from heat stress deformation (poor casting technique) and core sand inclusion.
3. The upper horizontal surfaces of the statue are covered with pigeon dung; the entire surface is covered with corrosion by-products and carbon deposits.
4. patina color should be based on extant material information or historic record. All evidence of historic patina color was obliterated by Talix Foundry, the foundry that cleaned the statue during the early 1980's. That foundry is presently near bankruptcy and I was informed that they did not assess original patina. There is no record of the casting foundry. In the absence of this evidence, the patina is generally colored to an appropriate dark brown bronze with black highlights.
5. BTA is benzotriazol, a copper anti-oxidant.

The surface of the statue is in very poor condition. It is extremely important that the statue be cleaned, chased, repatinated⁴, and buffered with BTA⁵ in microcrystalline wax. Heavy pits on horizontal surfaces should be power washed and chased to prevent deleterious hygrophilic chlorides from forming and exacerbating corrosion. The statue should also be cleaned and rewaxed on an annual basis.

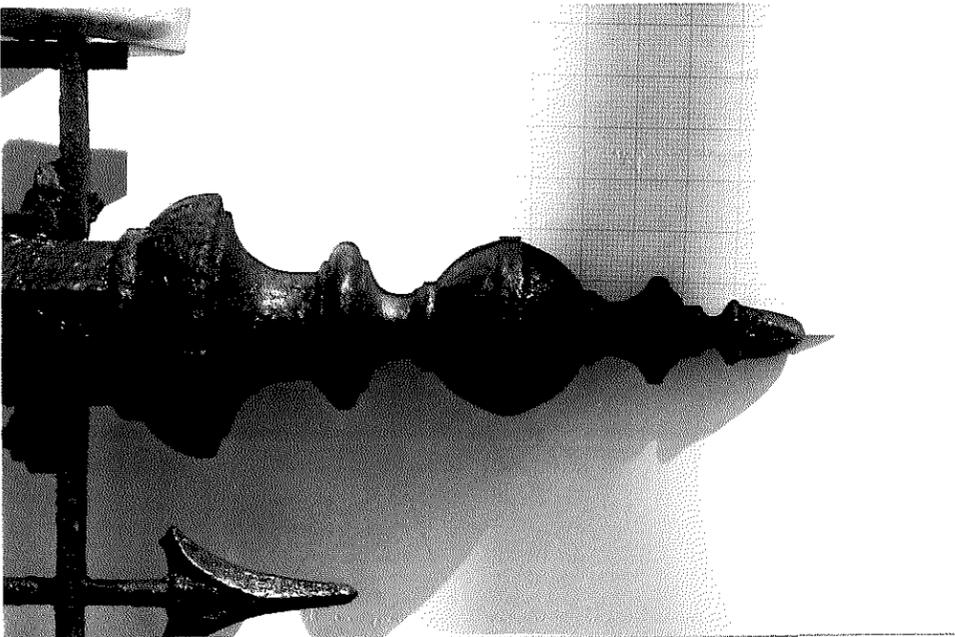
The fence is in poor condition (see photo plates pages 9 and 10): total alignment is deformed as the curbing has shifted and due to vandalism and automobile accidents; several sections are missing; many of the posts are missing elements; and many picket sections are deformed or missing elements.

Deformation along north side

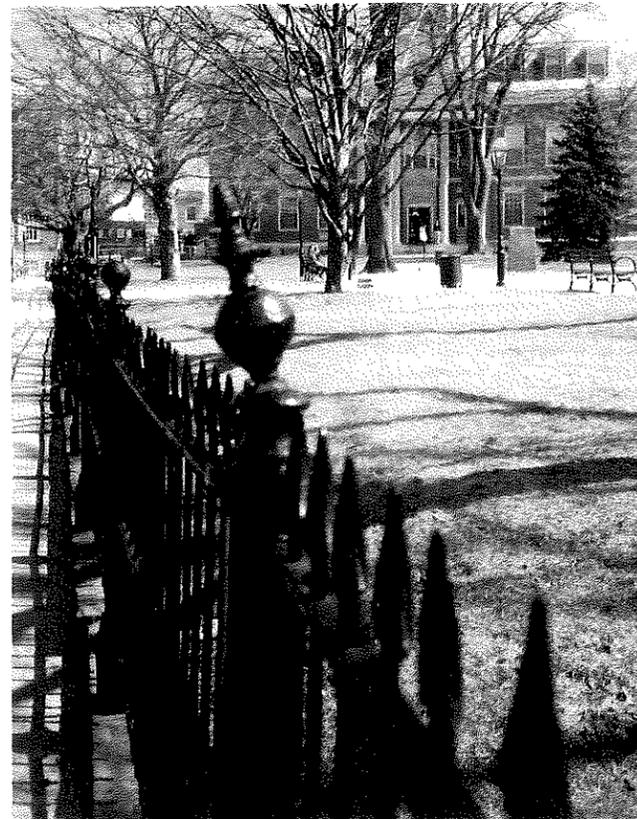
Typical post damage and deformation

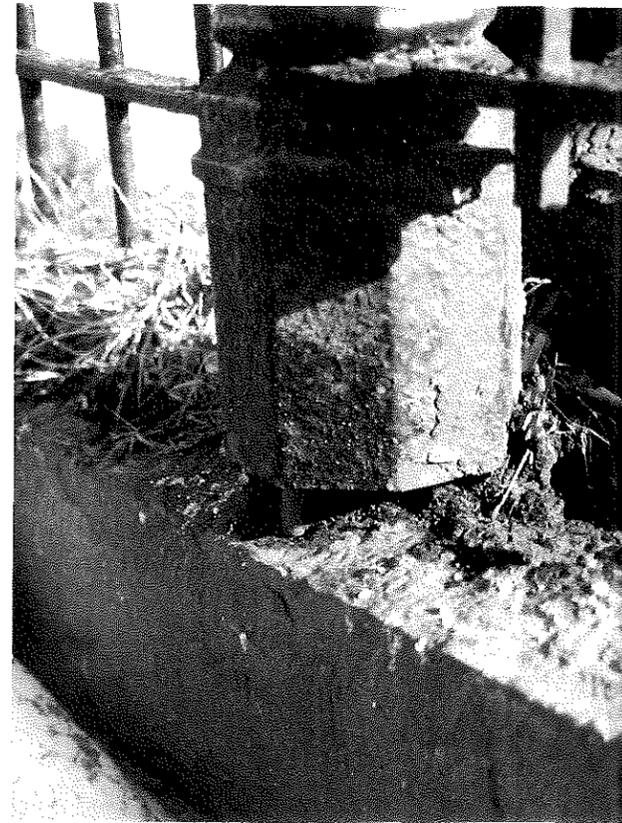
Original mount system in poor condition

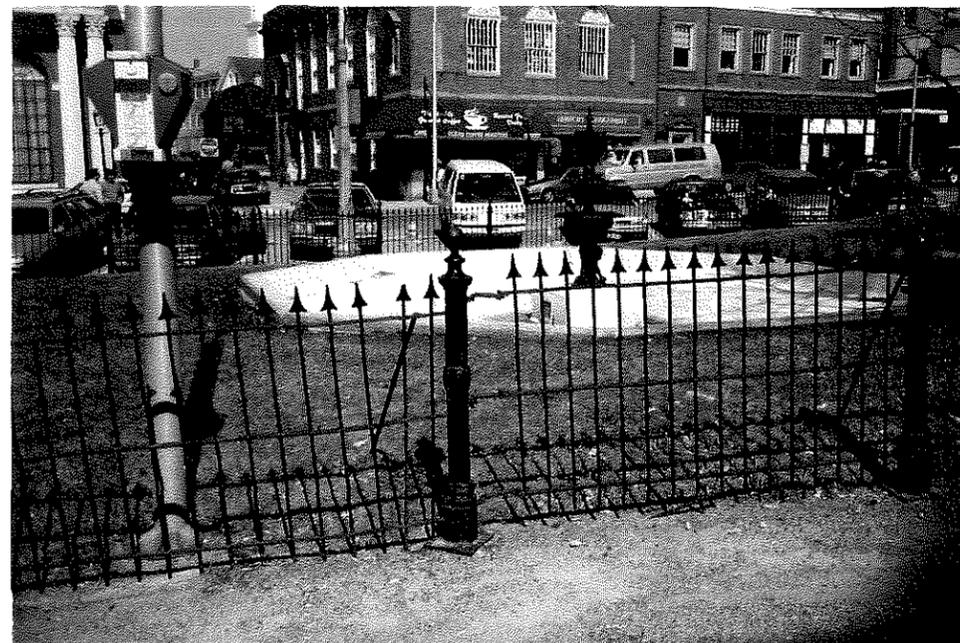
During the last "restoration", the entire south border was set in concrete. This concrete mount, which often rises above the lower rail, has veritably destroyed much of the fence so that it is no longer restorable. Oxidation has destroyed many of the posts: A restoration mount technique utilized galvanically incorrect materials which have exacerbated rust perforation. Condition details listing begin on page 9.

Embedded posts and lower rails; poor quality rail restoration

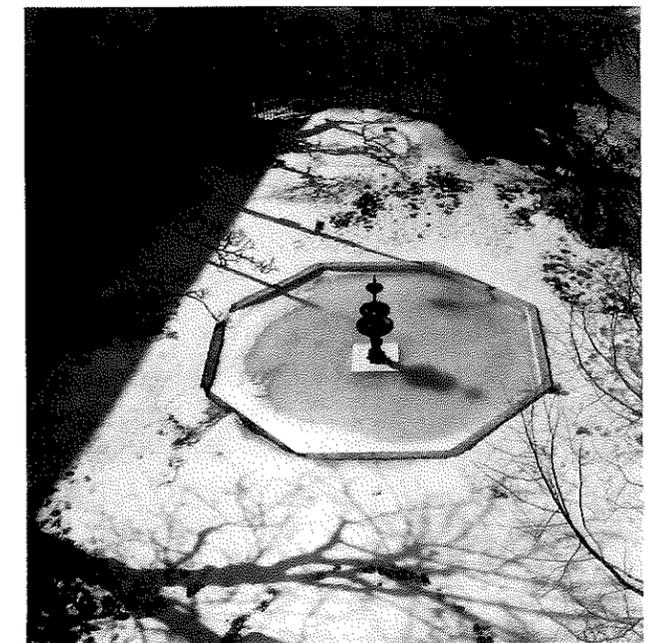
Design The drip fountain is located in the lower section of the Park surrounded by a disproportionately large octagonal fountain pool. The fountain is made from catalog stock items: Robinson Iron Roman Fluted Magnus (three tiers) top; Robinson Iron Griffin base. The fountain was designed for a 5' 6" diameter egg and dart fountain pool and either a much smaller or a more developed landscape (such as a garden).

Aerial view showing disproportionately large pool
