Coddling Farm Barn

Reuse and Rehabilitation
Feasibility Report

Academic Partner:
School of Architecture, Art
and Historic Preservation

Fall 2013

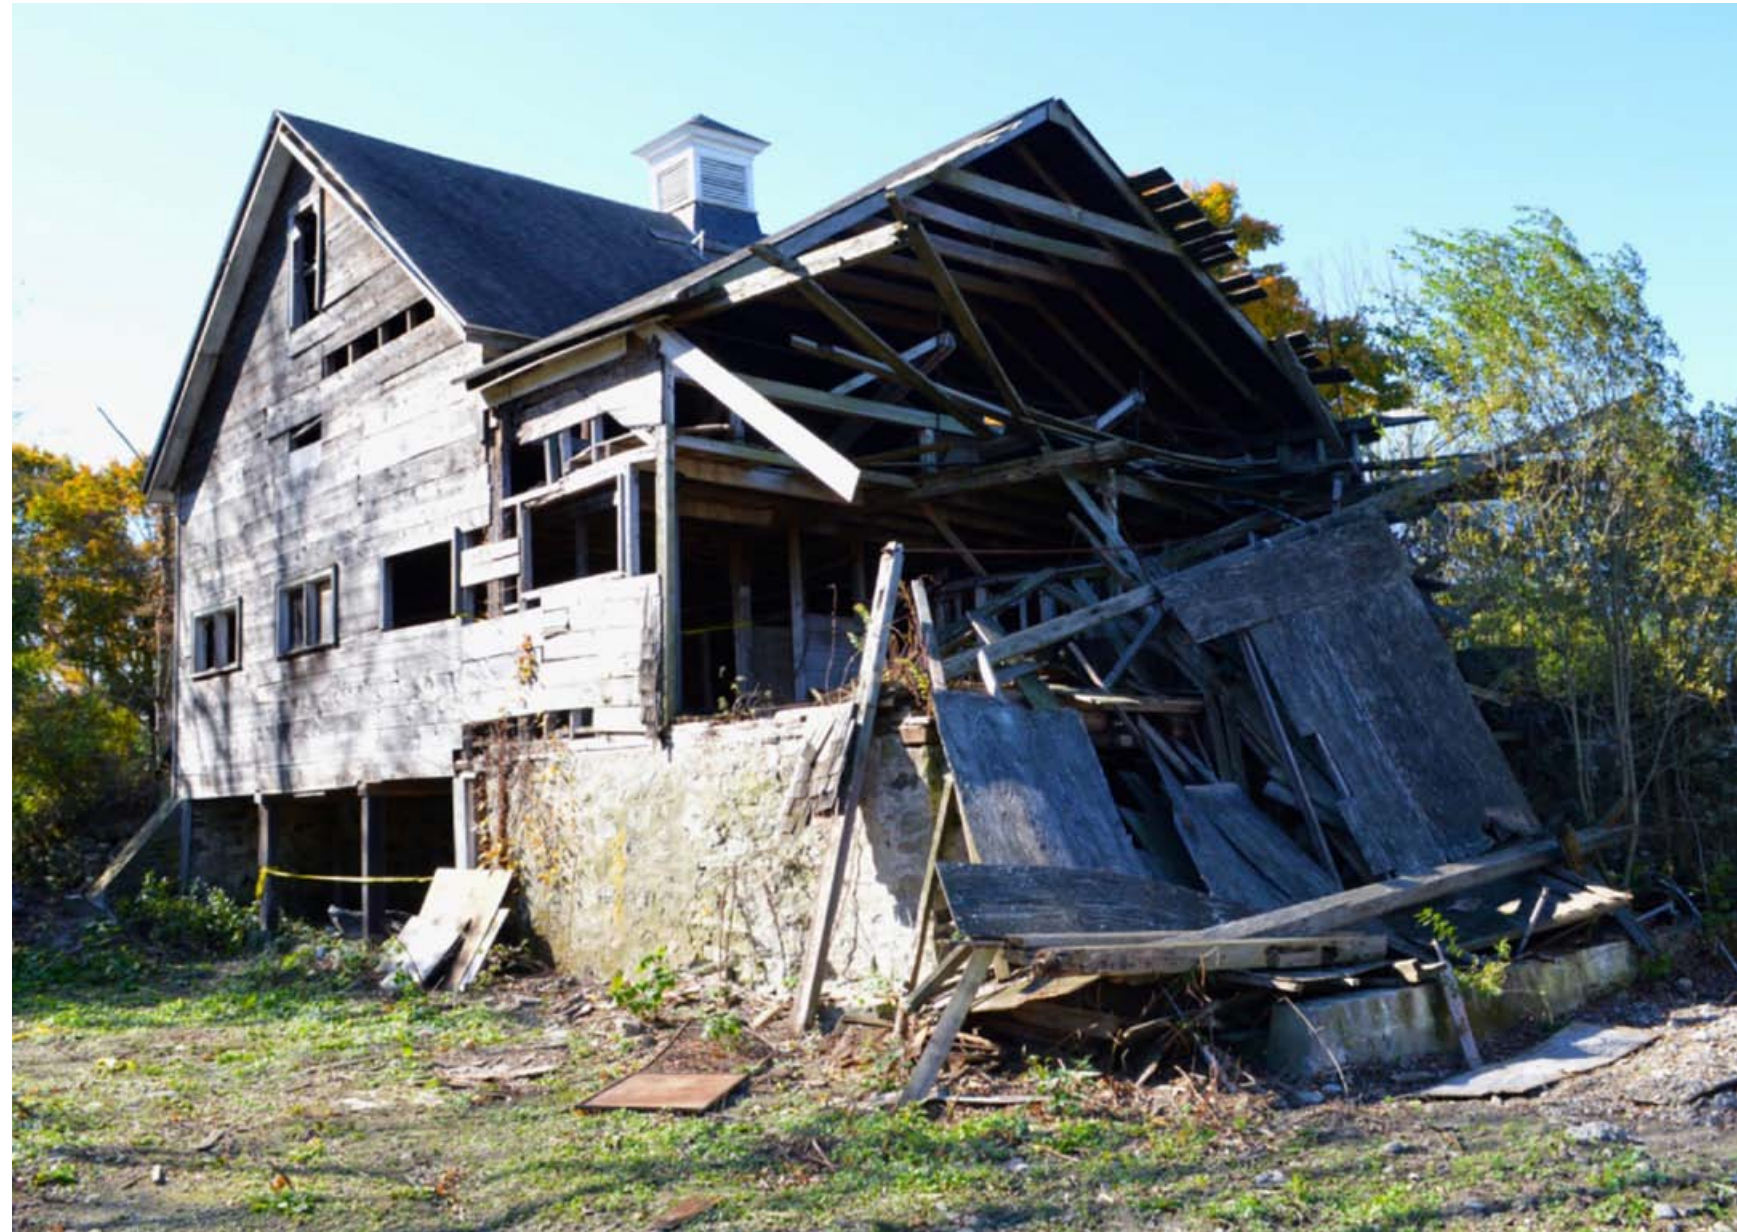
The collapsed northern section of the barn has let the interior become more vulnerable to the elements.

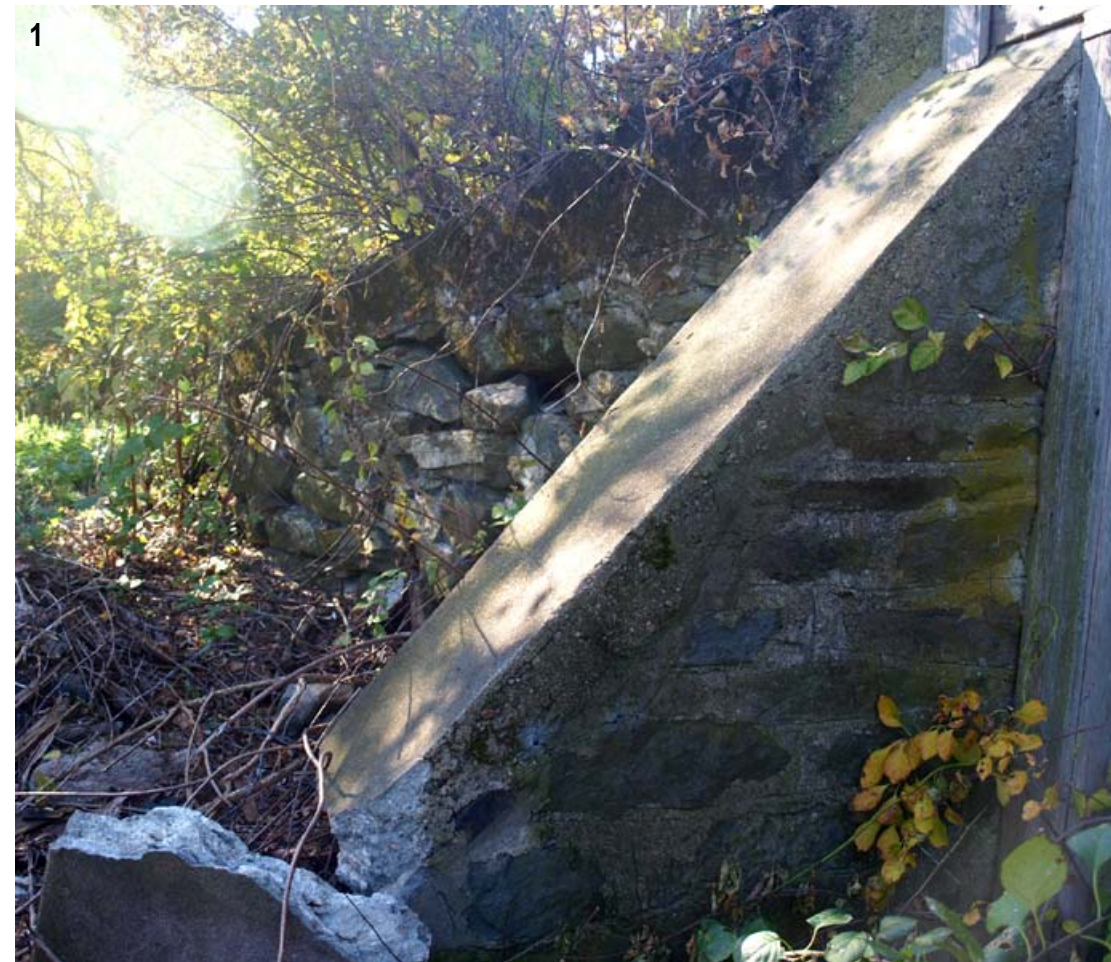
The foundation is in moderately poor condition. On the west and south elevations, the foundation appears to be original, made of rubble stone cemented together. In several places there are cracks or the cement has chipped off, as in the southeast corner. The north elevation has been extensively replaced to hold back the falling hill. This was presumably done after the north elevation of the barn collapsed when they were working on the site. This portion is in excellent condition.

1. The southeast corner of the foundation (made of rubble stone) is chipped off.
2. Deteriorated shingles on the east elevation.

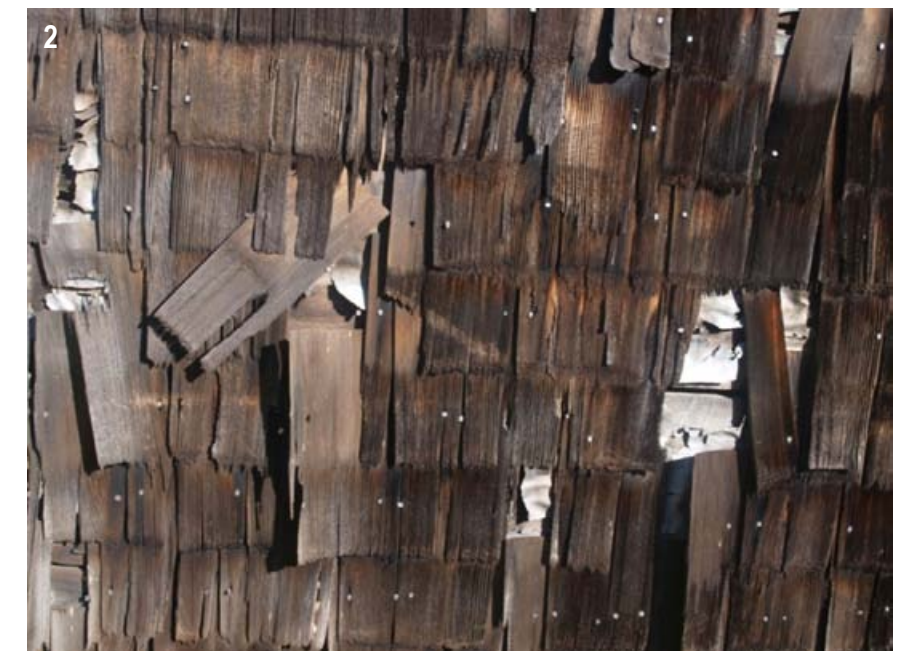
The siding, comprised of wooden shingles, is in poor condition. These shingles are largely rotted out and appear to be original to the barn at Codding Farm. Moss grows on some of the shingles. There are portions of the barn where shingles are completely missing, such as the area on the west elevation. Also, the wall on the north elevation is entirely missing.

- **10.2.1.** All cedar shingles will be removed from the south and west elevations, taking precautions not to damage the sheathing underneath.
- **10.2.2.** The extant portion of the barn will be entirely re-shingled with true cedar shingles to exactly match the historical finish.

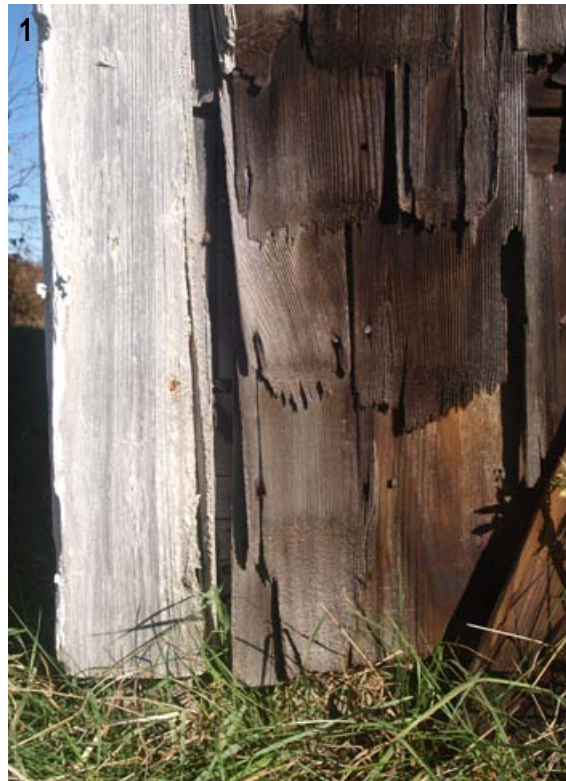
The decorative painted wood trim is original. The trim is flat and plain in design. The wood has weathered and is in need of some repairs and fresh paint.

1. The original decorative trim is weathered and in need of repair.
2. The disintegrating fascia on the east elevation; the soffit is hanging on with just a few nails.
3. The new asphalt roof and the cupola are in good condition.

- **8.2.1.** All extant wood trim will be hand washed with a gentle cleansing solution to remove dirt, grass and any loose flakes of paint.
- **8.2.2.** Any rough edges created from missing paint will be sanded to create a unified smooth finish.

- **8.2.4.** All vertical corner-boards will be tested for material integrity. Any rotted portions, particularly near the ground, will be repaired with wood splices. Epoxy may be used to make small repairs and patch holes. All repairs will be sanded to be congruous with the texture of the rest of the trim.

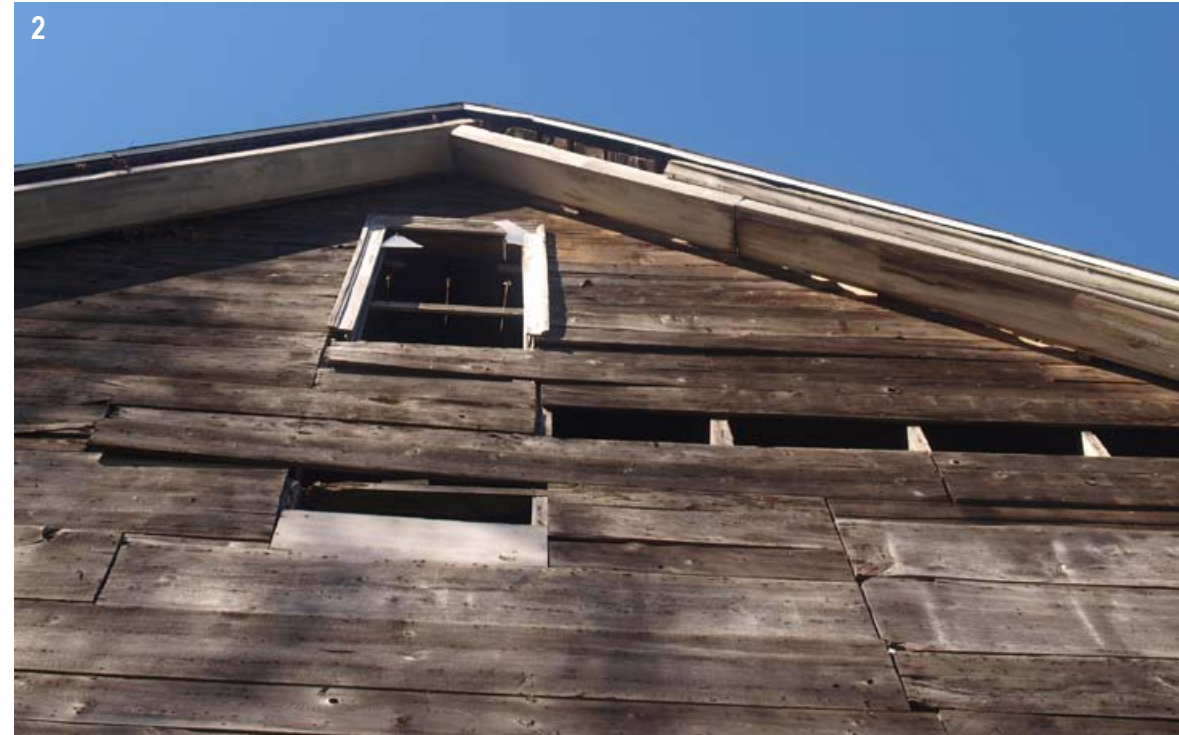
The fascia and soffit were examined from ground level since no ladder was available for a full examination. They are painted wood and have experienced minimal alteration. However, they are in extremely poor condition on the east elevation where the soffit has started to fail, disintegrate and is precariously hanging by just a few nails.

- **8.2.5.** The fascia and soffit on the east elevation will be secured back into place if the material integrity of the wood is sound. If these elements need to be replaced, they will be made to match the fascia and soffit on the west elevation.

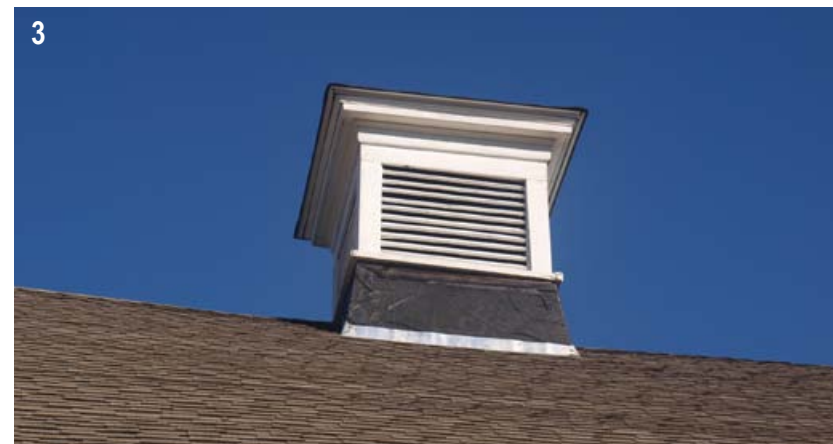
The roofing is in very good condition; it is not original. After the North Attleborough Historical Commission came into possession of the barn, the roof was replaced. The roofing material is asphalt shingles. This is not the material that would have been used originally, but the roof is watertight.

The cupola also appears to have been preserved during the roofing process and is in good condition with minimal to no weathering damage. The base of the cupola was never finished with cedar shingles, thus leaving the waterproofing membrane exposed.

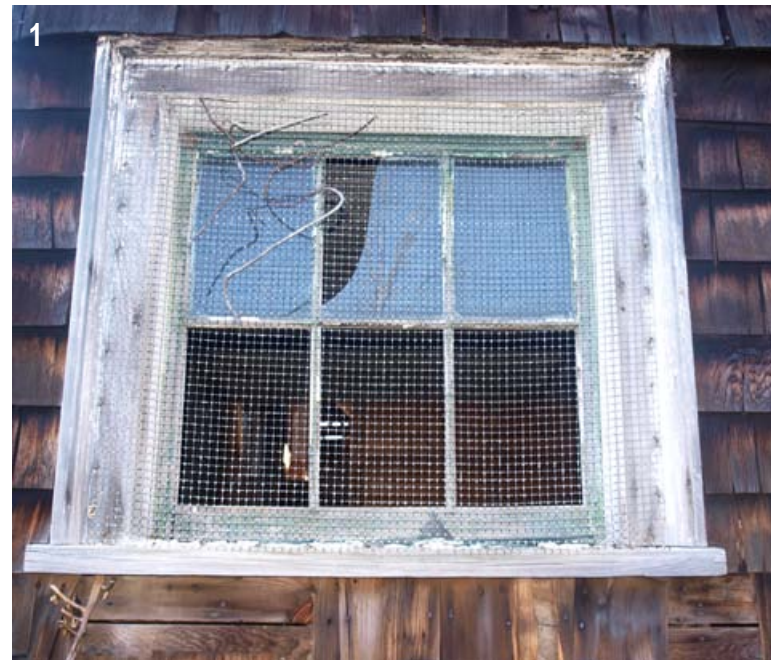
The windows are in varying levels of condition. Those located on the west elevation seem to be relatively protected, and therefore, the frames, sash, glass and glazing are still present. Windows on the east elevation have been completely removed leaving only the openings and frames. Some windows on the west elevation have a metal wire mesh on the exterior.

1. West elevation window covered with metal wire mesh.
2. Many of the structural beams are rotting away and need to be replaced.
3. The collapsed north elevation is precariously balanced on a crooked wooden column.

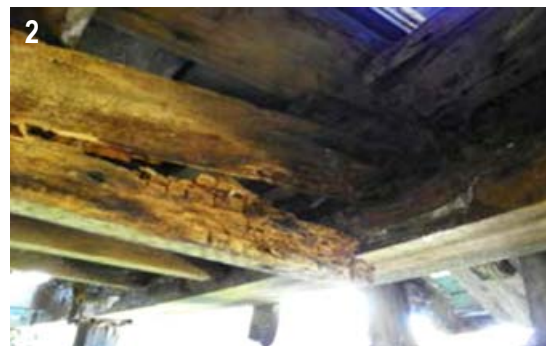
The structural system for the Coddling Farm barn is in very poor condition because of much rot to structural members. In several areas beams are on the verge of completely rotting away. Beams are also precariously balanced. At one point someone tried to make the barn structurally sound by jacking it up in several places. This was done poorly. These jacks are not on level ground, and the timbers balancing on them are not centered. On the first floor, the entire north elevation, which has collapsed, is resting on unstable structural support.

- **3.2.1.** Primary structural beams that are rotted or damaged by collapse will be replaced using wood to match the existing ones in materiality and dimension. Floor joists that can be salvaged will be; new joists will be added to replace any that are not structurally sound.

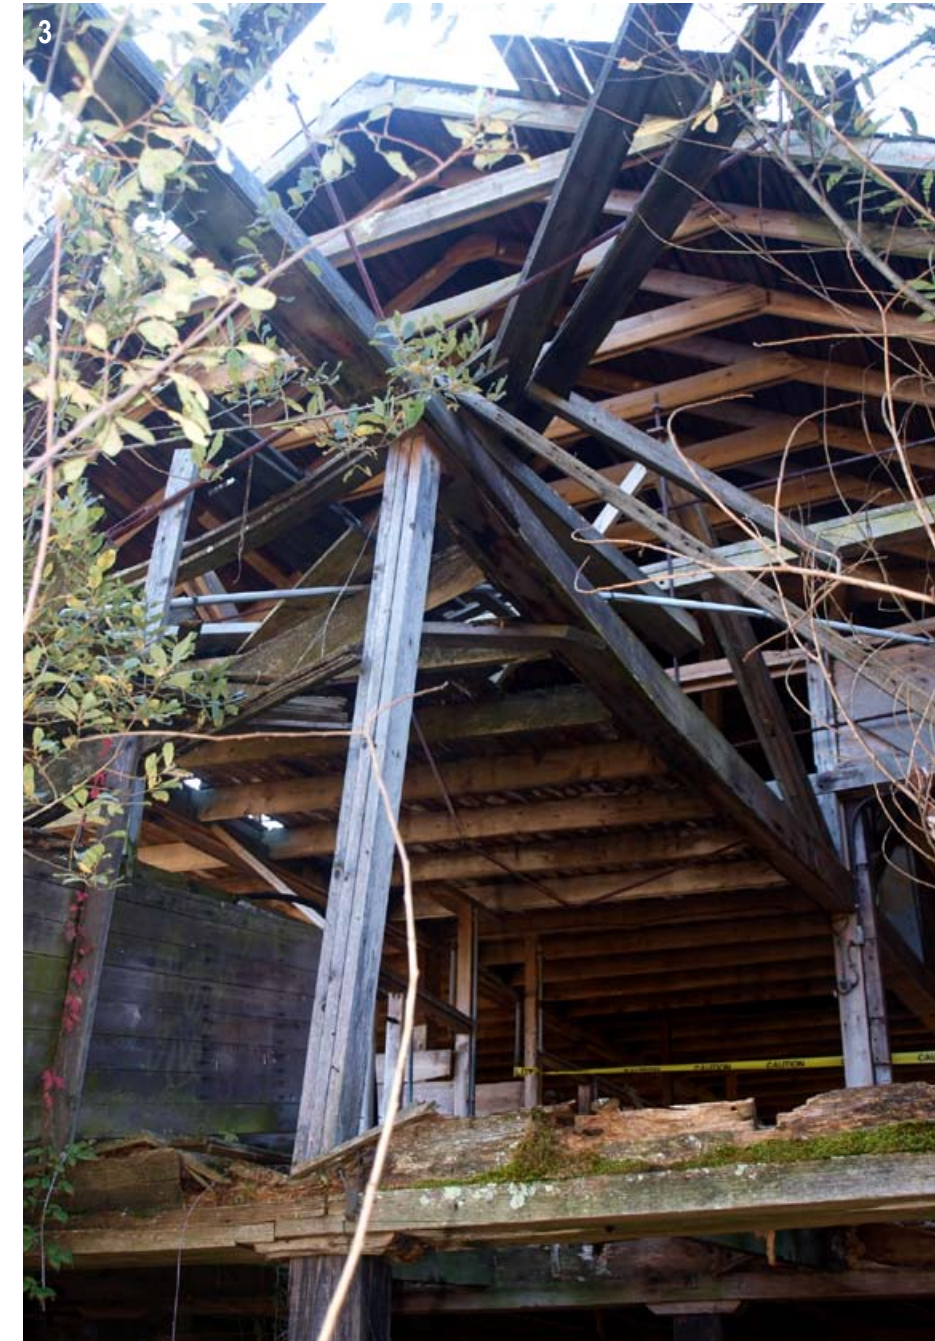
1.1. Existing Conditions: The north elevation structure has collapsed and compromises both the structural integrity and longevity of the still extant portion of the barn.

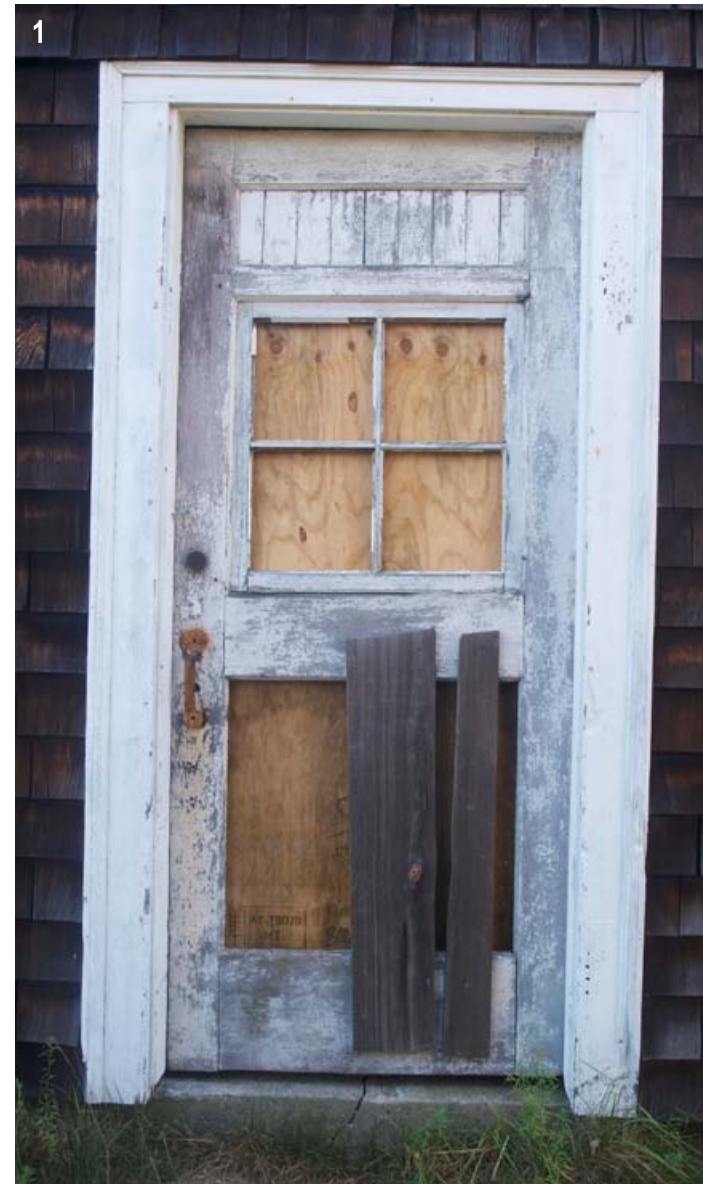
The barn has four different types of doors. The south elevation contains two: a regularly dimensioned solid access door and the primary sliding barn door. Both of these doors are extant, but the wood and paint have weathered and started to split towards the bottom. The access door on the west elevation is the most decorative, however, the wood is badly damaged—most likely the result of vandals—and has since been patched. Lastly, there were three doors on the bottom ground level that have been pulled off of their hinges. Only one of these is extant on the site, laying on the ground in very poor condition.

1. The door on the west elevation requires extensive repair or replacement.

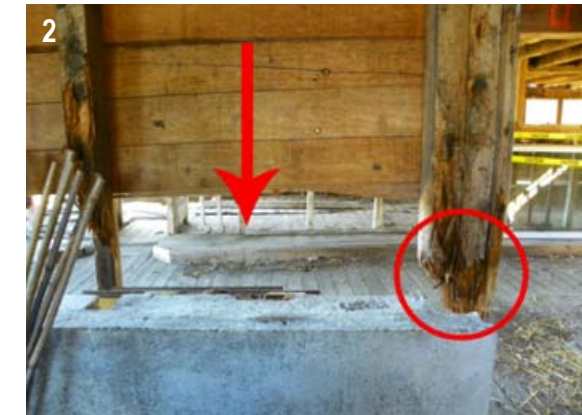
The walls all appear to be original to the Coddling Farm barn. They are all made of wood and have no insulation. The wall on the north elevation is completely missing. There are few interior walls. The condition of the walls is mixed. Some places are in good condition; other places show boards

missing and large portions of rot and termite damage. There is much paint failure, and graffiti is also present.

2. Walls show rot and termite damage.

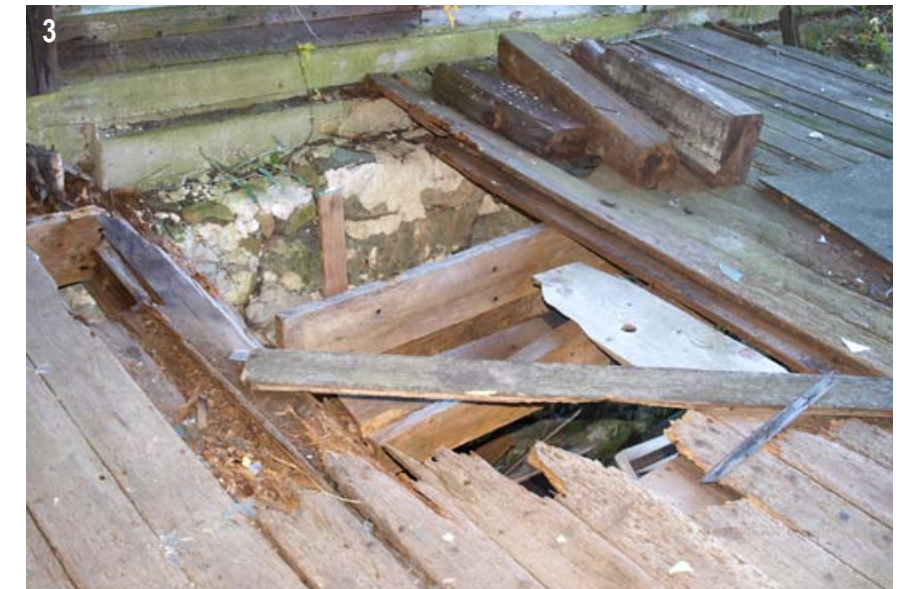
The floors can be divided into three identifying sections: the section taped off by the north elevation; the section adjacent to the east elevation where the cows stood; and the rest of the floor. The first two sections are in poor condition. Due to the north elevation wall falling down, much of the floor is missing, making the area completely unsafe for walking. Even in the areas that do have flooring, there are large gaps where floor boards have rotted away.

The section adjacent to the east elevation is also unsafe. This area contained the trough for the cows, and the entire trough is rotted out. Also, several boards are missing or rotted. The rest of the flooring is in better condition. It contains some rotted out areas and missing boards, but overall it is in fair condition.

3. Large sections of flooring have been broken or rotted away.

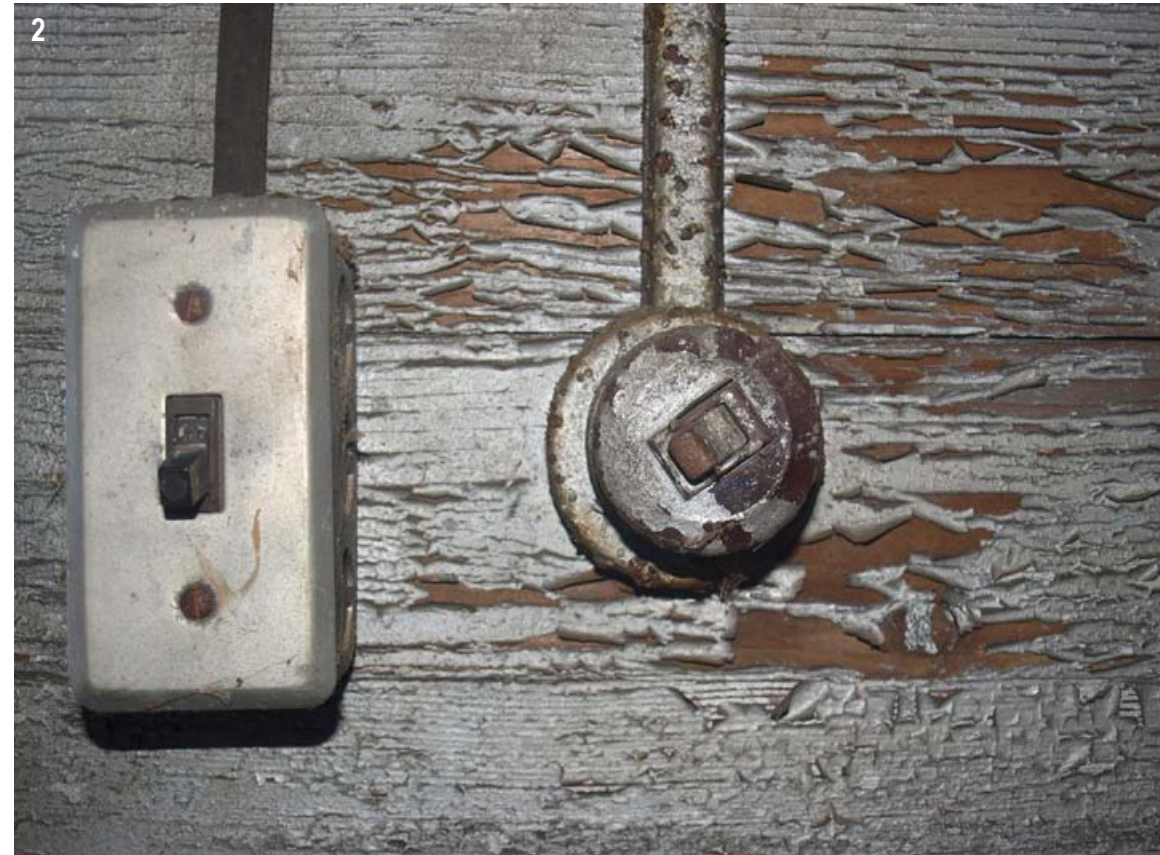
Some original hardware remains extant in the barn such as hinges and door knobs, although most are extremely rusted.

1. Some original hardware remains, although it is extremely rusted.

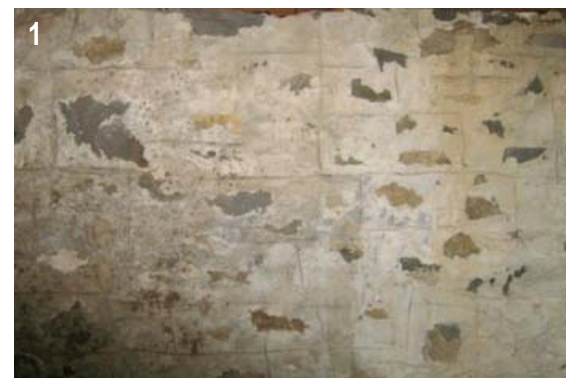
2.1. Existing Conditions: The fieldstone foundation wall was top-coated with plaster, but

portions of this finish are missing, and some stones have become loose in the mortar. There is also damage from moisture in terms of bio-growth.

1. A detail of the original rubble stone foundation – the top coating has been scored to resemble a more regular stone block.

- **2.2.1.** Bio-growth will be removed from the stones using a biocide compound.
- **2.2.2.** Remaining plaster will be carefully removed from the south and west walls, but the best portion of the finish on the east wall will be preserved to illustrate the plastering technique and scored pattern.
- **2.2.3.** The stone foundation wall will be re-pointed using a historically authentic lime mortar, paying careful attention to the areas in which the mortar has failed. Missing stones will be replaced as part of this process.

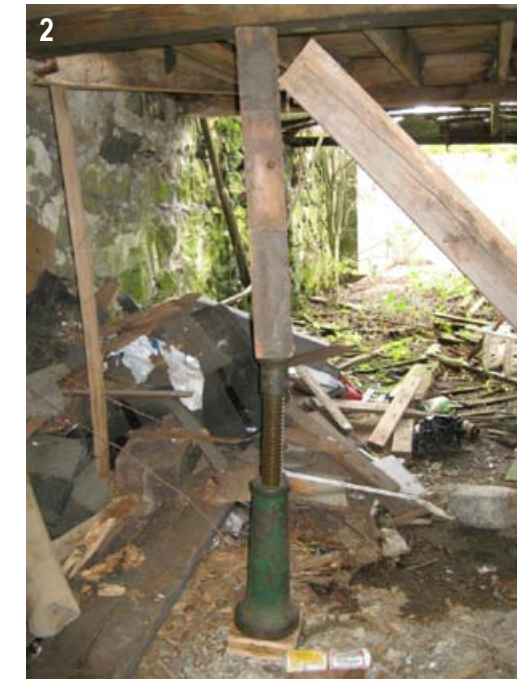
4.1. Existing Conditions: The primary wood columns and secondary wall studs show a variety of conditions. Most notably, the columns at the foundation level have been cut to remove rotted portions and are now supported by concrete footings. The columns on the first floor level have been reinforced with additional pieces of wood. An additive process of building up the structure is evident, although it is not clear if this is

2. The columns at foundation level need to be replaced. The temporary jacks are not on level ground.

- **4.2.1.** The columns at the foundation level will be removed and replaced with new material or salvaged pieces of the proper length. The obtrusive concrete footings will be removed.
- **4.2.2.** Vertical structural members at the first floor level will be replaced with wooden columns that are dimensioned to support the structure without added pieces and patches of wood.

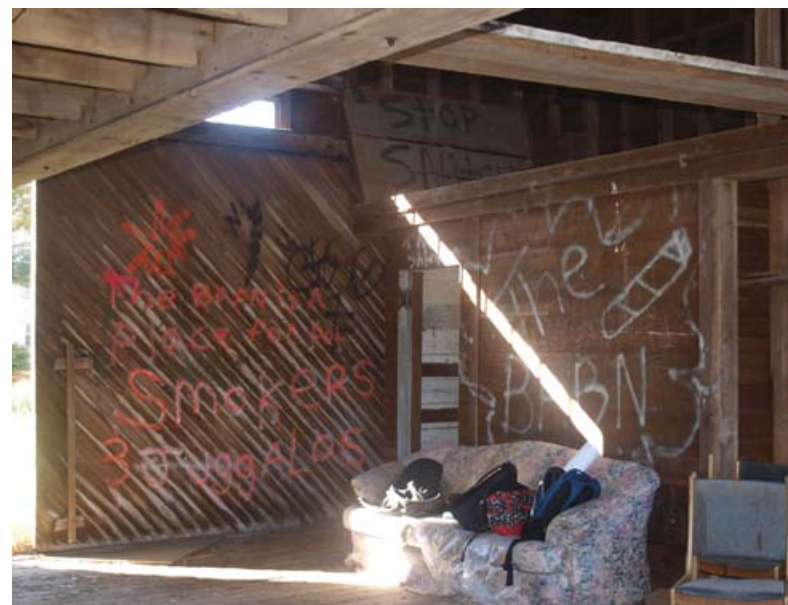
7.1. Existing Conditions: The south elevation on the first floor level has some extant interior wood paneling in fair condition, but the majority of the finish is missing. The interior walls of the main space on the first floor towards the west are also paneled in good condition with a natural finish, but some are broken and missing at the far north end. The walls of the dairy wash-out room and service space are wood paneled in good condition in terms of material integrity, but the paint finish is in poor condition. All of the wood paneling has been marked by graffiti.

The graffiti marking the wood paneling on many of the interior walls will be removed.

- **7.2.1.** Wood paneling that is not painted will be sanded to remove the graffiti paint as well as smooth out any scratches and etches left by vandals.
- **7.2.2.** Wood paneling that is missing or severely damaged will be patched or replaced with new wooden boards of the same type, texture and dimension. This will be done so there are no obvious vertical seams, especially towards the north end.
- **7.2.3.** Wood paneling that is painted will be tested for lead levels; if the tests return positive, additions will be added to the scope of work to safely abate the potentially hazardous material.
- **7.2.4.** Painted wood paneling will be hand washed to remove grime and loose flakes of paint, then sanded to create a smooth surface. Lastly, the wood will be repainted for a fresh finish.

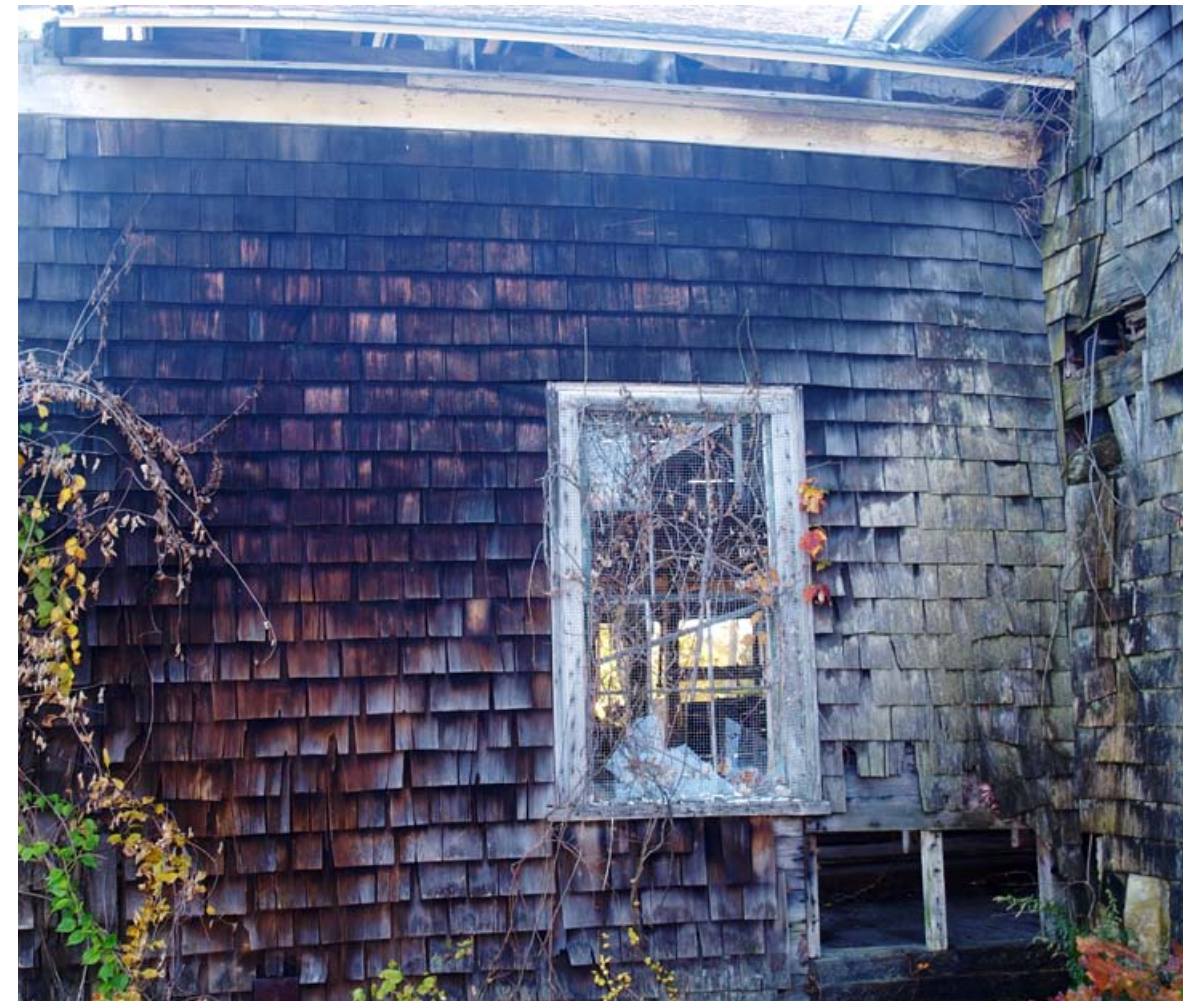
10.1 Existing Conditions: The cedar shingles that are still extant on the south and west elevations are in poor shape, as they are completely deteriorated. Many shingles are broken or missing entirely. There are no cedar shingles on the east elevation.

The south and west elevations of the barn will be entirely re-shingled with true cedar shingles to exactly match the historical finish.
