The Fuller Farmstead

Reuse and Rehabilitation
Feasibility Report

Academic Partner:
School of Architecture, Art
and Historic Preservation

Community Partner:
The Barnstable Land Trust,
Barnstable, MA

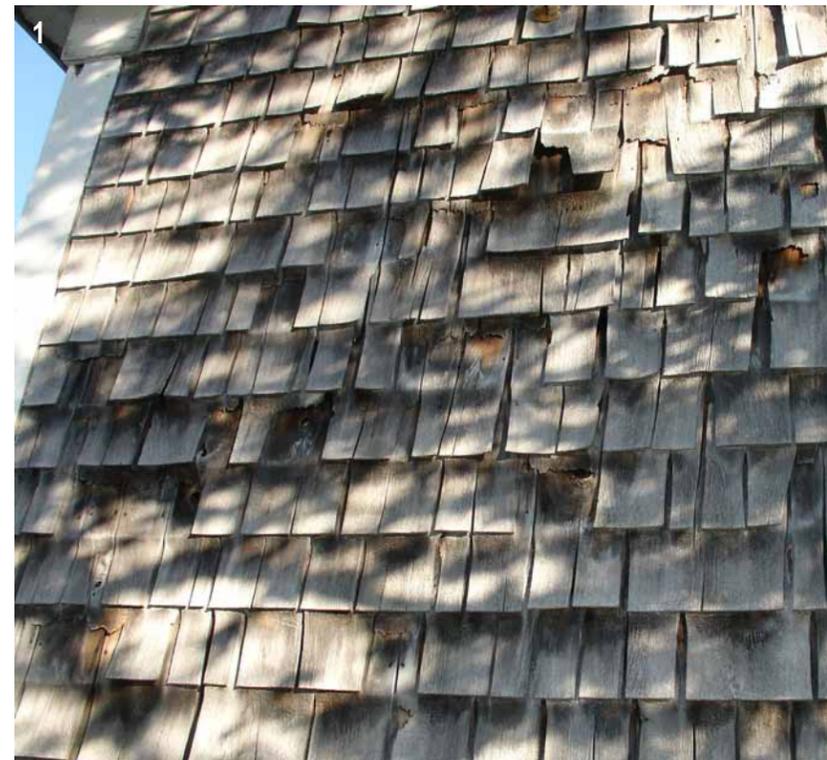
- Shingles are in poor or fair condition.
- Shingles are attached with machine-manufactured cut nails.
- Approximately 75-80% of the shingles are missing or have weather damage.
- Shingles on the second floor are rotting and in poor condition.
- There is no base trim or splash board.
- There is no vapor barrier between the shingles and sheathing.

1. 75-80% of the wooden shingles are damaged or missing.

- Remove existing shingles.
- Replace damaged shingles in original starter course.
- Add layers of rosin paper (Trimaco Red Rosin Paper) to help with sheathing and contracting of shingles.
- Install new cedar shingles
 - **Option 1:** Cedar Shingle Panes: Shakerstown Webster Gray 004-ST semi-transparent cedar shingle panels.

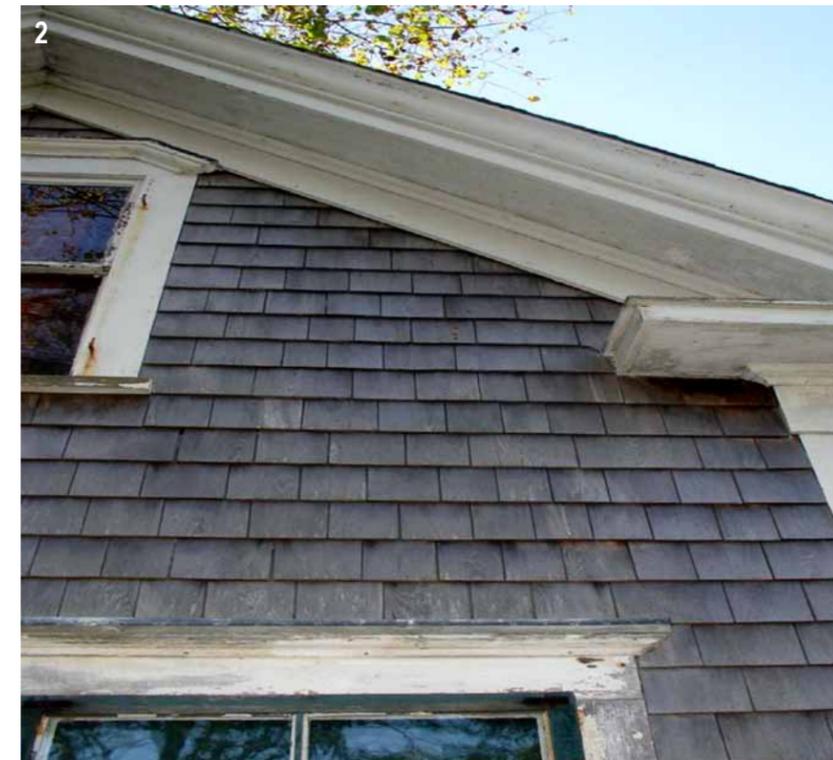
- Exterior trim shows signs of wood rot, extensive moisture damage and splitting.
- Evidence of damage from animal nesting is seen along the fascia on the roof line.
- Trim paint exhibits signs of wear and oxidation.
- First floor trim has little paint, while trim on the second floor has no paint.
- East elevation bead board is sinking and in poor condition.

2. Architectural trim shows wood rot, moisture damage, wear and oxidation.

- Replace sections where there is wood rot, extensive moisture damage and splitting.
- If a section has less than 20% rot, remove the damaged portion, seal with an epoxy-based sealer, fill, sand and finish.

- If section has more than 20% rot, remove the damaged portion, attach new material with replacement wood – either salvaged or new.
- Seal all animal nesting and bird holes with Dutchman Patch.
- Remove loose, flaking or checking paint by removing surface edges. Using two coats of primer, apply a white final coat with latex satin finish paint.

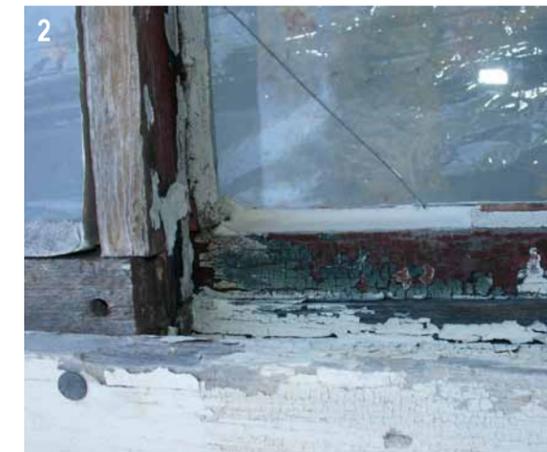
- East porch is missing trim boards.
- Porch indicates moisture and insect damage.
- Porch sills supported on concrete piers.
- Porch posts are missing ornamentation trim.

- Exterior wood sash storm windows are placed over windows.
- Storm windows show decay and failure, including: rotten sashes, broken glass and lack of glazing.
- Windows are not weather-tight or insulated.
- Two-over-two double-hung sash windows.
- Two-over-two double-hung sash windows have cylinder glass.
- All windows of this type on the structure show glazing failures, sash failures, broken panes and significant weathering.
- Sashes are in need of repair and rebuild.

- Chimneys consist of two brick and one stove pipe.
- Chimney in northern ell shows signs of cracking and moisture damage.
- Chimney on southern ell is missing above the roof line.
- Flashing around all chimneys is in poor condition.
- Both brick chimneys show signs of being rebuilt within the last ten years; however, the mortar used looks to be Portland cement, which will cause brick deterioration and cracking.
- The profiles of the rebuilt chimneys are not true to the profiles indicated in the historic 1890 photo.

1. East porch sills are supported by concrete piers.
2. Storm windows show decay and failure.
3. Chimney in northern ell shows signs of cracking and moisture damage.

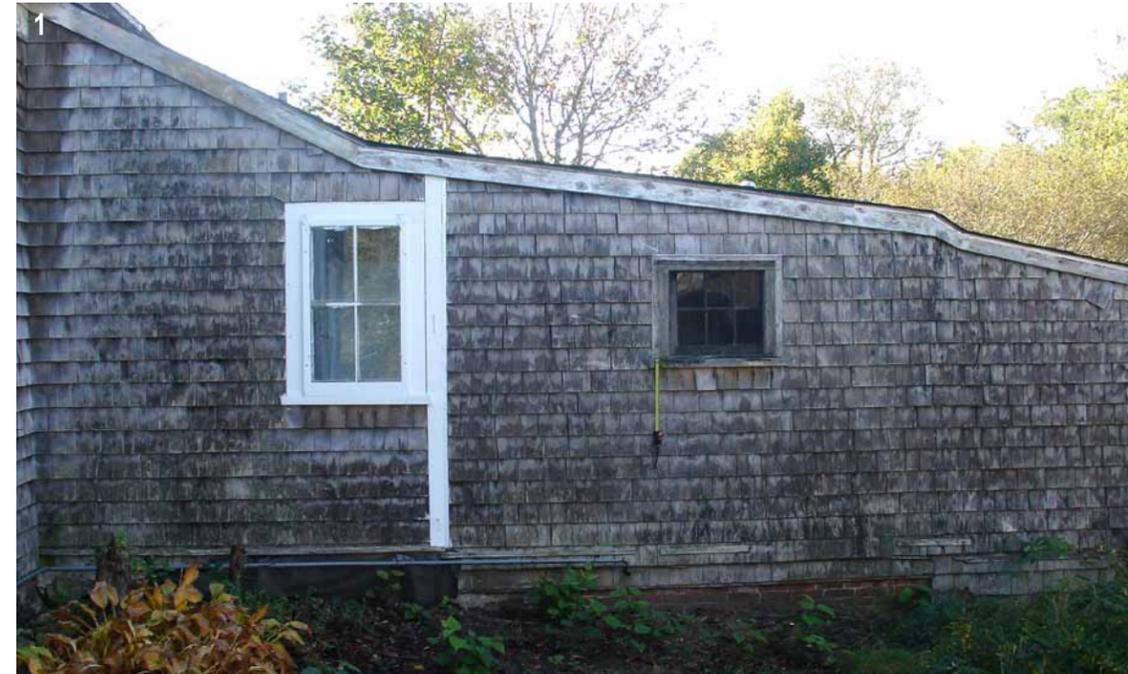
- Southwestern ell constructed at three different times.
- Moisture and weather have damaged the third part of the ell.
- Separation of second section of ell reveals horizontal planning.
- Southwest corner indicates structural failure.
- Window missing and replaced with plywood.
- Foundation consists of fieldstone, brick and cinder blocks.
- Second and third ells are in poor condition.

1. The exterior ell on the western elevation was constructed at three different times.

- Second and third section of ell will be demolished.
- Retain first section of the ell, which has the fieldstone foundation.
- Install windows in remaining ell with matching windows from the rest of the structure.
- First section of the ell should be replanked and reshingled in line with the existing exterior structure.

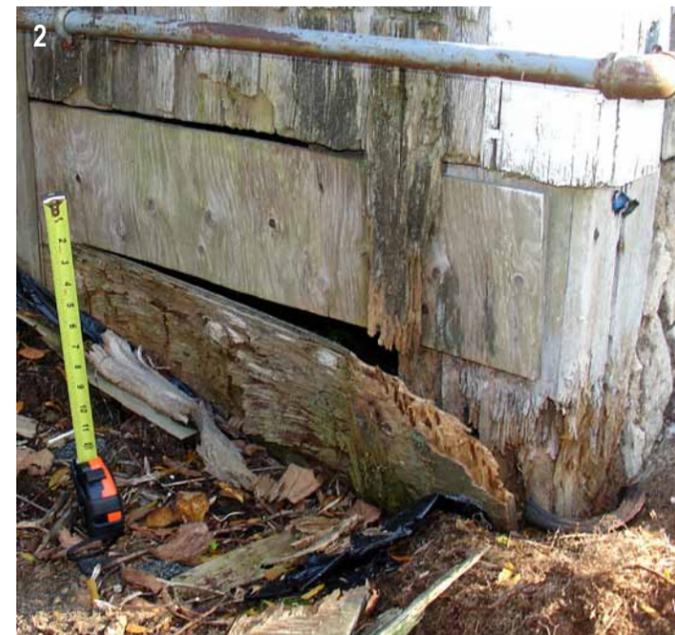
- The foundation includes round poles, roughly 10" tall and 8" in diameter, which are embedded within the walls. It is unknown how deep the poles run.
- Poles are located midway across the foundations walls and at the corners, but it is not apparent if the poles actually help support the structure.
- Currently, the sills rest unattached upon the poles.
- Foundation poles are extremely decayed.
- There is a hole approximately 10" wide from ground level to sill, located immediately below the double-hung windows in the central part of the western wall. This appears to have been made as an access path.
- The foundation has a point of failure in the southwest corner. Signs indicate that part of the foundation was removed to allow access under the new wing of the house. This hole is currently covered with rotting plywood.

2. Portions of the south west corner foundation were removed, and the hole is covered with rotting plywood.

- Program calls for a new foundation to be installed under the main structure to create a basement.
- Rubble façade should be added to replicate the original appearance.
- Replace wooden poles at corners/midpoints with concrete piers.
- Restack and recement stones.
- Fill access holes with stone/concrete that match the exterior of the structure.
- Recement and restack foundation at southeast corner.
- Construct angle iron frame with metal doors on southwest corner.

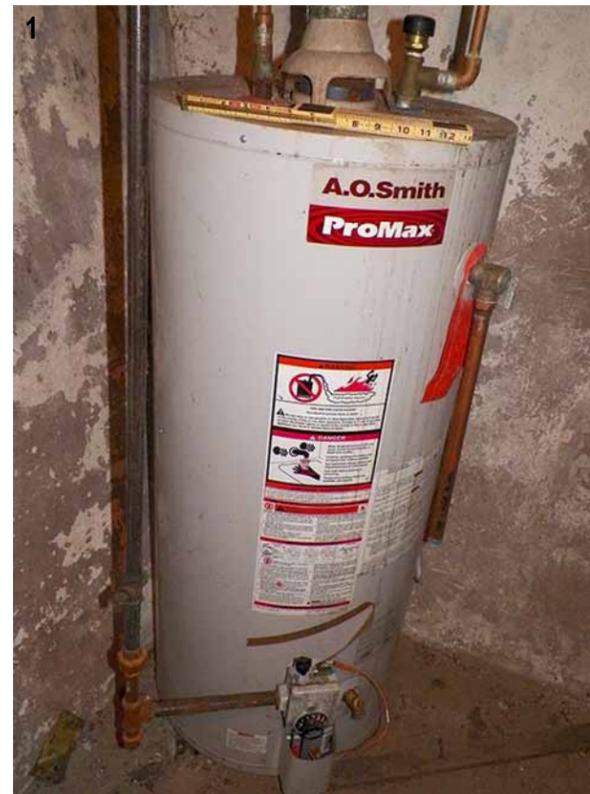
1. Gas hot water heater appears to be new.

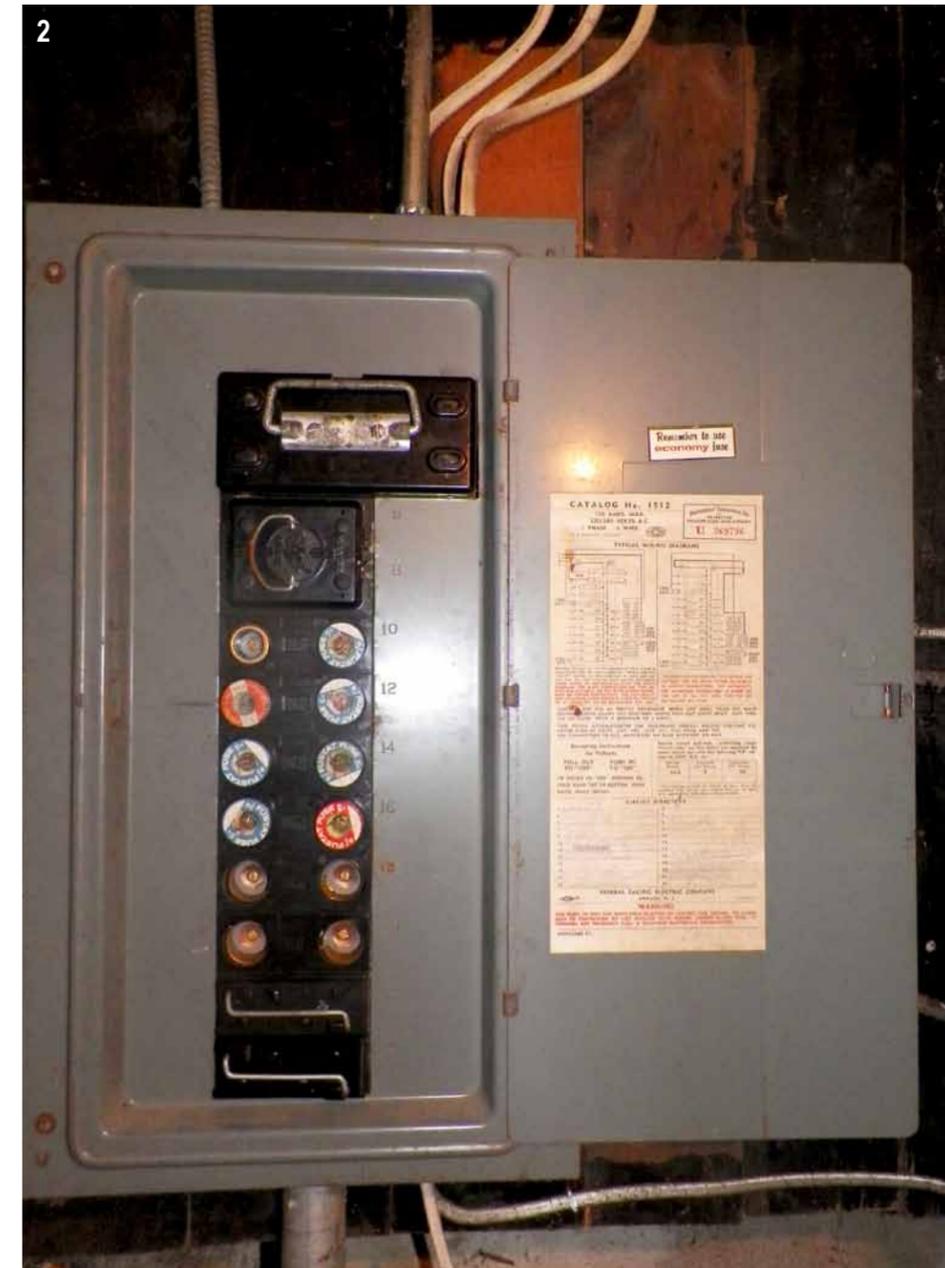
- The electrical system reflects different generations of wiring.
- The panel is a 150 amp maximum panel.
- The circuit panel is of the round glass fuse type, with large block main fuses.
- There are broken fuses in some circuit areas and fuses missing in others.
- The branch wiring is of three different vintages: cloth (possible), metal sheathed and Romex style.
- It's not possible to determine if any of the wire consists of aluminum rather than copper.

2. Electrical panel is 150 amp maximum.

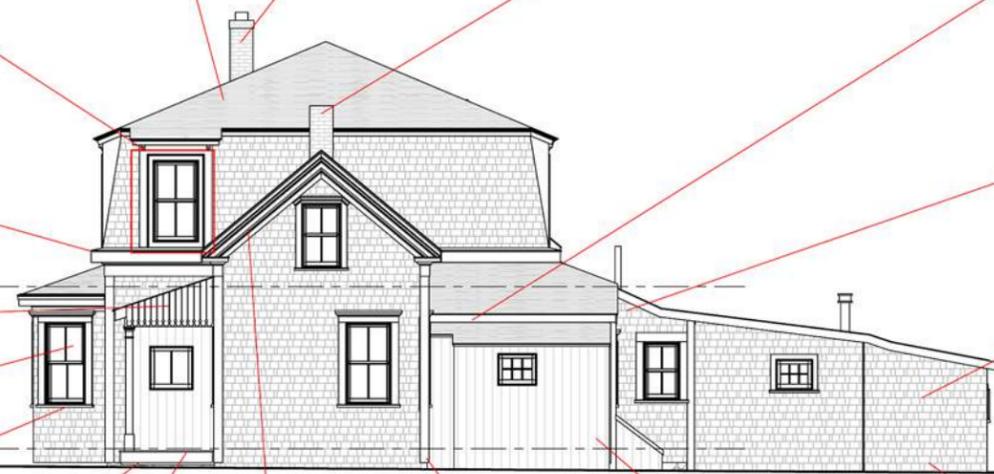
EX 2.2

Window has total failure of glazing putty and paint. Cylinder glass panes have cracks. Accumulation of bio. growth, dirt and other natural elements on glass panes and along sill. Not weather tight. Typical.

3-tab asphalt shingles are recent and in good condition. Typical.

Masonry chimney stack has poor repair work.

Brick chimney has failing mortar joints. Accumulation of bio. growth, creosote, and dirt. Typical.

Improper flashing installation

Significant water damage. Cedar shingles damp and decaying.

Cedar shingle siding (5"x6" exposure) is weathered, broken, cracked, cupping, or missing. Typical.

Decorative trim weathered, damaged, improperly repainted. Typical.

Some panes have been replaced with sheet glass.

Storm Windows have rotting frames. Many also have crack panes of glass. Not weather tight - some barely attached. Typical.

Corner post bottom severely damaged and decaying

No foundation. Wood supports are decaying and cinderblocks crumbling

Wooden porch posts are weathered, damaged, have failing paint and separating joints. Typical.

Wood band board and decking has water damage, bio. growth and is significantly decayed. Typical.

Trim and raking boards have crazing, peeling, and loss of paint. Soffit has hole and other damage

Lean-to exterior beadboard has bio. growth and decay.

Wood framing members are decaying. Currently sagging and has no structural integrity.

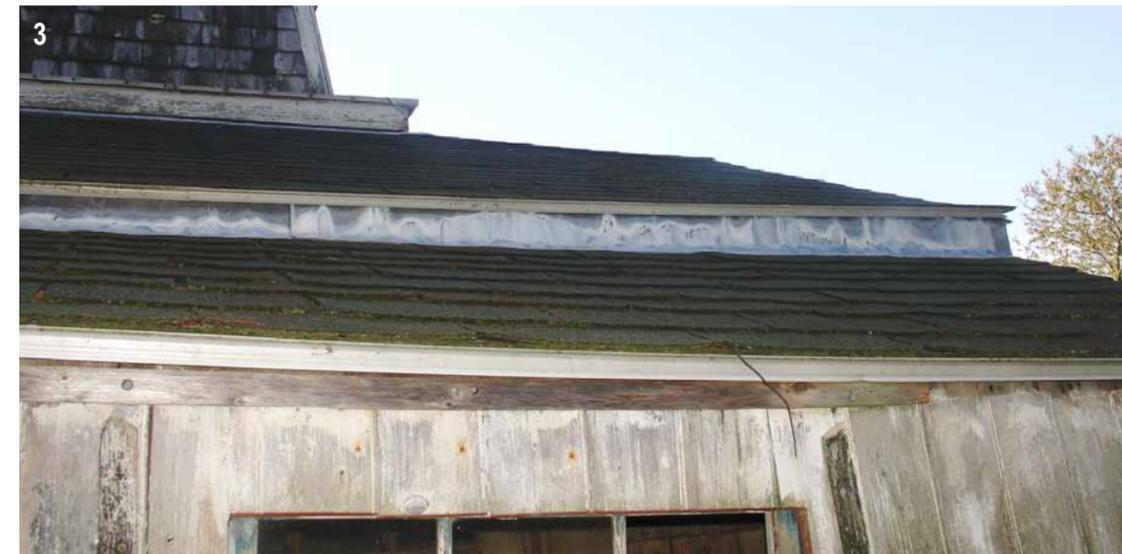
2. Restack and recement foundation stones.

3. Replace some roof shingles and check the integrity of the flashing.

- Replace cupped or curled shingles with like shingle material.
- Check security and integrity of valley flashing.
- Replace and repair damaged or loose shingle pieces.

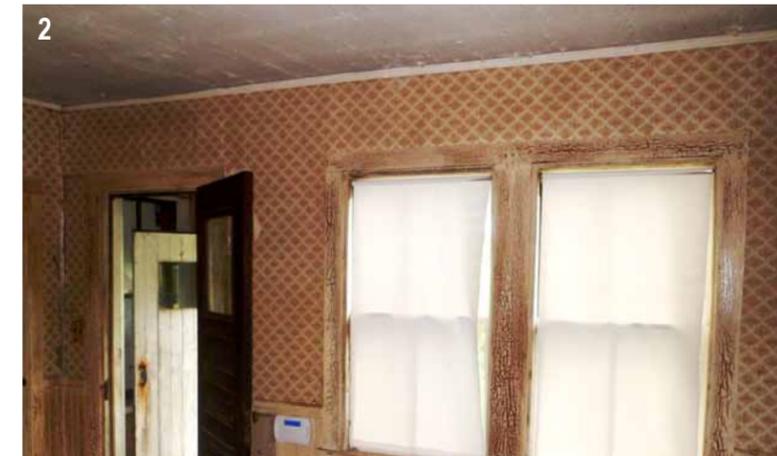
1. The shed on the property needs to be removed due to structural failure.

2. Damaged wallpaper to be removed and replaced. Ceiling cracks to be repaired.

- Damaged walls should be stripped, removing loose or broken plaster.
- Gypsum plaster should be used according to Brief 21, Repairing Historic Flat Plaster.
- Structural cracks at stairs should have interior studs braced and plastered.

- Existing shed should be removed due to structural safety concerns.
- Removal of the shed will improve the view shed of the property.

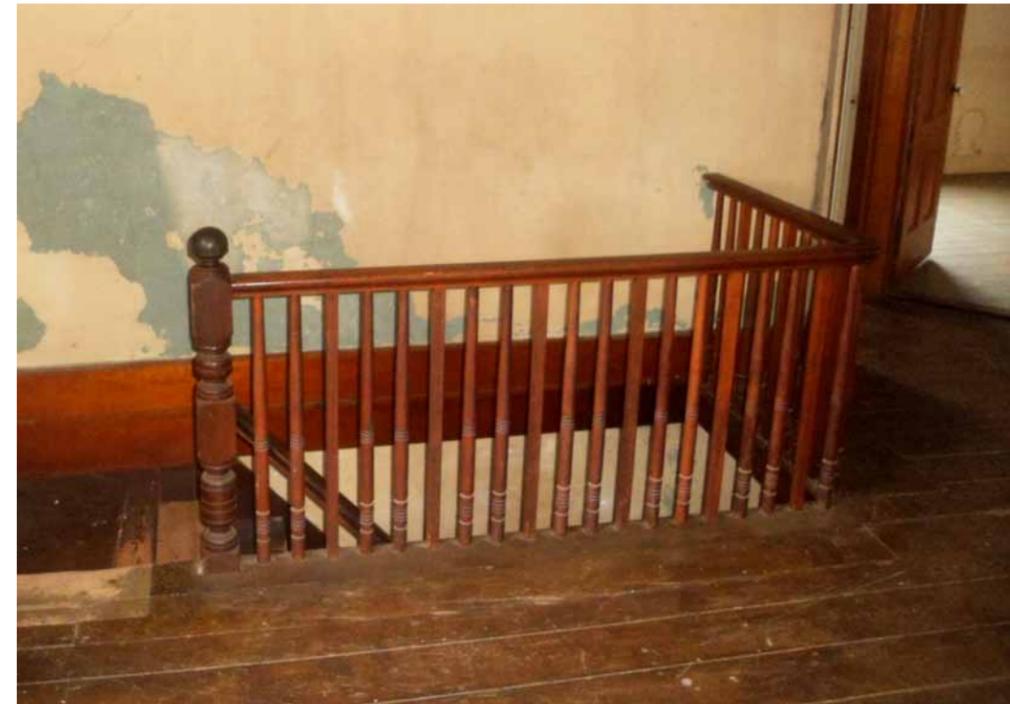
Wood floors and banisters need to be cleaned and refinished.
