Longley Building

[Reuse and Rehabilitation Feasibility Report](#)

Community Partner:
City of Woonsocket, RI
Fall 2012

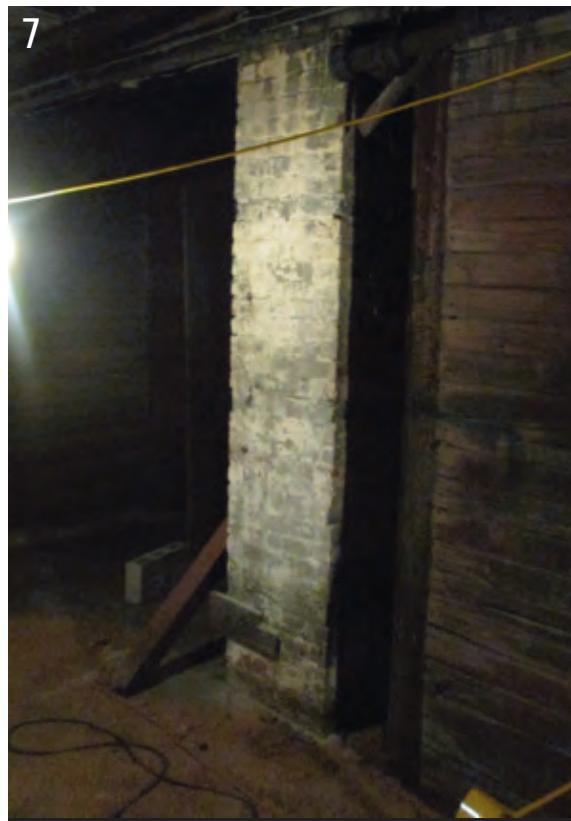
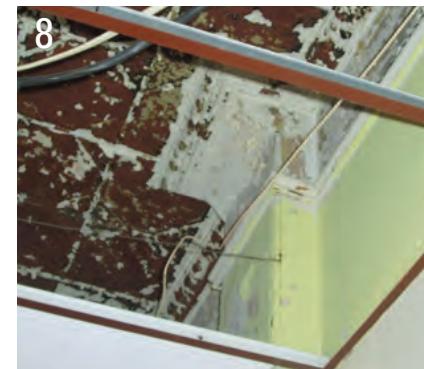
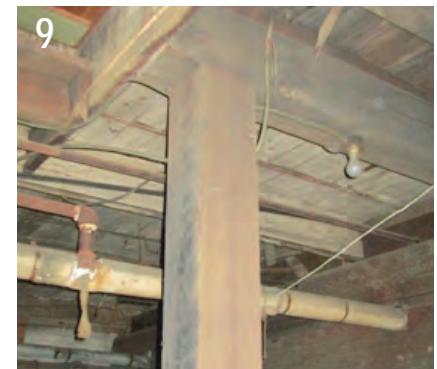
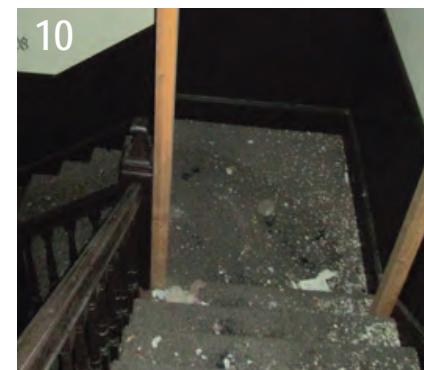
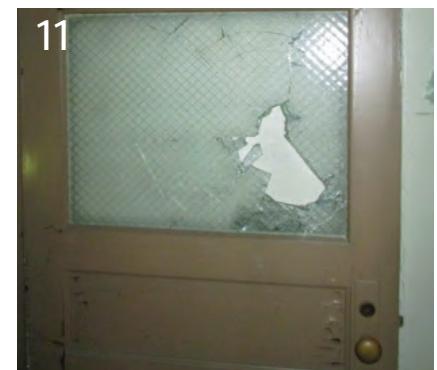
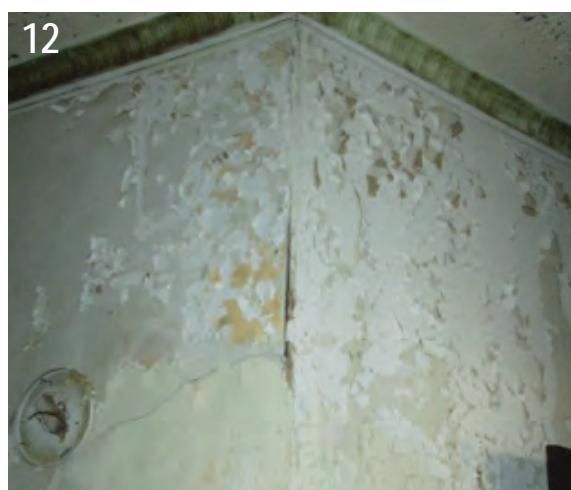
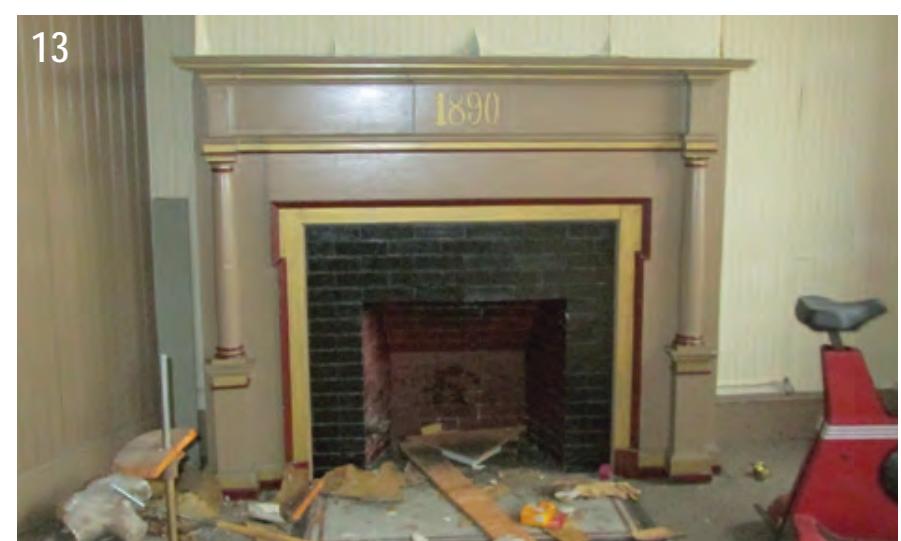
The basement contains structural brick piers and stone foundation walls which are in good condition (Photo 7).

There are tin ceilings in every room in varying conditions. Some ceilings are falling down and are beyond repair. Others are in good condition. Many of the offices have drop ceilings that are covering the tin (Photo 8).

The wooden structural posts in the basement are in good condition (Photo 9). All wood trim including crown moldings, window surrounds, and wainscoting has been painted. There is no photographic evidence to show that the wood would have been left unpainted, but this would be typical of the late 1890s. The main staircase is in fair condition. It is missing a few balusters, and the railings are too low to comply with ADA standards (Photo 10). Some of the steps are slanting, and there is some temporary wood and metal bracing in place. The stairwell is open to all floors, which does not meet fire code. The secondary staircase is in similar condition to the main staircase.

The interior hallways are in fair condition. Some of the glass transoms have been broken or painted over. All of the original doors remain intact in various degrees of disrepair including broken glass and peeling paint (Photo 11).

The plaster is in poor condition throughout most of the building (Photo 12). There are drop ceilings in most of the offices that were added circa 1970. They are in poor condition and missing many ceiling tiles. A majority of the floors are covered with wall-to-wall carpet circa 1970. The carpets are in poor condition. All of the offices contain interior partition walls. Many of them appear to be original or early additions. However, many of them have been covered with various materials including composite wood. The mantel on the fourth floor is in good condition (Photo 13). It is unknown whether or not the fireplace functions.

Division 14 – Conveying Equipment
 The original elevator is intact but most likely not functioning. It is also not up to ADA requirements as far as size. The shaft is not enclosed, which does not meet fire safety code. The elevator appears to be in fair condition and is a character-defining feature of the building (Photo 14).

The bathrooms are located in column through the 2nd, 3rd, and 4th floors. They are inadequate as far as ADA requirements and building capacity. Also, it is unknown if the toilets and sinks are functioning (Photo 15).

- Proposed Solution: Remove the drop ceilings to investigate the condition of the unexposed tin. Remove and replace the tin that is beyond repair. The tin will be reproduced based on the existing patterns. The existing tin in fair to good condition can be temporarily removed for cleaning. Each tile must be labeled so it can be reinstalled in the correct position. To remove certain kinds of paint, the tin tiles can be frozen and then slightly bent to pop off the paint. Otherwise, the paint can be removed with strippers or a wire brush. Once clean, the tiles can be reinstalled and then painted a metallic silver color for the tin ceilings on the first through third floor. The fourth floor tin ceilings will only be repainted. These tiles may contain lead paint, so this process must be undertaken by a lead abatement specialist.

- Existing Condition: Most of the original interior doors remain intact. Some of the glass in the doors is broken.
- Proposed Solution: Preserve and refinish original doors and replace broken glass.
