Mathewson Street United Methodist Church

Reuse and Rehabilitation
Feasibility Report

Fall 2012

The Roger Williams University Community Partnerships Center

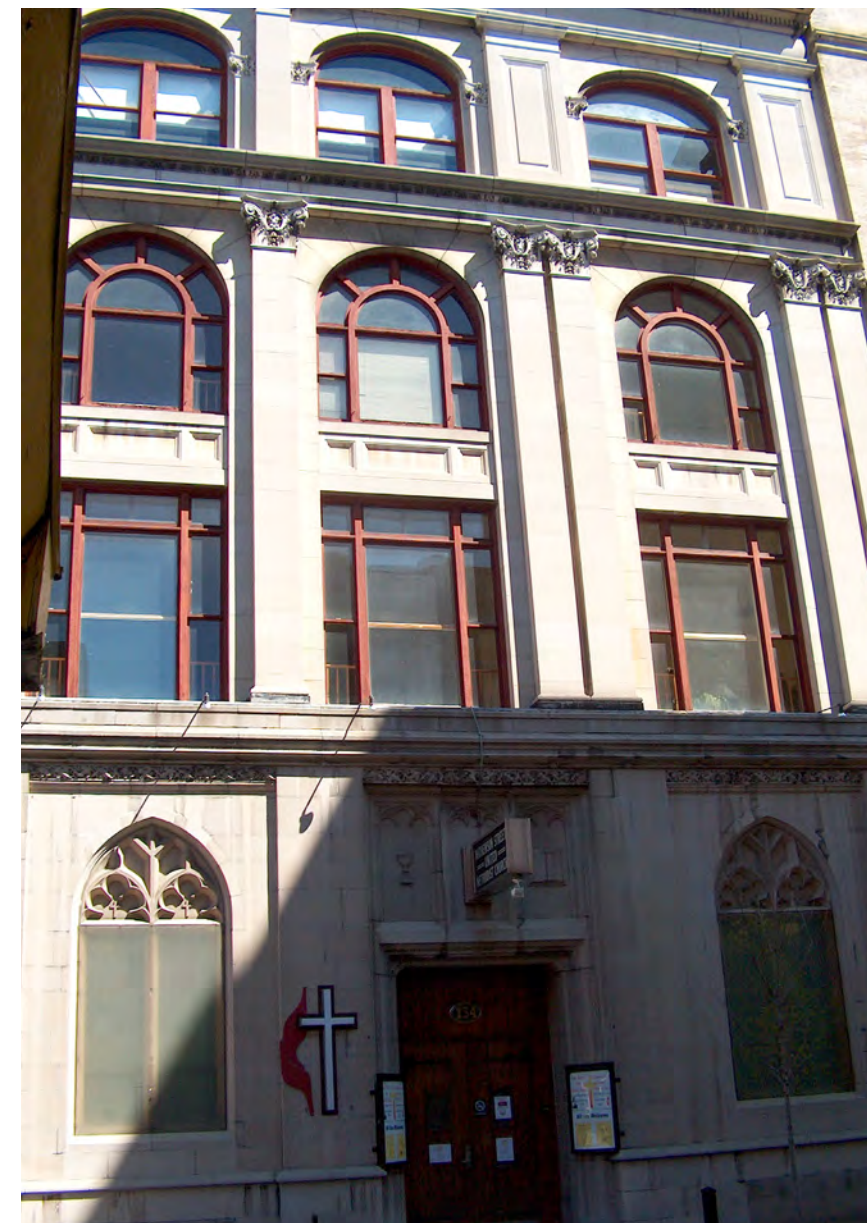
West elevation of Mathewson Street United Methodist Church.

The first story façade on the west elevation is made of aggregate stone and is in fair condition. It was applied in 1951, and it appears that the former 1896 façade was hacked away to apply the new façade. It appears that water is wearing away at the binder over time. The façade exhibits a build-up of grime, which is unattractive and detracts from its appearance.

The second, third and forth stories are made of limestone. The masonry is in good condition. The façade exhibits grime build-up, which detracts from its appearance.

- **Solution:** The aggregate stone façade should be cleaned to remove surface dirt and areas of staining in accordance with Preservation Brief No. 1, "Assessing Cleaning and Water-Repellent Treatments for Historic Masonry Buildings." The gentlest cleaning methods, such as low pressure washing with a mild soap and water, should be employed first. If a more robust treatment is necessary, a mild non-acidic alkaline detergent should be employed and then rinsed off, such as Sure Klean® 766 Limestone & Masonry Prewash and Sure Klean® Limestone & Masonry Afterwash by Prosoco Inc. This will have the impact of improving the appearance of the entry-level façade of the building.

- **Problem:** The upper story limestone façades exhibit grime build-up, which detracts from the appearance of the façade.
- **Solution:** The limestone stone façade should be cleaned to remove surface dirt and areas of staining in accordance with Preservation Brief No. 1, “Assessing Cleaning and Water-Repellent Treatments for Historic Masonry Buildings.” The gentlest cleaning methods, such as low pressure washing with a mild soap and water, should be employed first. If a more robust treatment is necessary, a mild non-acidic alkaline detergent should be employed and then rinsed off, such as such as Sure Klean® 766 Limestone & Masonry Prewash and Sure Klean® Limestone & Masonry Afterwash by Prosoco Inc. This will have the impact of improving the appearance of the entry-level façade of the building.

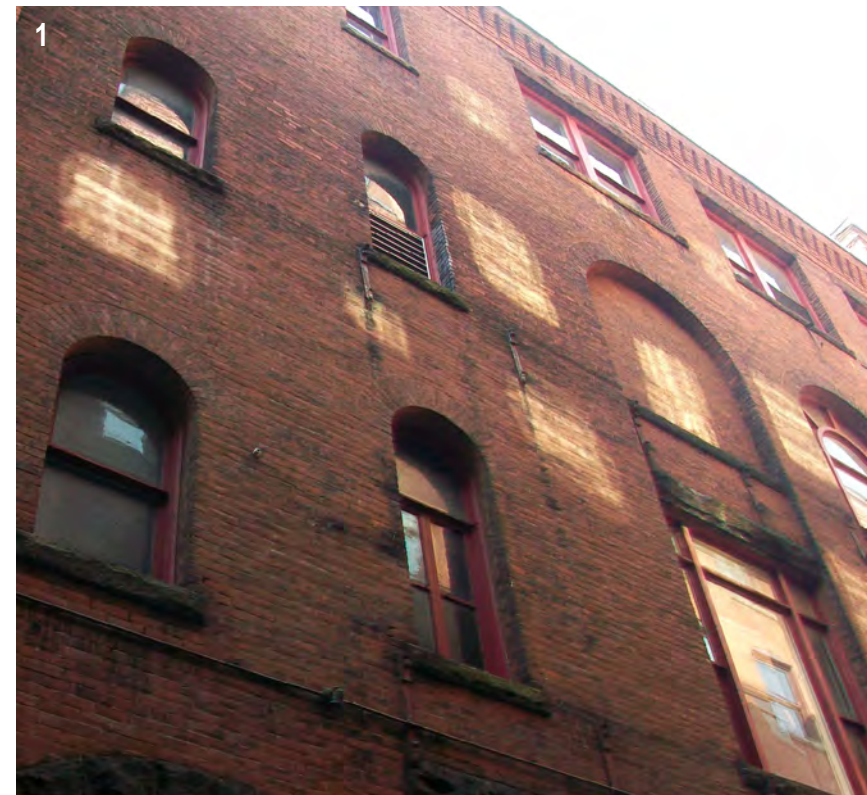
Select locations on the brick rear (east) façade have deteriorated mortar joints. Bricks are in good

condition. Mortar is in fair condition. Dark areas show signs of water flow down wall. (Photo 1)

1. Brick wall on the east facade needs cleaning and repointing.
2. Deteriorating east chimney is wrapped with chicken wire to hold loose bricks in place.

- **Solution:** Deteriorated mortar joints to be raked out by hand and repointed to match original in color, texture, strength and joint tooling in accordance with National Park Service Preservation Brief No. 2, “Repointing Mortar Joints in Historic Brick Buildings.” Impact will be the preservation and protection of the historic brick façade while maintaining visual cohesion.

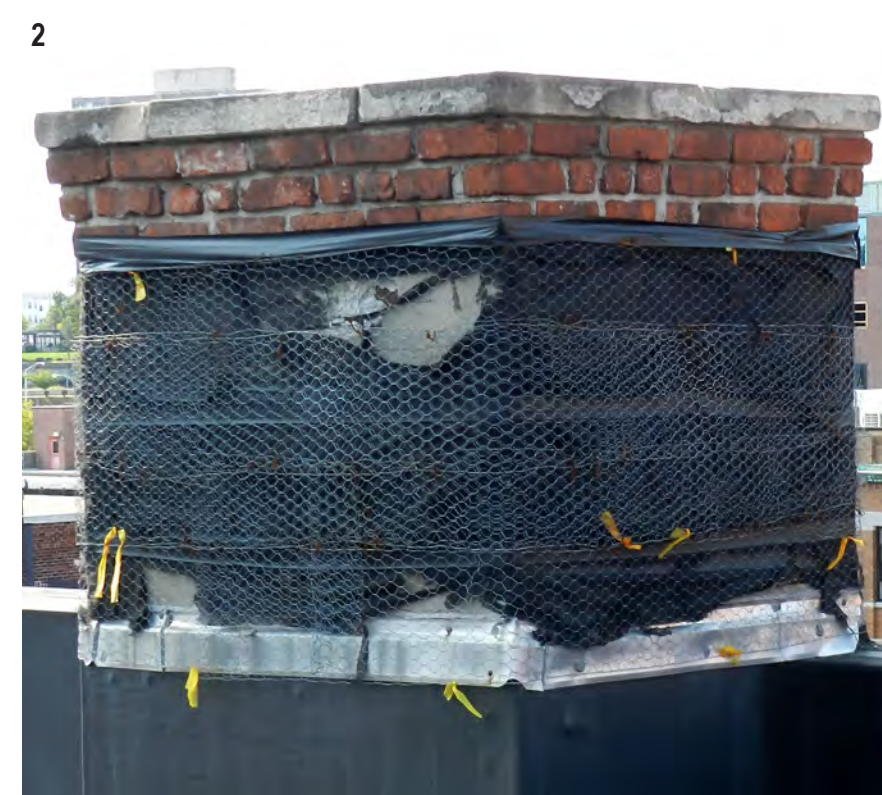
The two chimneys on the roof of the building are failing. There is severe mortar degradation, and the bricks are dangerously loose. Chicken wire cur-

rently secures bricks from falling and causing injury. The west chimney is filled with debris. It is suspected that the east chimney (Photo 2) contains the venting for the building's boiler system.

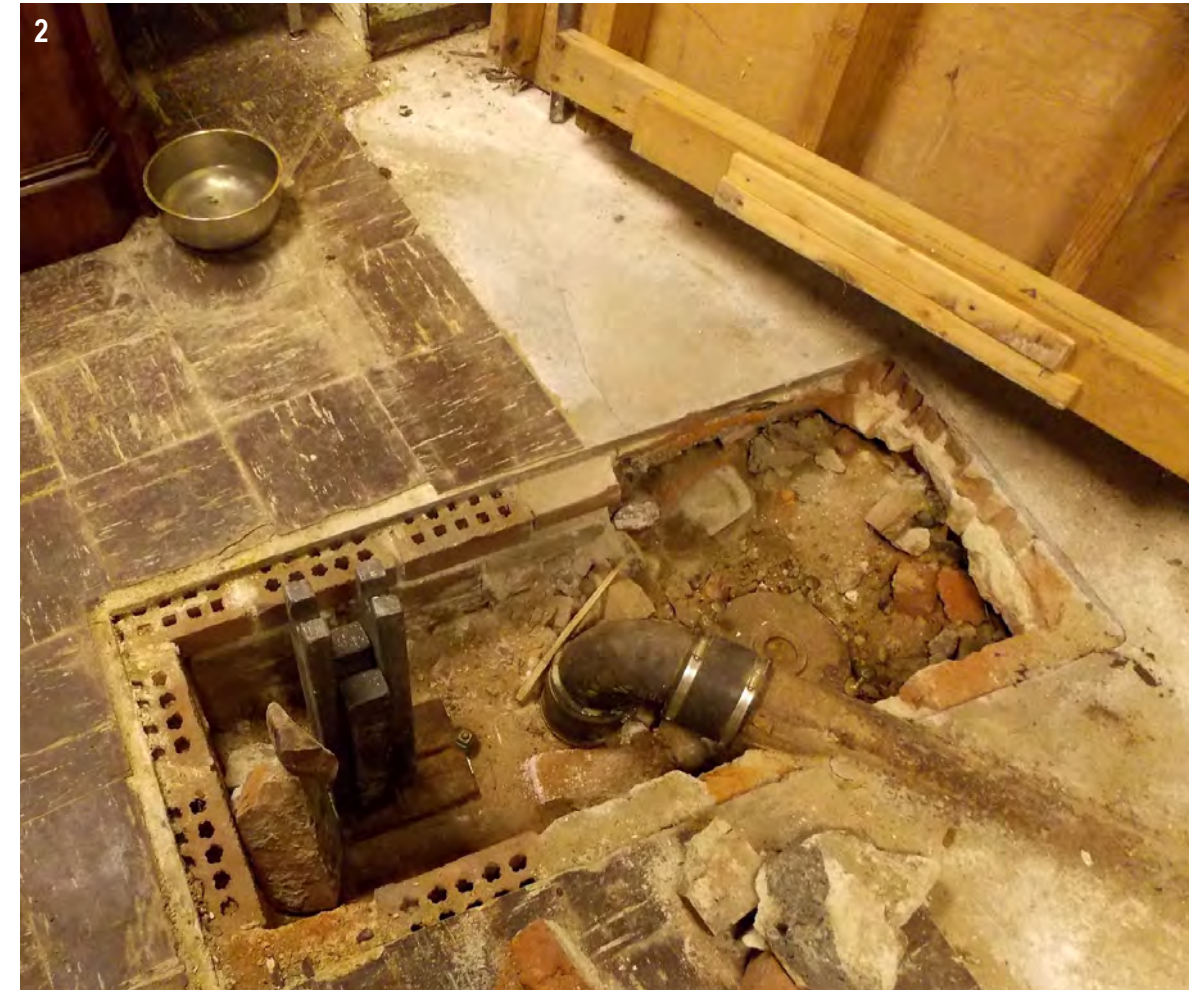
Water seeps up through the basement floor, which is causing damage to the material of the floor. The protective layer between the floor covering and the ground below may be inadequate or deteriorated due to age. (Photo 2)

The original wood windows on the top three floors of the building are in fair to poor condition. Several window sashes exhibit various degrees of deterioration: rotted wooden mullions, significant loss of putty, glass in need of re-glazing and pervasive peeling paint. (Photo 1) Storm windows are no longer in place due to fire code concerns. The windows are also not energy efficient due to a lack of insulation in the winter and solar gain in the summer. Windows are a character-defining feature in the structure.

1. Windows exhibit deterioration in rotting wooden mullions, loss of putty and pervasive peeling of paint.
2. Floor moisture and asbestos tile deterioration in the basement.

- **Solution:** Further investigation, potentially through invasive analysis, is required to determine the exact cause of the moisture penetration. This should be determined prior to any renovations in the basement. The floor will probably require enhanced protection from moisture through the installation of a ThermalDry Basement Floor Matting system (or equivalent product).

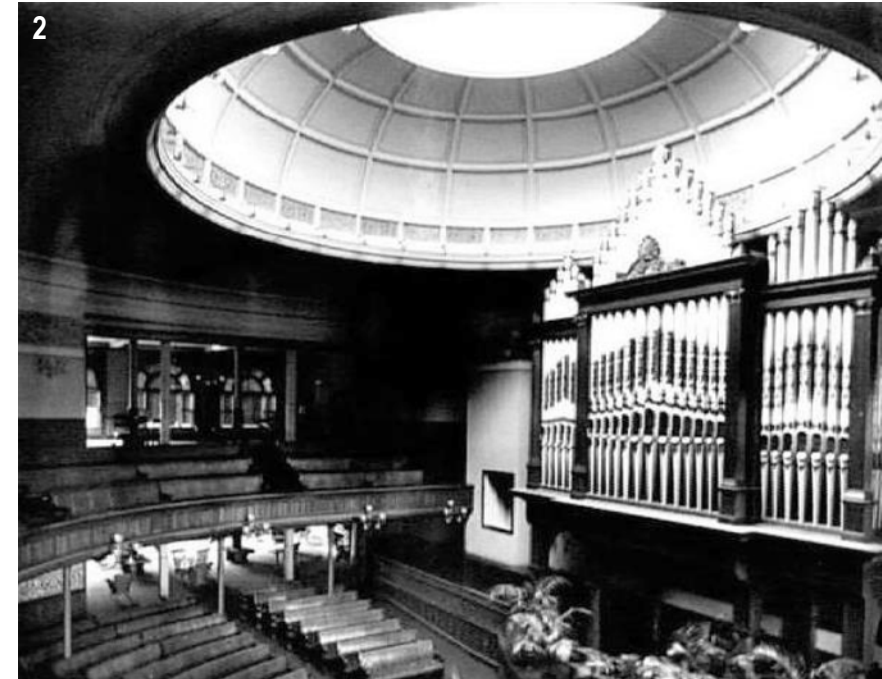
The historical opening in the sanctuary wall is currently closed, cutting off the connection between the sanctuary and the adjacent room off of the balcony. It appears that these changes were made in the 1980s, and metal studs and sheetrock were used to close the opening. A restored wall opening without a partition would not meet current building code requirements. While drawings and photographs of the historic opening exist, adequate documentation for the historic opening is lacking.

1. Current sanctuary space has a wall that closes off the adjacent room.

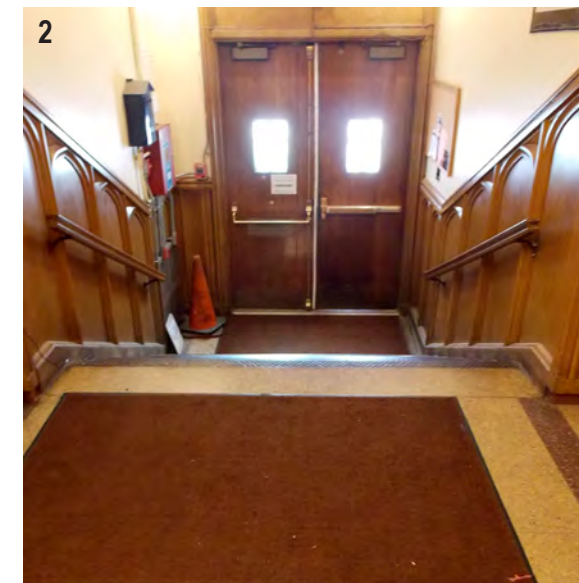
2. Current entry vestibule configuration, which is not compliant with ADA regulations.

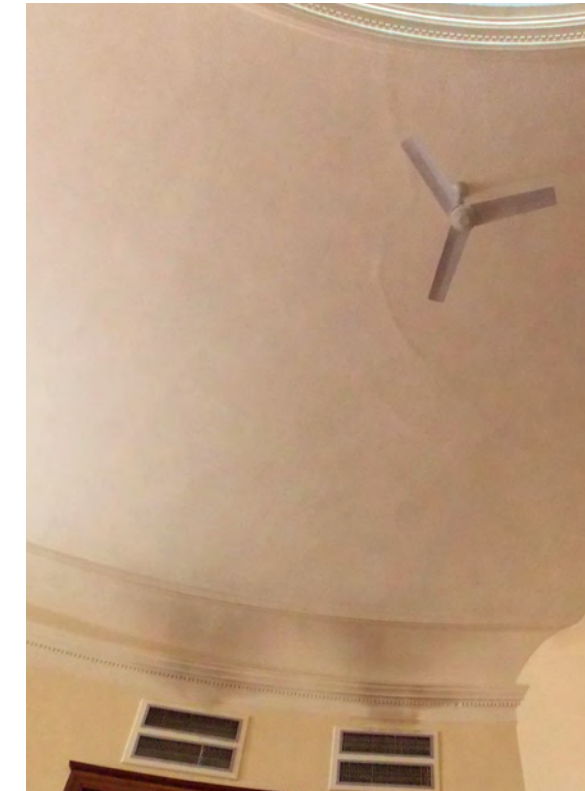
Ceiling surfaces consist of a lath and plaster system covered in various layers of paint. There is pervasive paint failure throughout the building especially on the ceilings of the ground floor offices and the chapel. Newer latex paint layers may be incompatible with older calcimine paint layers.

Air vents in the sanctuary have stained the ceiling.

Ceiling paint failure and staining from vents to be analyzed and addressed.

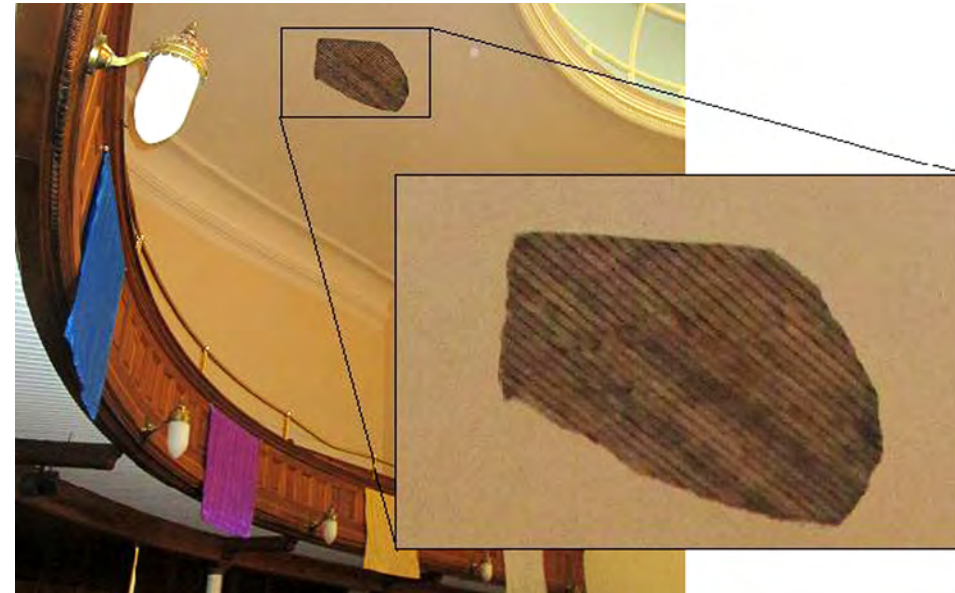
The plaster on the ceiling of the sanctuary has failed. The plaster keys between the laths have

given way in one spot, and the rest of the ceiling may be in danger of failing as well. The problem appears to be a saturation failure, which could point to water issues and potential issues with the sink of the black box theatre above the worship space.

Plaster failure on sanctuary ceiling to be analyzed and addressed.

- **Solution:** Further investigation is required to determine the cause and extent of the failure, which can be done by inserting a flexible bore-scope to document the condition of the plaster keys. There should be no space between the plaster and the lath. Areas with space between the plaster and lath are loose and will require stabilization in accordance with Preservation Brief No. 21, "Repairing Historic Flat Plaster Walls and Ceilings." After any moisture issues are remedied, loose areas can be stabilized with plaster washers or fasteners, which are screwed into the lath. Mesh tape and a patching compound should then be applied over the washers and sanded to create a smooth surface. Areas with missing plaster should be patched by re-plastering the area in accordance with Preservation Brief No. 21. After all work is completed the ceiling should be primed and painted. The impact will be the preservation of the original plaster.

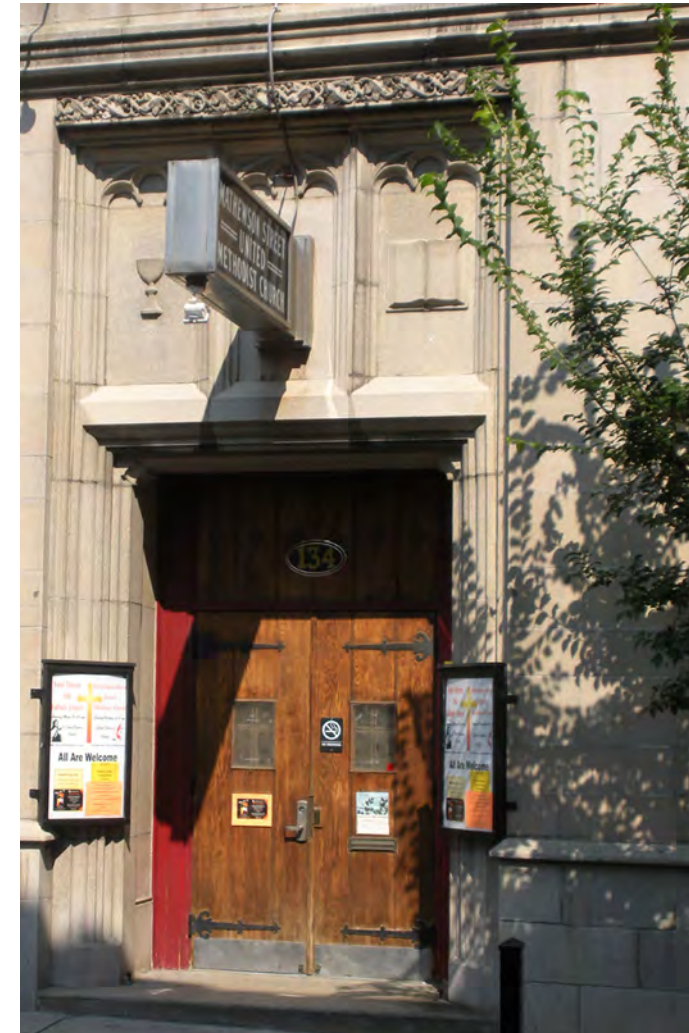
Present church entry on Mathewson Street needs to be made handicapped accessible.
