Charles G. Calder House Rehabilitation Plan

22 Whitmarsh Street | Providence | RI

Rehabilitation Plan

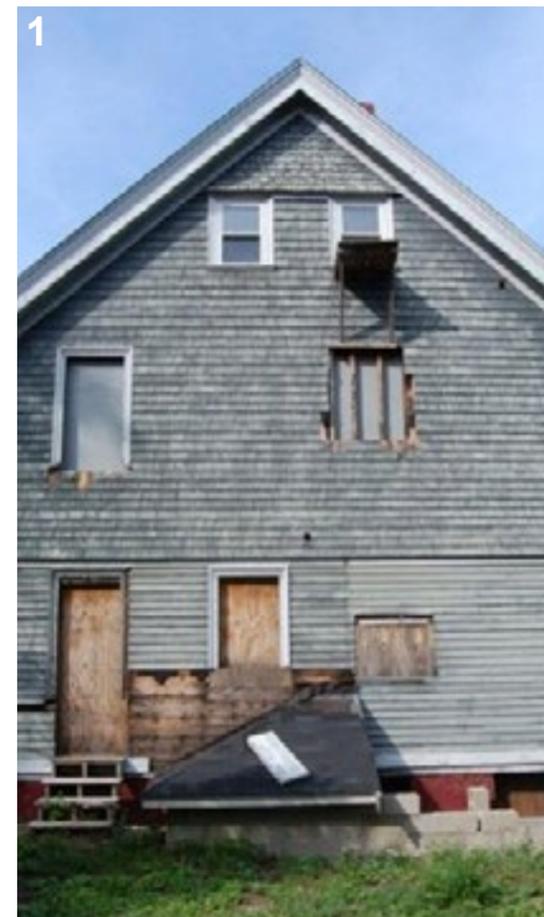
On the southern elevation of the house a "ghost" of a previous addition (with subsequent replacement clapboard) is evident. Additionally, some of the clapboard has been removed due to the addition of the bulkhead. Wooden corner boards, band boards, and the water table are in relatively good condition except for the area in the building's northwest corner where a missing downspout is saturating this area.

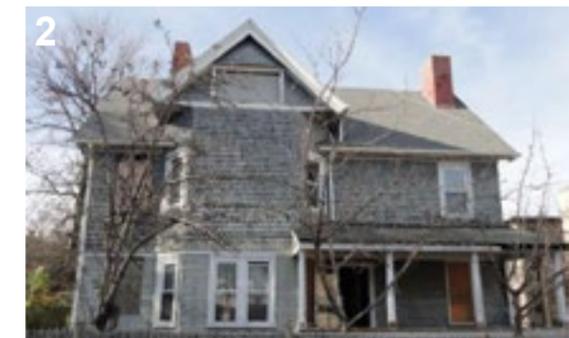
Building: The house is a two and one-half story, cross-gabled structure of wood construction. The building sits atop a brick foundation, clad in shingles and clapboard. The main entrance on the east elevation is accessed via a single-story porch. Many structural and decorative elements on both the interior and the exterior of the house have been altered or have suffered from lack of maintenance. Specific elements and their condition include:

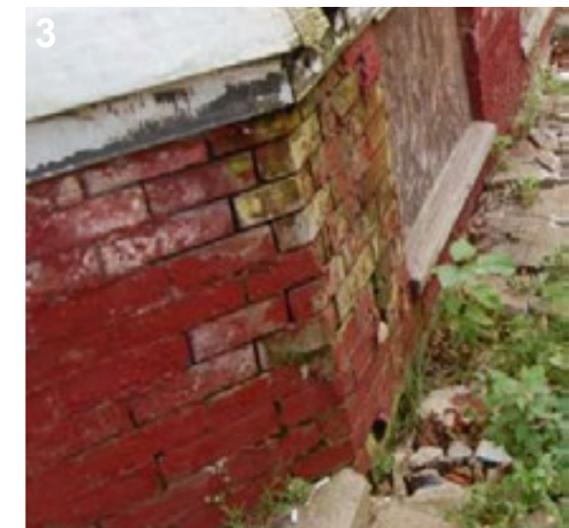
Foundation: The primary foundation for the house is constructed of brick, which has been painted in most areas. There is minor spalling on the brick throughout the foundation, but most of the brick has been protected by the paint and is in good condition.

The mortar in many areas of the foundation is either highly deteriorated or missing. Several basement windows are missing. There is significant damage to the foundation at the northwest corner due to the missing downspout and resulting water/freezing damage.

In recent years, a partially constructed concrete block bulkhead has been added to the foundation. This has resulted in a haphazard removal and reconstruction that appears to be structurally inadequate.

Unit Masonry Restoration: Bricks will be gently brushed and cleaned. Joints will be repaired to match existing mortar where mortar has eroded or cracked. Deteriorated bricks or bricks with cracks of greater than 1/2" will be replaced with bricks of similar size and color.

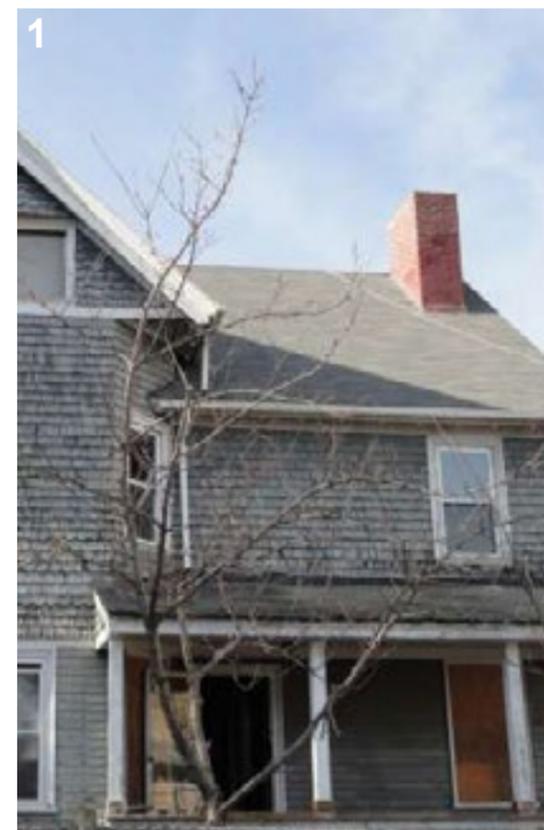
Chimneys: Two chimneys are located at the north and south ends of the roof ridge. The southern chimney has been painted red and improperly repointed. The mortar is deteriorated and is in need of being repointed. Many of the bricks are no longer in line with the coursing of the rest of the bricks, and associated flashing is warped and partially painted. The northern chimney exhibits two campaigns of inferior mortar repointing, the lead flashing is warped, and the entire chimney is coated in a layer of red paint.

Refractory Brick Masonry: Old mortar will be removed to a minimum depth of 2 to 2-1/2 times the width of the joint to ensure an adequate bond and to prevent mortar "pop outs." Any loose or disintegrated mortar beyond the minimum depth will also be removed. New mortar for repointing will be compatible to the existing mortar and condition of the bricks. New mortar will match color of existing. Chimneys will be re-lined.

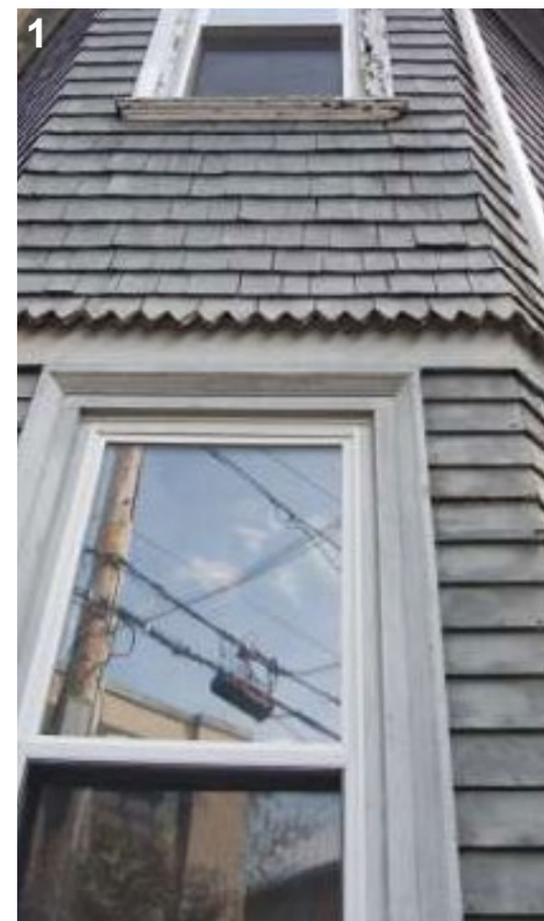
condition, the non-galvanized screws used to install them are rusting, especially below windows. Some of the clapboard is splitting and experiencing rot around the fasteners due to water saturation on the western side of the house.

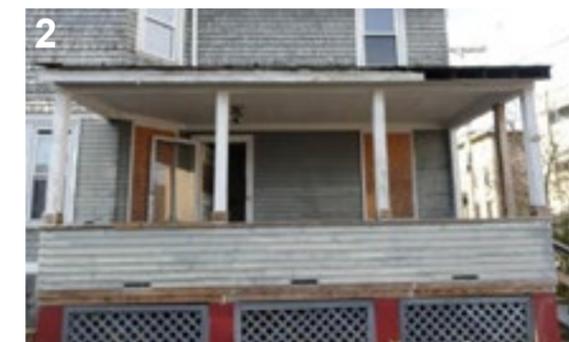
Roof: The main roof of the house is sheathed in asphalt shingles, appears to have been recently installed, and is in sound condition. The porch roof is constructed of wood sheathing and has asphalt shingling over earlier wooden shingles. The porch roof's fascia and soffit are badly rotted leaving the rafter ends exposed.

Porch: While the house originally had a large semi-circular porch located on the eastern side of the house, at some point this appears to have been removed and the existing porch added. The existing porch is of a smaller, square design with a clapboard skirt, square columns and a simple shed roof. The porch roof is in poor condition, with no functional gutters or downspouts. The deck is in fair condition and the lattice-work skirting below the porch at the foundation level is in good condition.

Wood Floor Decking: Replace wood floor decking and stairs on front porch with 3" wide hardwood spaces not more than 1/16" apart.

Asphalt Roof Shingles: Replace asphalt shingles on the porch roof to match the main roof in style and color.

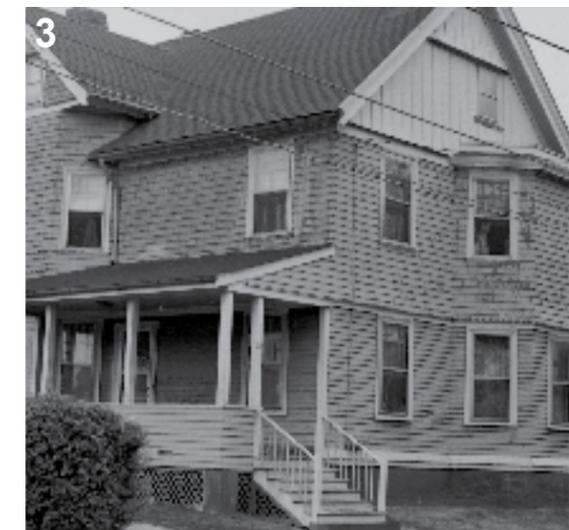
A photograph from the mid-1970s shows that the windows for the first, second and third floors were originally wood sash with multiple panes in the upper sash and single panes in the lower sash. This was a typical configuration for a house designed in the Queen Anne style.

Metal-Clad Wood Windows: All original patterns of the openings and their sizes (1886) will remain the same. All existing windows shall be removed and replaced with six-over-one sash metal-clad wood windows and will match selected and approved proportions of the frame and sash; configuration of window panes and muntin profiles. All replacement windows will be made as energy efficient as possible by the use of appropriate weather stripping to reduce air infiltration.

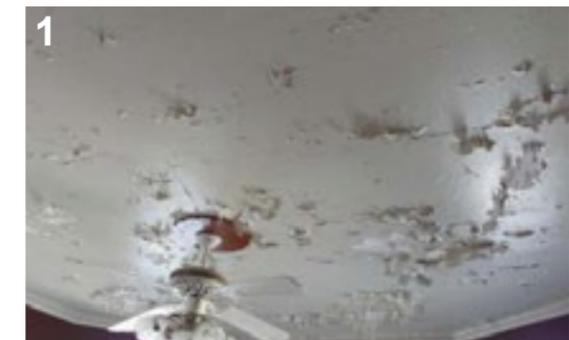
1. Interior bedroom ceiling

Ceilings: The ceilings of all three floors are in good condition. Ceiling plaster that was in poor condition has already been removed throughout or marked for removal, as is the case on the third floor. Certain ceilings do require patching and refinishing but not removal. The most prevalent damage has been caused by the removal of wall plaster and framing, which has resulted in cracking and deterioration at the wall-ceiling junctures. Due to moisture, exposure, and lack of climate control, the paint is failing on many ceilings.

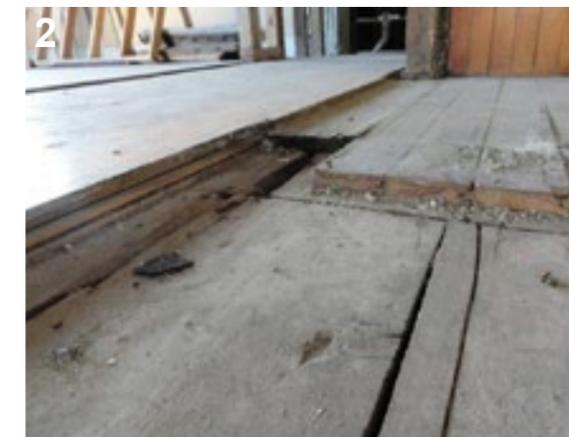
2. Interior floor condition

Floors: The conditions of the floors vary from moderately good to fair throughout the house. The floors are heavily scuffed and removal of the original heating system, including the radiators, has resulted in holes in both the floors and ceilings. The addition and removal of interior walls, as well as carpeting and floor tiles, has resulted in a confusing layering of floor boards and floor treatments. Most of the damage is cosmetic (not structural) and therefore most of the floors will only require patching, sanding, cleaning and refinishing. Some floors will require complete installation of new flooring layers over existing sub-flooring.

Flooring Restoration: Floors will be gently cleaned with an appropriate cleaner to remove wax build-up and dirt. Losses in the flooring will be patched with the same type of wood and stained to match existing floor color. Floors will be waxed and buffed.
