# FASAD: First Floor Existing Condition Report

October 30<sup>th</sup> 2015

## Report Summary

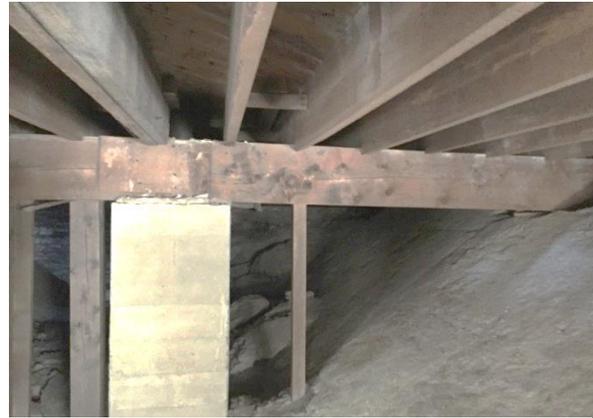
floor. The girders are primarily not visible from the first floor due their location in the interstitial space above the masonry arches that span the structure. The timber girders have actual dimensions of 13-1/2'x11-1/2' and approximately 24' long (see Figure 1). The girders have visible cracking throughout on both the top and side planes. The extent of the cracking and the type of wood is also unknown at this time. The girders are supported at both ends by masonry columns and rest atop most of the masonry arch structures throughout the space as shown in Figure 2. The ends of the girders rest on the metal base plates of the iron structural columns which rest on top of the masonry block columns as shown in Figure 3.

**Figure 1:** The photo was taken next to the first floor staircase in between the first and second floor. Note how the girder rests on a masonry column and travels over the masonry archway (right of photo).

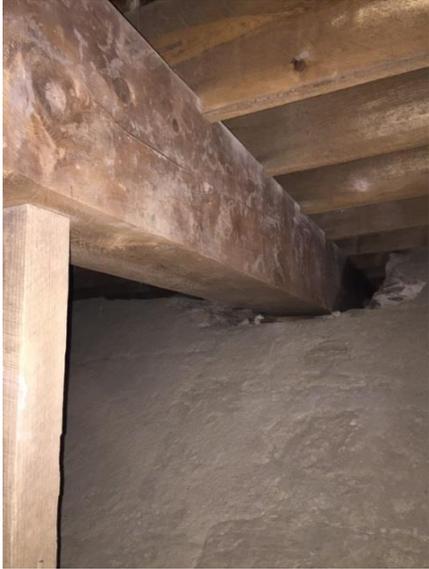
**Figure 2:** The girder is supported by the concrete/masonry arches spanning the space.

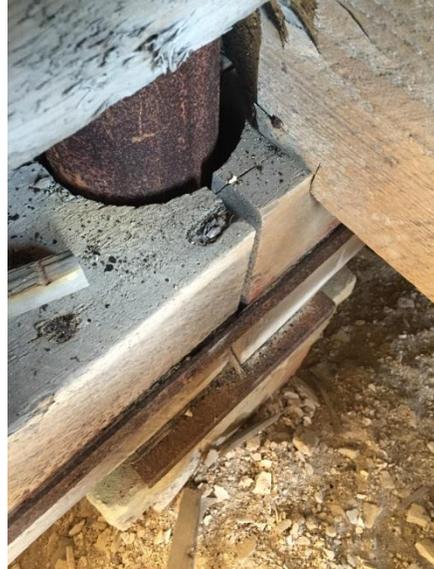
**Figure 3:** The girder shown in the picture is cut to allow the iron column to rest atop the masonry block column.

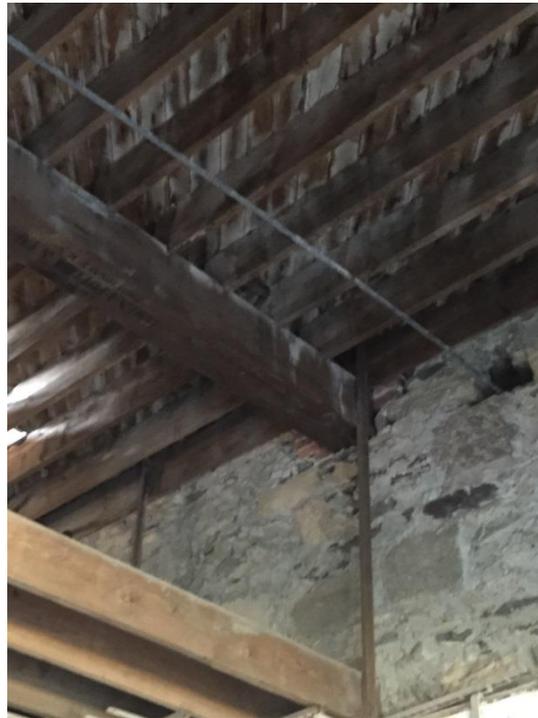
The end girders are fixed in keys located in the exterior Southwest Barracks brick masonry walls as shown in Figure 4. The keys act as fixed supports at the ends of the heavy timber girders, but currently are a major liability in the structural integrity of the girders. Due to the waterfront location of the Fort and the natural moisture which occurs in masonry structures, deterioration and rotting of the wooden girders at their connections is a serious concern which must be taken into account during the analysis and redesign.

**Figure 4:** The phot shows an end girder rests in a key inside the brick masonry wall.

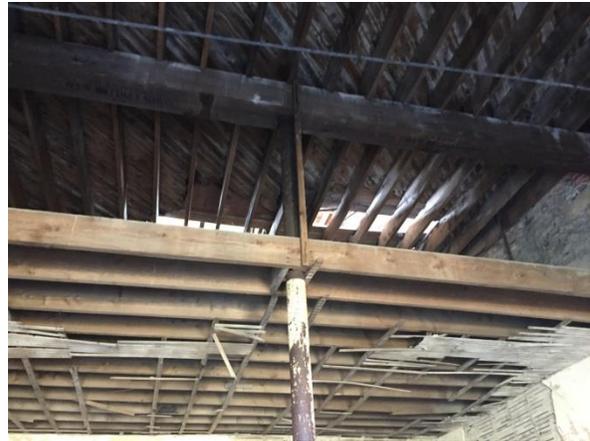
**Comments/Descriptions:** The timber floor joists (wood type unknown) run the width of the Southwest Barracks. The joists 2"x12" are spaced 16" on center and function as the structural supports for the second floor structure (see Figure 5). Three joists were used to span the width of the Southwest Barracks, flushed faced as shown in Figure 6. The interior joists span the distance between two main span girders that run the length of the Southwest Barracks. These joists are nailed in place and notched to fit into the main girders. The exterior joists connect from the exterior walls to the main span girders.

Figure 5: The photo was taken from the first floor where the archway was removed. Note that the joists above support the 2<sup>nd</sup> floor.

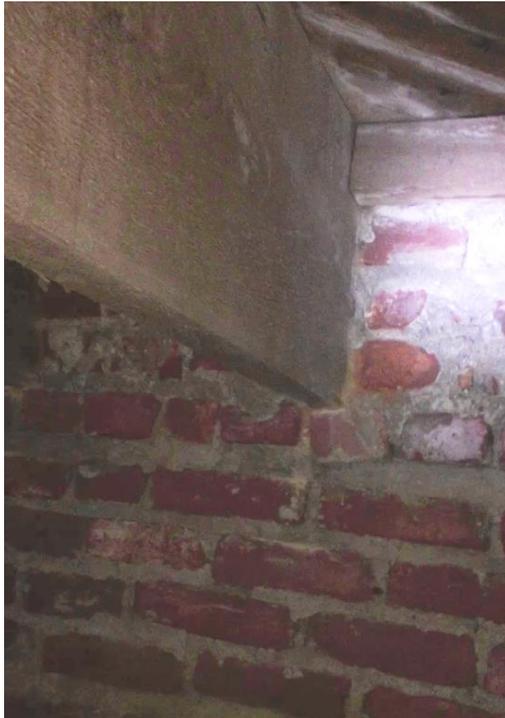
The exterior joists attach to the the exterior walls of the Southwest Barracks by keys cut out of the brick masonry exterior walls as shown in Figure 7 below. The timber to masonry connections are not acceptable with regards to modern construction practices due to the high moisture content of the brick masonry walls. The location of the Fort and its proximity to the Naragansett Bay has caused major deterioration and rott to occur in the timber joists at their connection points to the South-most facing exterior walls of the Fort rendering them structural defficient.

Figure 7: The photo shows the joist connection to the masonry wall. Note that the timber joist sits into the masonry in a key.

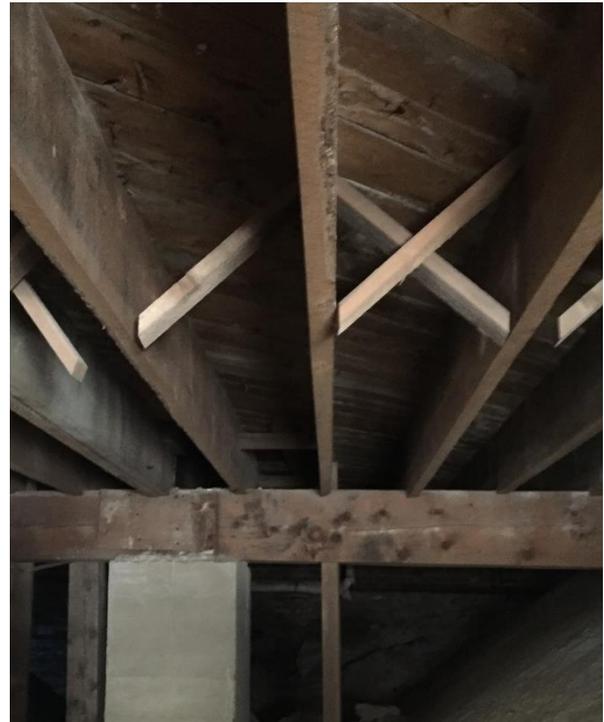
Cross bridging is installed between each joist. The bridging provides lateral support for the joists and is common in modern construction. Some of the bridging is currently missing in between the joists and needs to be replaced as shown in Figure 8.

Figure 8: The photo shows the bridging between each joist in the center of each joist span. Note that some bridging is currently missing.

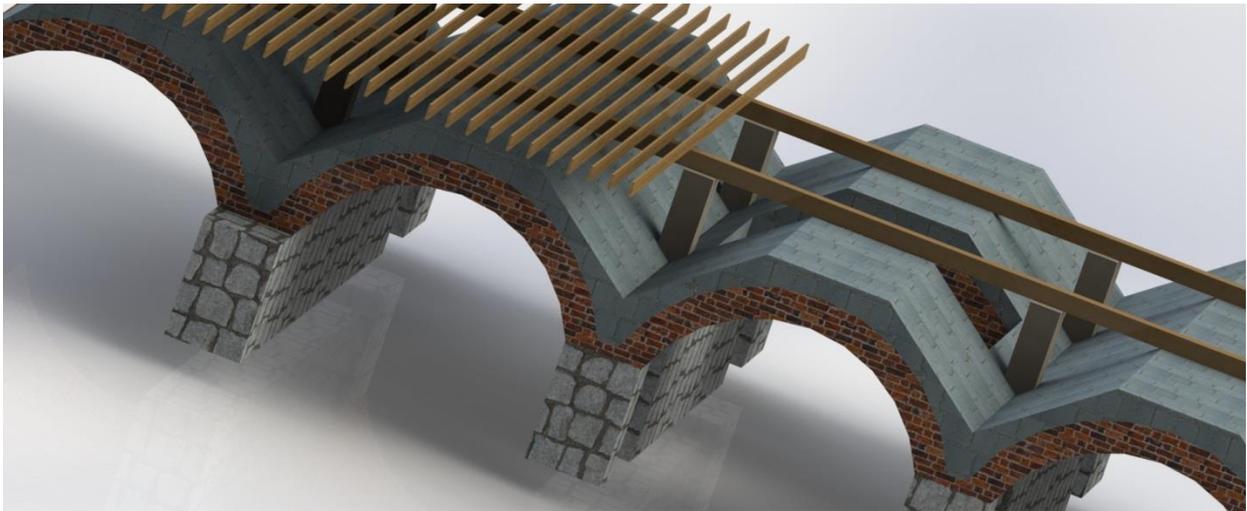
**Figure 8: The arches support the main girders supporting the second floor and are a base for masonry block columns.**

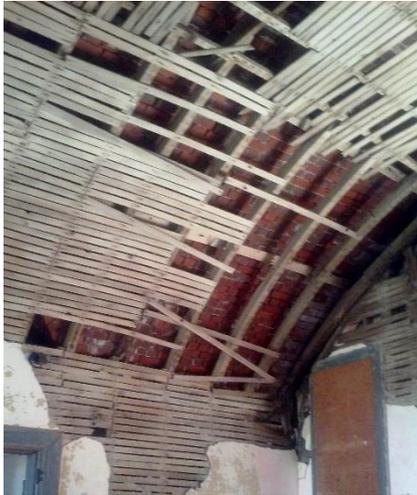
**Comments/Descriptions:** The masonry arches run along the first level of the Southwest Barracks. The composition of the masonry arches was easily observed due to the deterioration of the lath and plaster which used to completely line the wood studded walls of the first floor as shown in Figure 9. The vault line of the arches is composed of brick (see Figure 11). This is typically 2' thick. A layer of gray shale masonry rock covers the brick vault line with a maximum thickness about 2'. The piers under the arches are made from a combination of stone and shale with an approximate thickness of 5'. shown in Figure 10. Overall, the spacing of the arches is about 23' on center. Masonry block columns are located over the piers and in between each arch. As shown in Figure 8 the masonry arches support the girders which support the second floor of the Barracks. The arch system does not seem to have suffered significant deterioration. Bricks, stone, and shale are adequately preserved.

**Figure 9: Deterioration of the lath and plaster exposed the composition of the arches. Brick vault line is in good condition.**

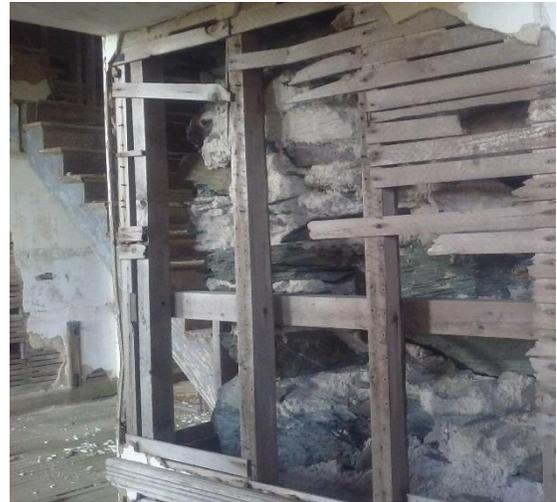
**Figure 10: This is a pier wall under an arch made from local stone and shale. The structure is sound.**

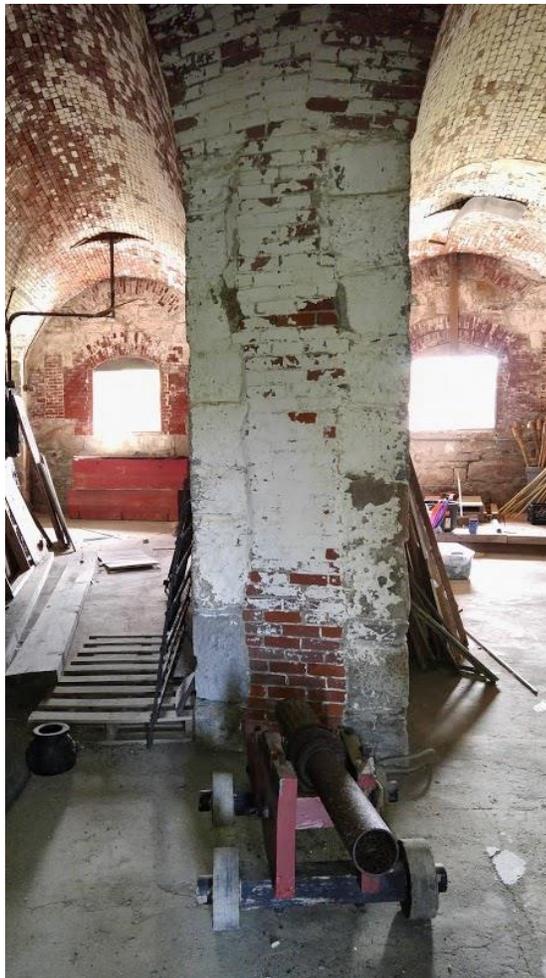
**Figure 11: The brick masonry arches located in the Southwest Barracks Armory have been well preserved and are in good condition.**

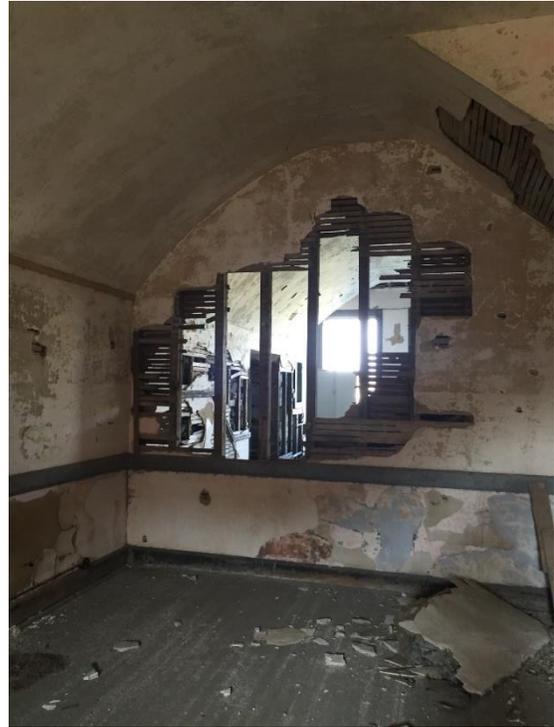
The wall is not load bearing and functions mainly as a partition between the rooms. Figure 12 is another example of a partition wall on the first floor of the Fort. The frame appears to be in average condition but the nails holding it together have primarily rusted away and most likely will not be salvageable. The wood studded construction is also used as a façade or covering over the interior arches as shown above in Figure 9 in order to function as a base for lath and plaster wall cover.

Figure 12: Wooden dividing wall in between two rooms.

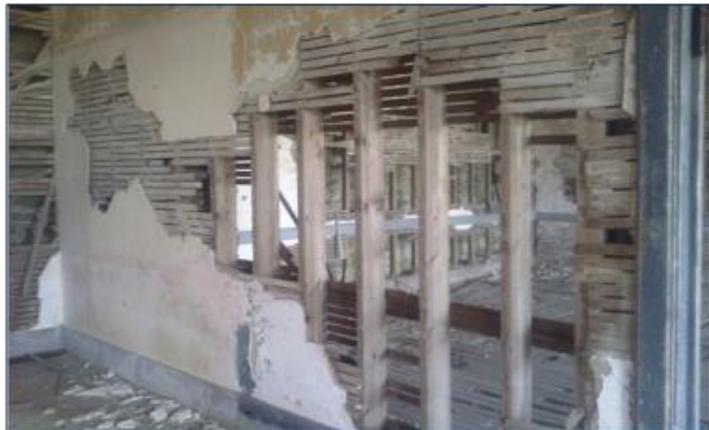
**Comments/Description:** The western room on the first floor contains a wooden framed wall separating another room. This is believed to be in place because there is not a full arch located at this section unlike the rest of the first floor. This wall is shown in Figure 13. The wall connects to a half arch and protrudes the rest of the length 35' down the room.

Figure 13: Is a photo of the wooden framed wall that runs north to south in the most westerly room. This is not load bearing and has a column enclosed inside of it.

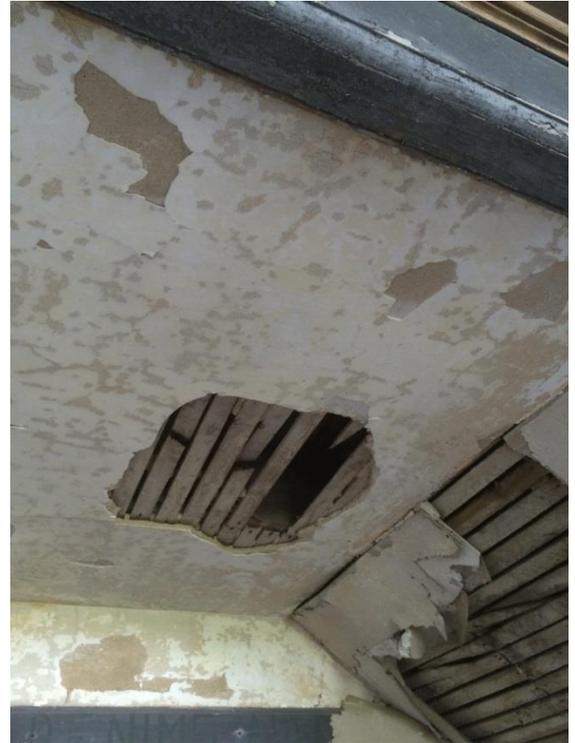
Figure 14: Taken under the most west staircase and shows the detail of the wall finishing.

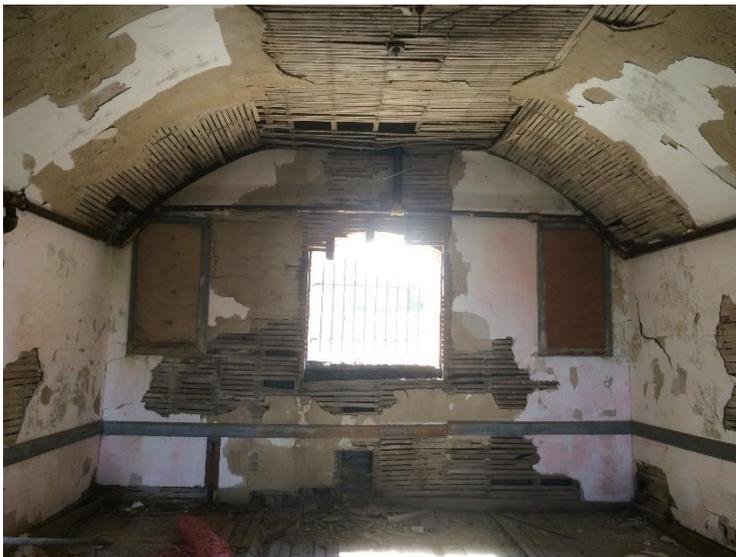
**Comments/Description:** On the entire first floor, with the exception of the armory, the interior walls of the Fort are concealed by lath and plaster wall cover. The detail of the finishing is shown in Figure 14. This covering occurs on all of the interior walls and ceilings and is attached to wood stud framing. The amount of deterioration throughout the first floor varies but majority of the material is falling down, weathered and not salvageable. Figure 15 shows the variation of the condition of this finishing.

Figure 15: This photo shows the variation of lath and plaster conditions on the first floor. It was taken looking at the south side of the barracks.

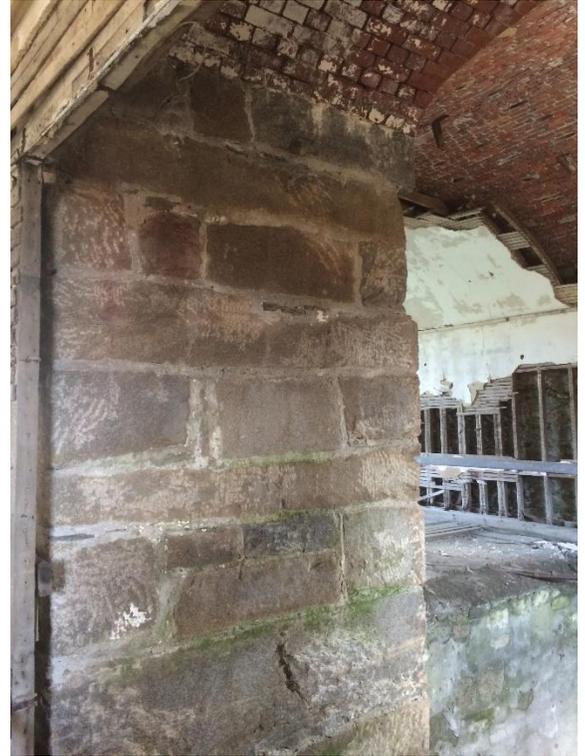
Figure 15: Shows the smooth finish on the blocks in the doorway arch. This photo was taken looking in to boiler room.

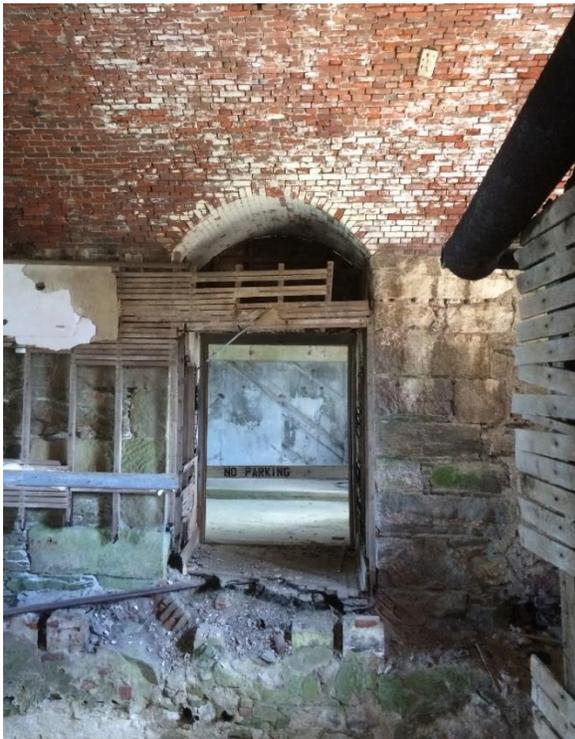
Figure 12: This photo looks into the doorway of the boiler room. It shows a double arch structure.

The smooth finished blocks are detailed in Figure 15, above. They are double arches, meaning there is another brick curve under nether the flooring. Figure 16, shows part of that double arch located in the boiler room. This is the only section where they are visible. These arches are built into the larger arches that run over the room.

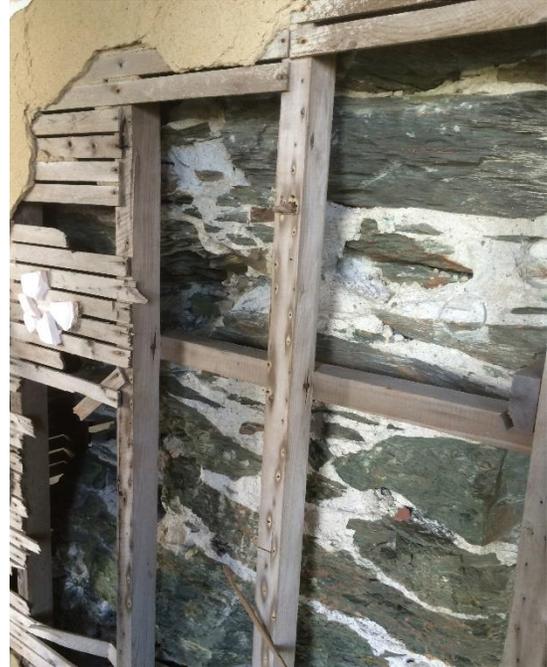
**Comments/Description:** There are five rough arch doorways on the first floor. These rough cut arches were cut out of the masonry piers supporting the masonry and brick archways in order to allow access and flow between each room on the first floor. These rough cut arches are on the northern side (interior Fort wall) and shown in Figure 17, below. The arches are typically 10' high at the peak, 6' wide and 5' deep. It appears these doorways were an afterthought and chipped away after creating the jagged stones. The finishing is shown in Figure 13. There is no masonry top to these arches either.

Figure 13: Shows the rough edges of the doorway.

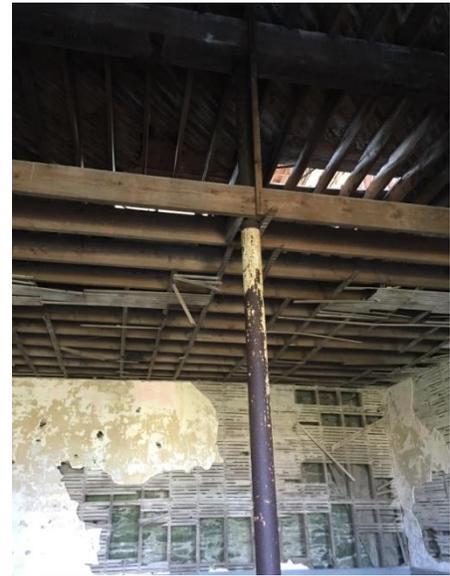
**Comments/Description:** There are only three columns in the first floor. These columns are located in rooms 1 and 3 (Figure 16 below), with one of the columns located in the wall between the two rooms (Figure 17). The columns support the main span girders which support the load of the second floor. The columns are all in poor condition which is attributed to significant oxidation and deterioration. The columns also may not be sufficient for meeting modern building codes, especially if the second floor was to be used as an event space in the future. Column number 3 is currently not supporting any load as it is not currently connected to the main span girder located above. Column number 3 is also effectively rotted out at its base as well which leads to major concerns regarding the other columns located throughout the structure.

Figure 15: The photo shows an image of column 1, located in room 1.

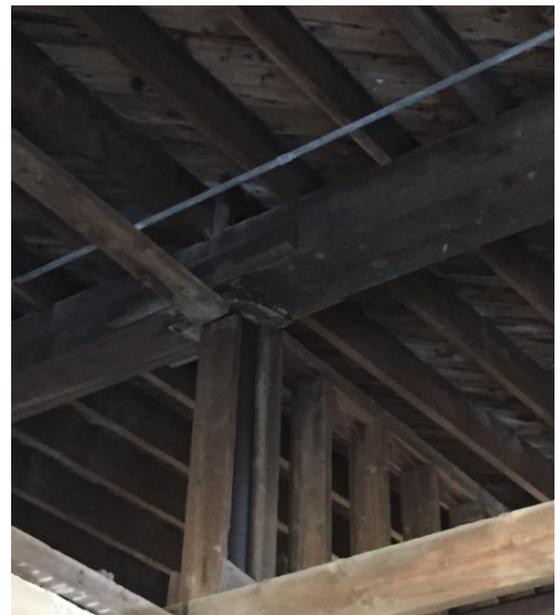
Figure 17: Column 2, located in between the partition wall frame wall between rooms 1 and 3.

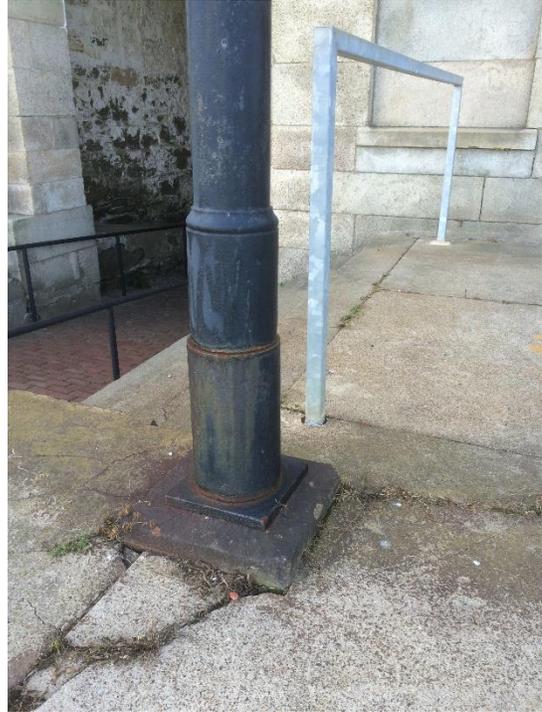
**Comments/Description:** The balcony starts on concrete footings and iron plates, Figure 18. The four columns that still exists extend up to the spilt of stone and masonry on the exterior wall. It appears that the iron is placed into slots in the side of the building. This is where the balcony floor would have been places. The balcony floor seems to have been supported with diagonal crossbars and the same design was used to support the roof shown in Figure 19. There is also still a three rung railing system. Only part of the balcony structure still exists and there is no roofing or flooring elements. Figure 20 shows the balcony as a whole.

Figure 14: Is the footing of the balcony

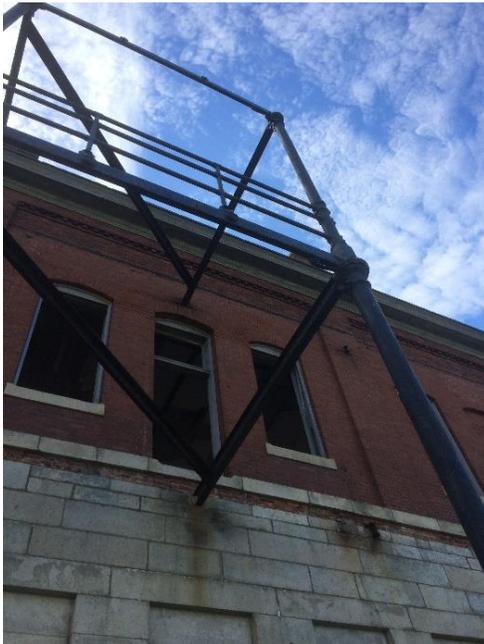
Figure 19: Shows crossbars of balcony

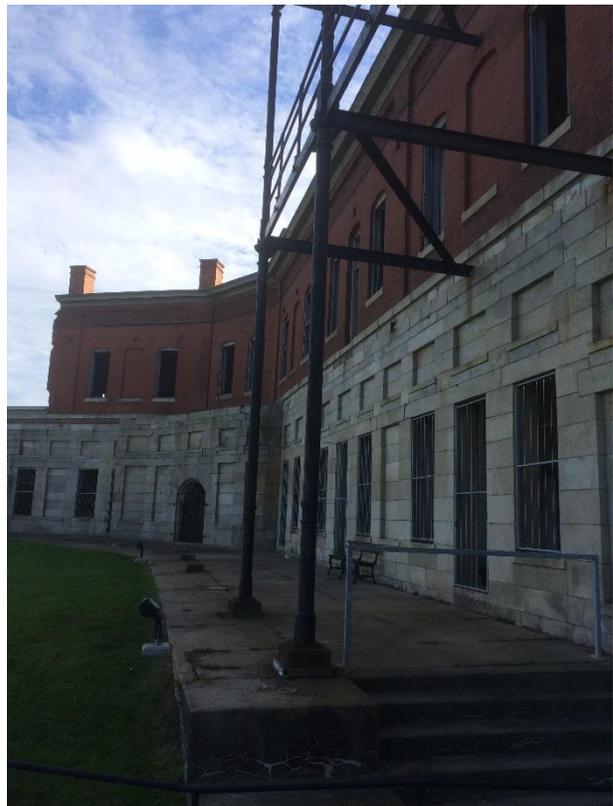
Figure 20: Shows the balcony as a whole structure.
