Liberty Street School

Reuse and Rehabilitation Feasibility Report

Community Partner:
Town of Warren, RI
Fall 2012

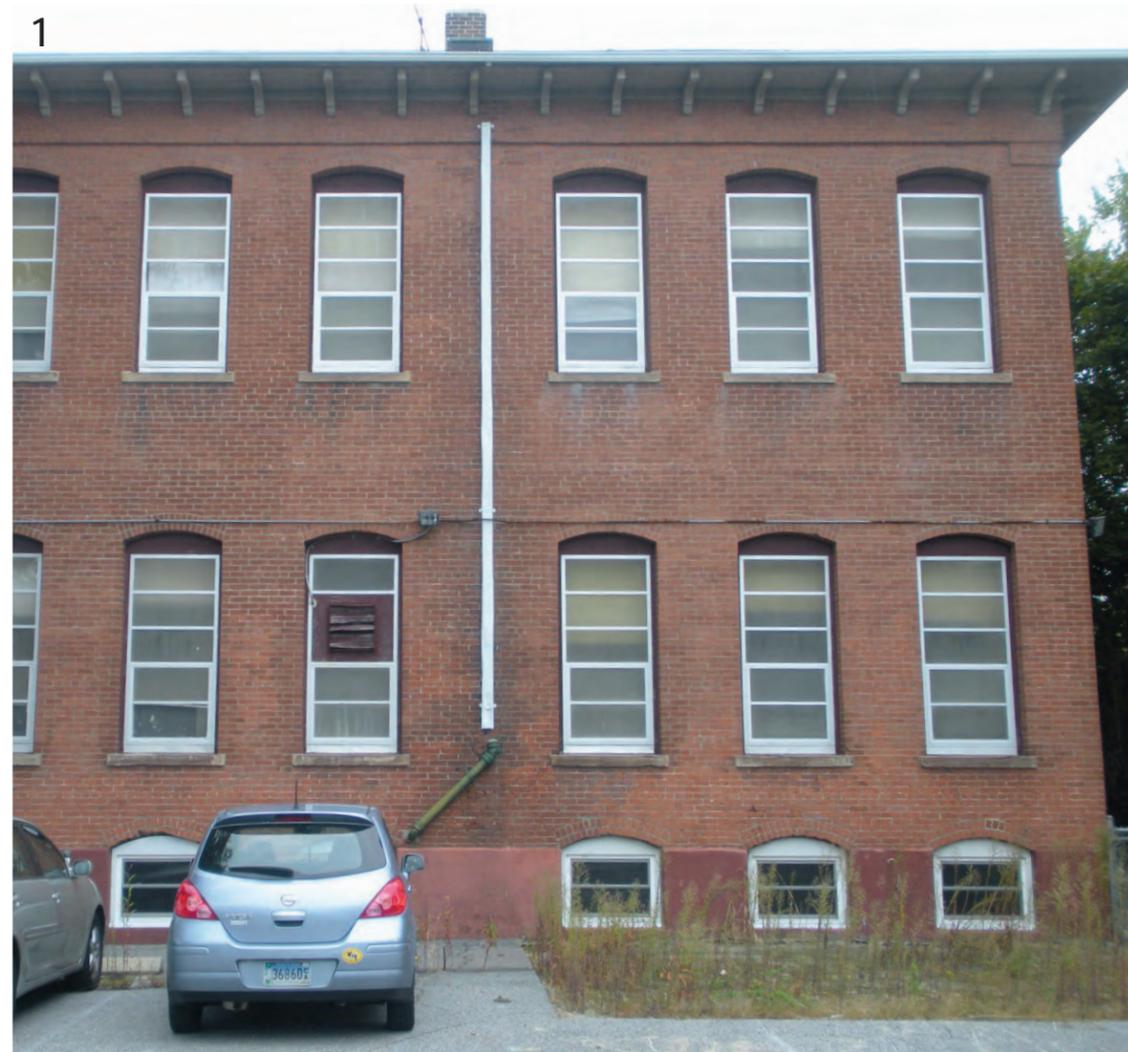
There are two trees that are located along the street on the site, which block a direct and clear view of the north elevation. There is plant growth throughout the site in areas where the asphalt has cracked, small spaces between the asphalt and the foundation, and in areas where there is no asphalt (Photo 1).

It is recommended that the asphalt be removed from the site. The asphalt detracts from the historic character of the site, which was historically a play area for the schoolchildren. The removal of the asphalt will also help with site drainage. There is currently a problem with water draining away from the building. One proposal to help the site drainage problem is to have a permeable surface, such as small stone pavers, to allow easier access for water to dissipate into the ground. In addition, underground water tanks can be installed which have a permeable surface on the bottom. This would also allow the water to slowly dissipate into the ground.

The two trees that are located along the north edge of the lot should be checked to determine the condition and health of the trees. It is possible that the excessive amounts of asphalt paving have caused the trees to become sick. If it is determined that the trees need to be removed, a plan should be developed to figure out if new trees should be planted. Through evidence in historic photographs and drawings of the building, it is clear that there have been trees along the street in a similar position to where the current trees are. The current trees block most of the view of the historic elevation when they are in full bloom. If new trees are installed, they should be trimmed in order to maintain the image of the north elevation. It is also recommended that more plants and shrubbery are added throughout the site to make the appearance of the site more aesthetically pleasing.

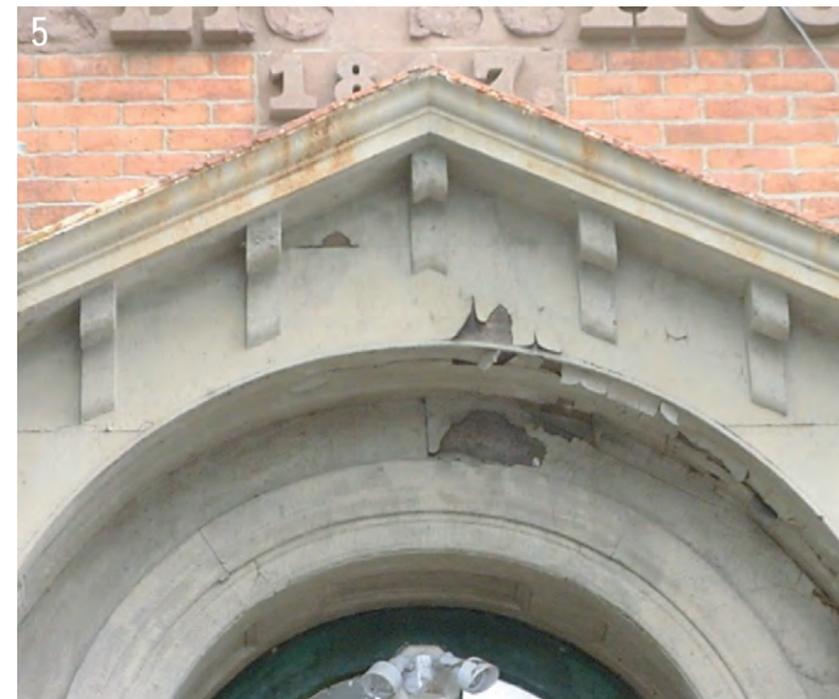
There is lead paint on the door surround on the north elevations. The paint is currently failing in many places (Photo 5). The wood window hoods have lead paint on them. The lead paint is failing and some of it has weathered off (Photo 6).

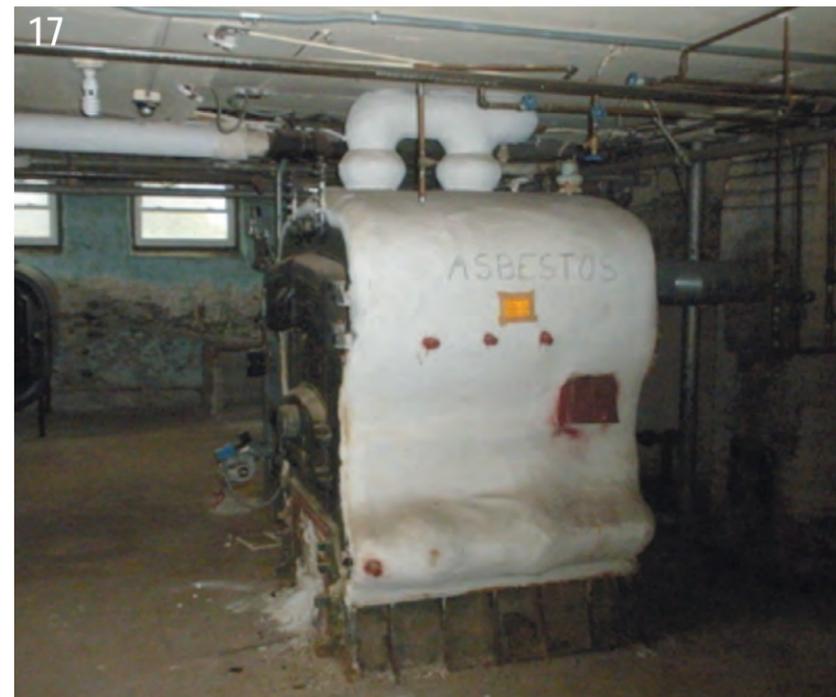
There is asbestos located in multiple places throughout the interior of the building. In the basement, there is a furnace/boiler that is covered in asbestos as fire protection (Photo 17). In addition, there are asbestos-covered pipes in the basement. There are 9" x 9" asbestos floor tiles, covering most of the floor area on the first and second floors (Photo 18). There is an asbestos panel covering one side of the door of the third floor/book storage space. There is lead paint on most of the interior surfaces. The paint ranges from good to fair condition, depending on the room. There is mold in small areas on some of the basement walls. There is guano in the attic.

All of the asbestos will need to be removed from the building. The asbestos-covered furnace/boiler in the basement will need to be removed from the site, likely by disassembly. The asbestos-covered pipes in the basement will also need to be removed. The asbestos floor tiles, which are in most rooms on the first floor and second floor, should also be removed and replaced with new flooring material. The following process is the proper way to remove the tiles: use plastic sheeting to cover wall surfaces and openings, wet the tiles during removal, use a wide putty knife to pry up the tiles, place the tiles in a leak-tight container, and transport the asbestos tiles to a landfill that accepts asbestos waste (<http://www.deq.state.or.us/aq/asbestos/docs/Asbflr.pdf>). The asbestos door panel on the door to enter the third floor/book storage space (top of the stairs before one enters the space) should be removed. The use/reuse of the door should be assessed depending on the use of the space, as well as if it is financially feasible to replace the door when doing any work to the building. Most of the interior wall surfaces have been painted with lead paint. To remove the lead paint, one must wet the wall surface to reduce dust, scrape the paint off with a hand-held scraper, and once the paint is removed to the smoothest possible surface, repaint the wall surfaces. There was mold discovered in the basement. The mold should be removed by the following process: determine the cause of the problem and addressing it, isolate the contaminated area by closing all doors and windows in the affected areas, suppress dust by misting the contaminated areas, remove all wet and mold-damaged porous materials (in this case would be the plaster-like material on some of the basement walls), place the material in plastic bags, clean the moldy areas using a detergent solution
