St. Mary's Parish House

Reuse and Rehabilitation
Feasibility Report

Fall 2013

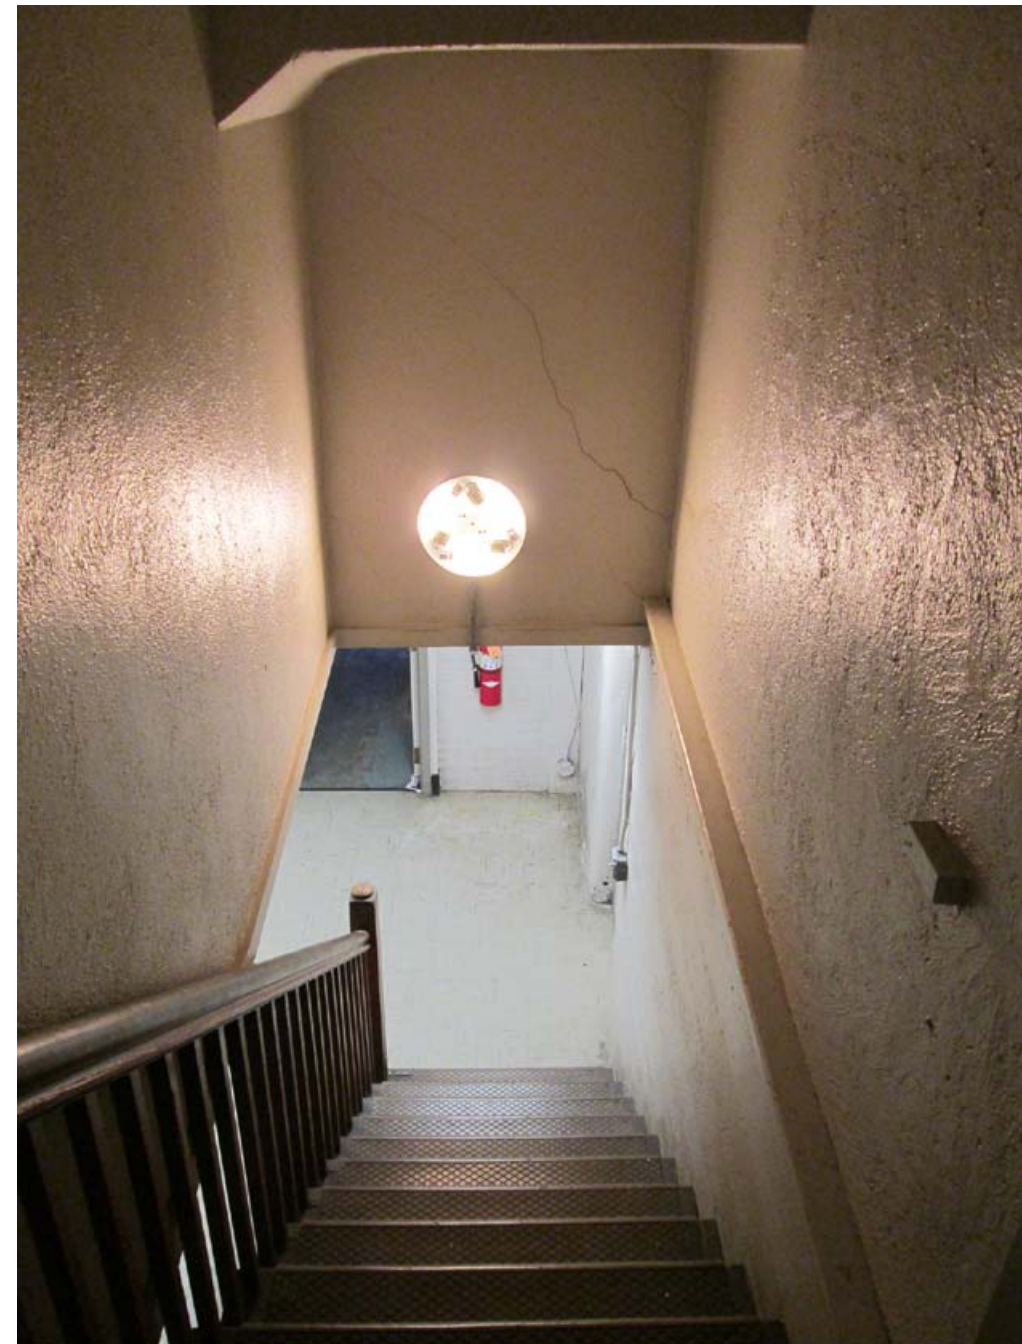
Stairs leading to the basement. Plaster walls exhibit cracking. Light fixtures will be replaced with ones that respect the building's historic character.

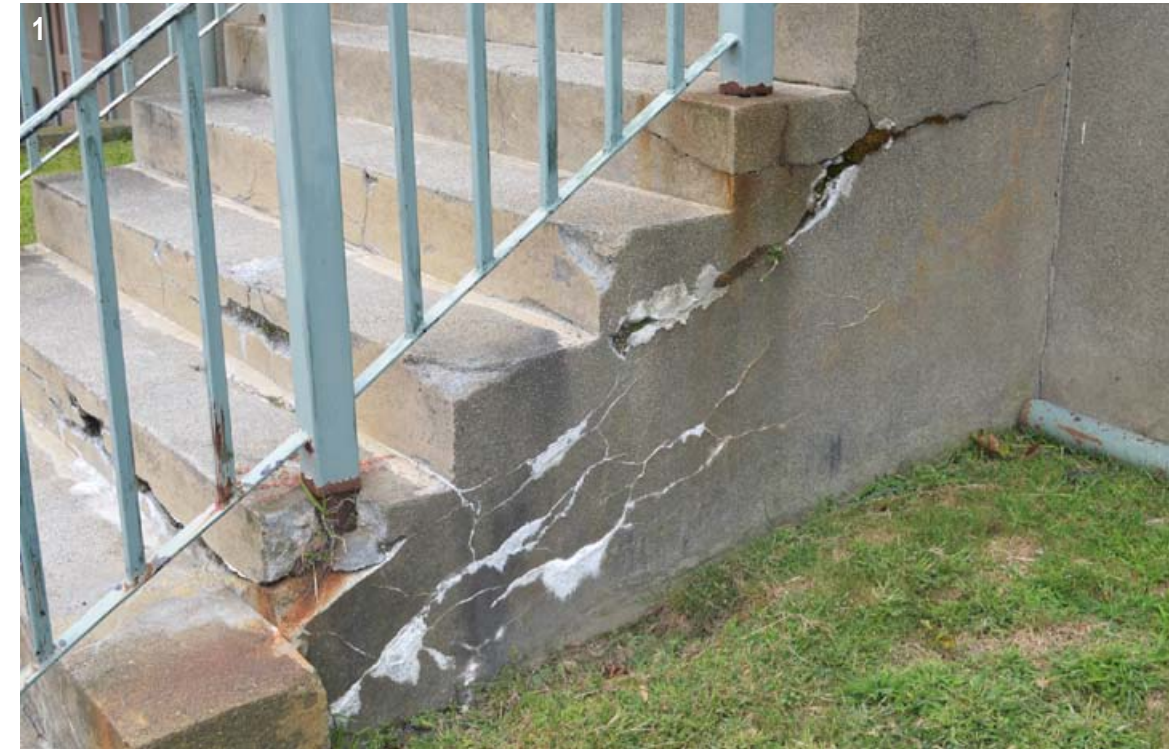
The concrete front porch stairs are in poor condition with significant cracking throughout, rust and loss of large chunks of concrete.

The painted cast iron railings on the steps to the front porch are in poor condition with a significant amount of rust and paint loss. They appear to have been added c. 1980.

1. The front stairs exhibit significant cracking and loss of concrete. The railings show rust and paint loss.

2. The south fire escape shows wood rot, paint loss and detached risers.

The south fire escape is in fair to poor condition. There is significant weathering of the wood, including some rot. Risers are detached from stringers, and treads are detached from risers. There is also significant paint loss.

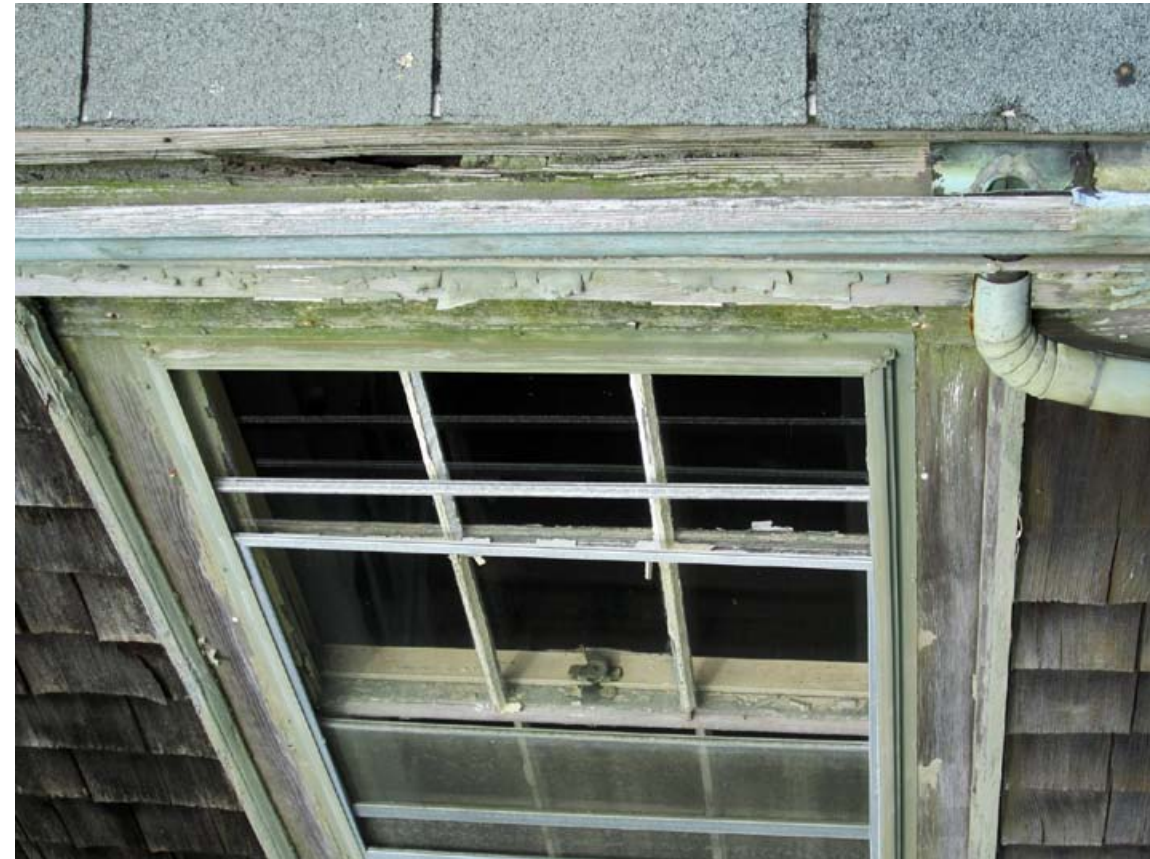
This window on the south elevation shows a deteriorating wood frame. The wooden gutters show signs of rot and many are disconnected from the downspouts.

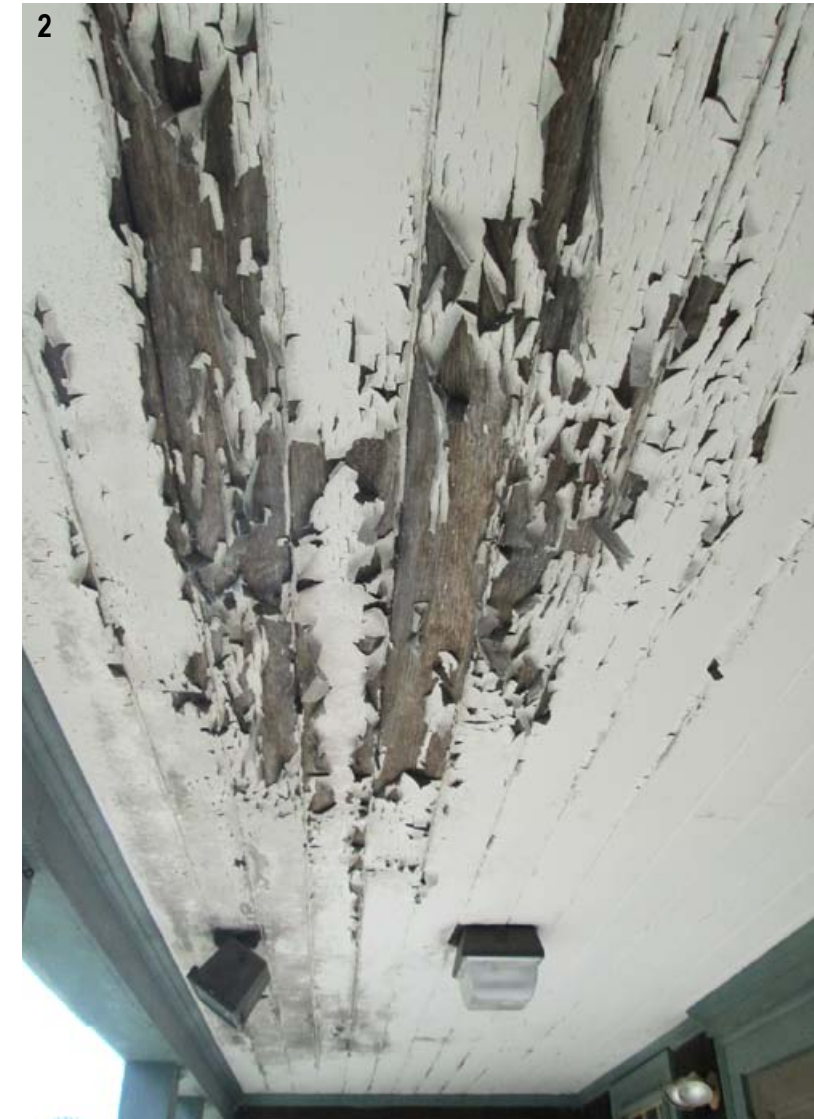
Paint throughout the exterior of the structure is in poor condition. Paint on the front entry door is cracked. Paint on the porch ceiling is peeling off in large flakes that hang from the ceiling. There is significant paint loss on the cornice and most window surrounds.

1. All exterior doors are in good condition including this metal one.
2. The porch ceiling exhibits significant paint peeling.

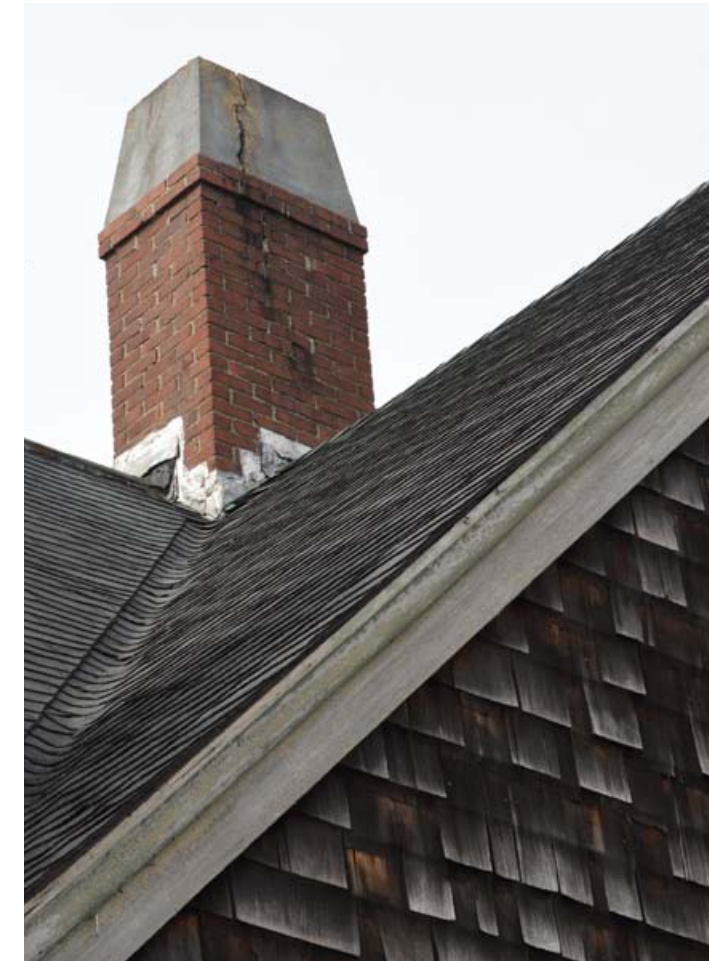
- **Problem:** The chimneys are in fair condition, showing signs of deterioration. There are loose mortar joints in both chimneys and visible cracks running down the exterior of the north chimney up into the concrete chimney cap.
- **Solution:** On the south chimney, all exterior masonry joints will be tapped with a masonry hammer to determine failing joints. Where loose, mortar will be removed down to a sound layer and repointed in kind with matching mortar and joint profiles. This should be done in accordance with NPS

To repair cracks and loose mortar joints, the north chimney will be removed and rebuilt with salvaged bricks.

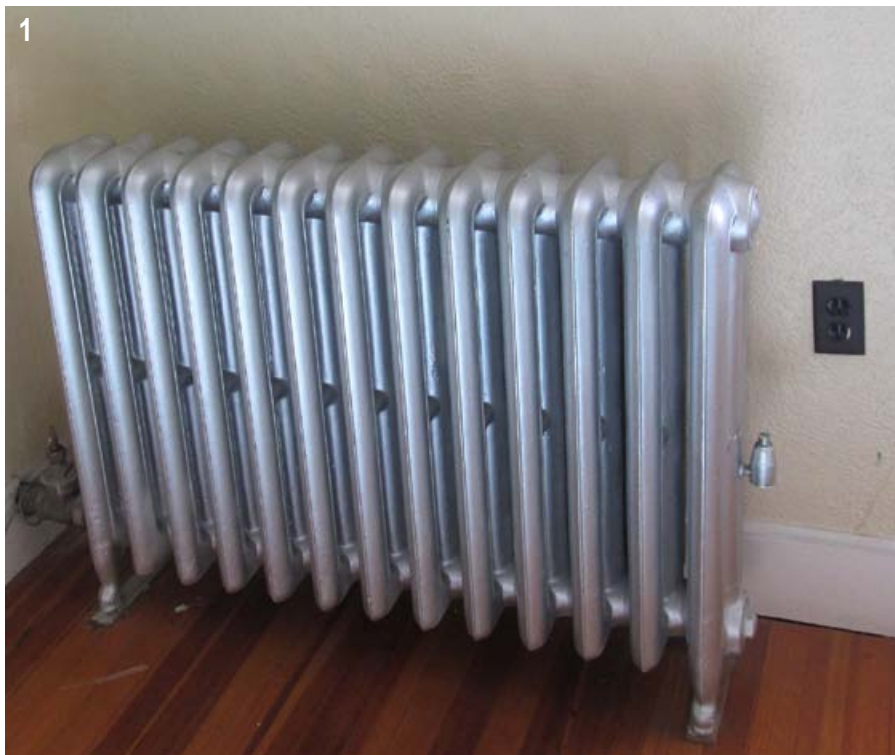
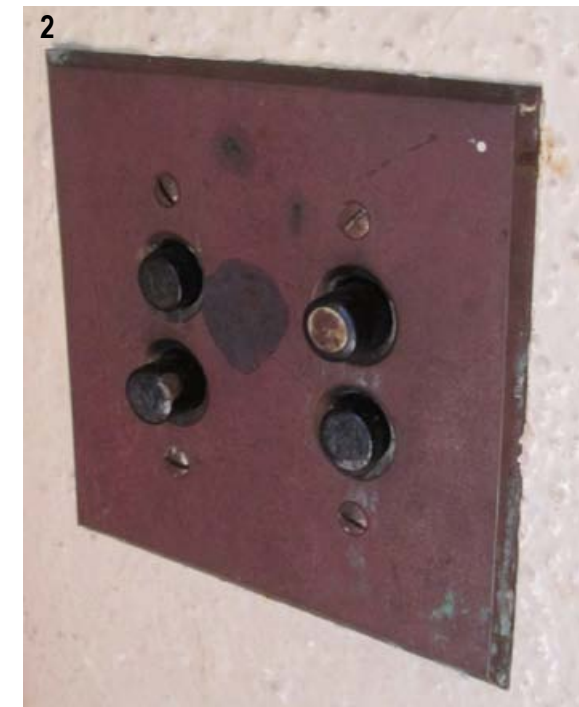
1. The cast iron radiators are in good condition, though some require minor scraping and repainting.
2. An historic light switch plate in one of the classrooms. Electrical wiring behind it needs to be examined.

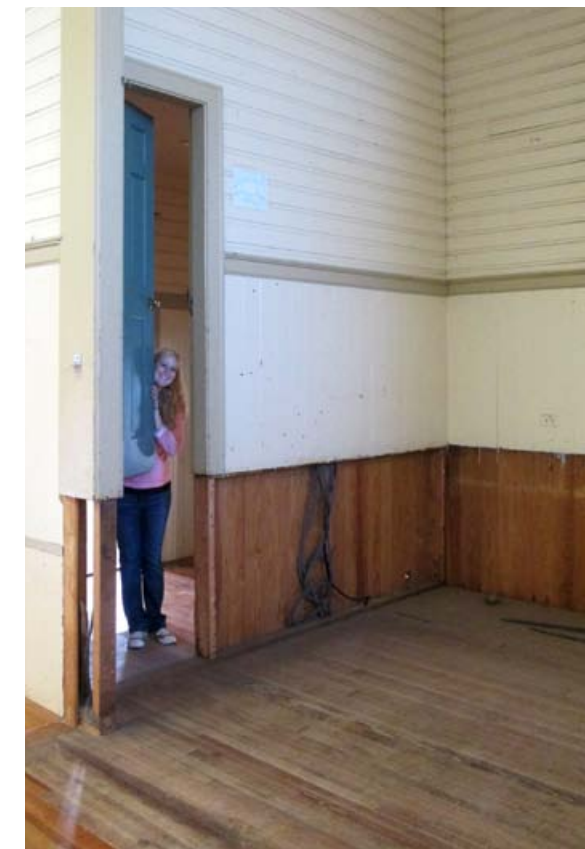
A team member peeks through one of the floating doors of the removed stage area.
