# The Baptist Church in Warren

Rehabilitation and Preservation Report

Fall 2013

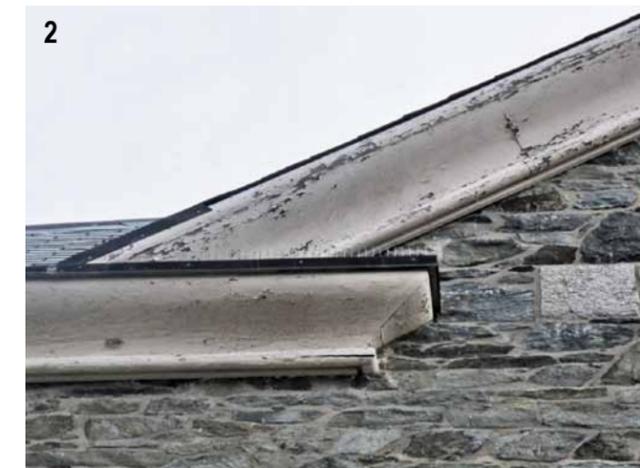
The cornice is composed of a single solid wooden Grecian ovolo profile that is terminated by a large bead at the base. The cornice wood is in good condition with the exception of the paint finish, which is flaking throughout the perimeter of the cornice.

1. Drainage holes along the base of the north facade show mildew growth from water damage.

2. Paint failure on cornice.

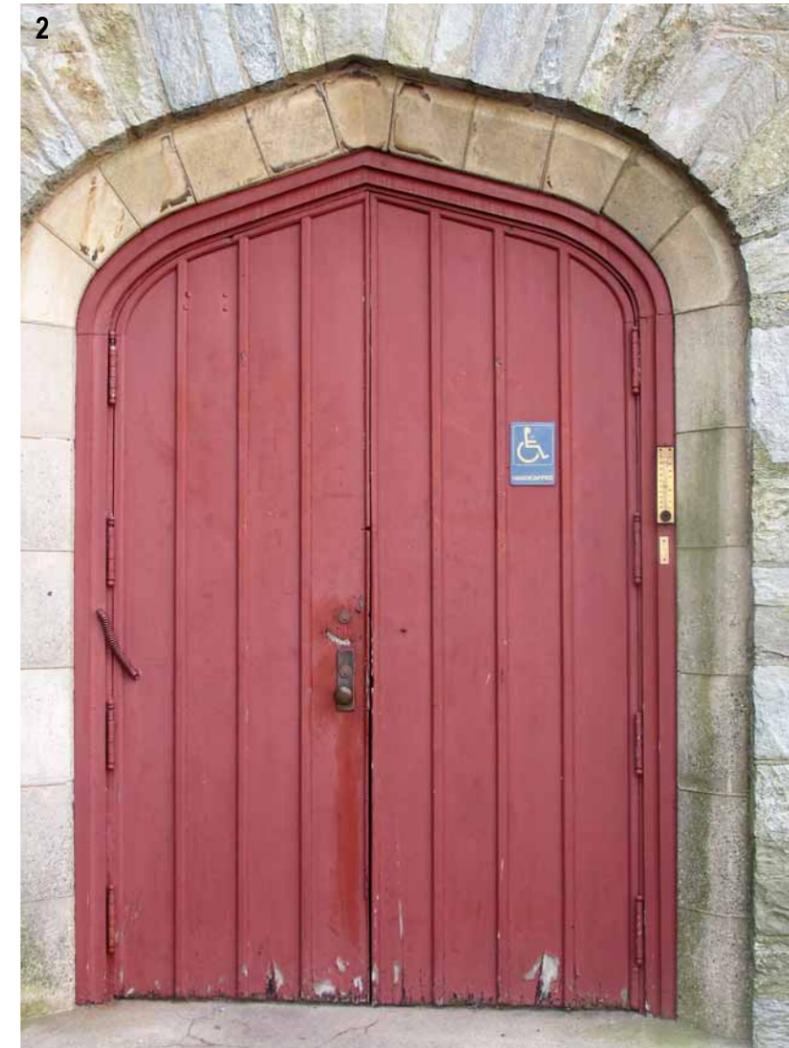
The window glazing is failing. This process has become exacerbated due to the storm windows. The storm windows are not properly ventilated, causing a micro climate within the space between the storm window and the wooden window. This micro climate is causing the paint and glazing to peel away.

1. The northeast window, located on the east façade, has an opening that traps moisture in the cavity between the window and storm window.

2. The doors on the northern entrance exhibit paint peeling and rot at the bottom.

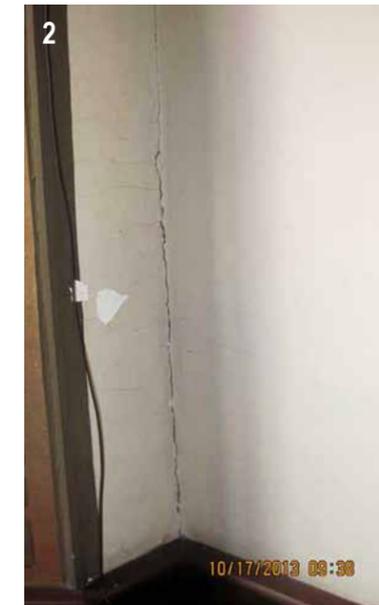
1. Narrow stairway to the bell tower, accessed through a door in the sanctuary's balcony.

2. Cracked plaster walls in the sanctuary.

3. Faux wood graining shows failure throughout the church.

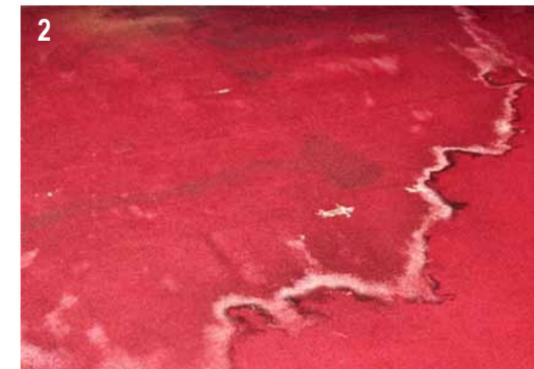
The carpeting in the main sanctuary is heavily stained by water damage with sections worn through to the backing. The finishes throughout the rest of the building are all stable and do not require any necessary replacement at this time.

1. A pronounced view of the stained glass bowing of the doors leading into the sanctuary.
2. The carpet shows signs of water damage.

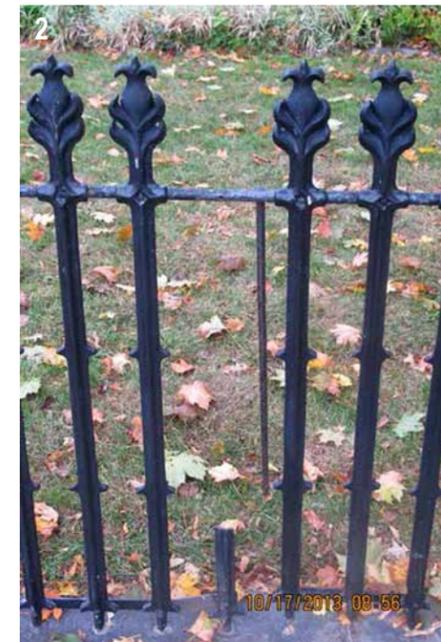
Skirting the perimeter of the church property on Main Street and Miller Street is a decorative cast iron fence. Overall the fence is in fair condition. There are broken cast iron posts and some issues with the protective finish. The granite base has shifted because of freeze/thaw cycles, which have upset the balance of the fencing.

2. Cast iron fence exhibits missing and broken posts.

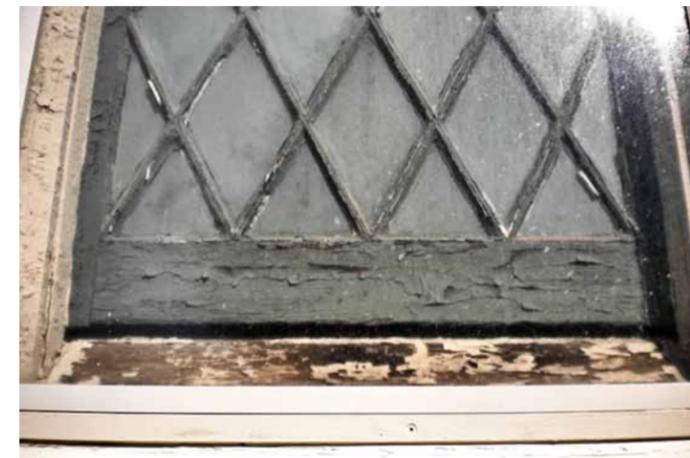
Paint failure around the windows due to moisture exposure.

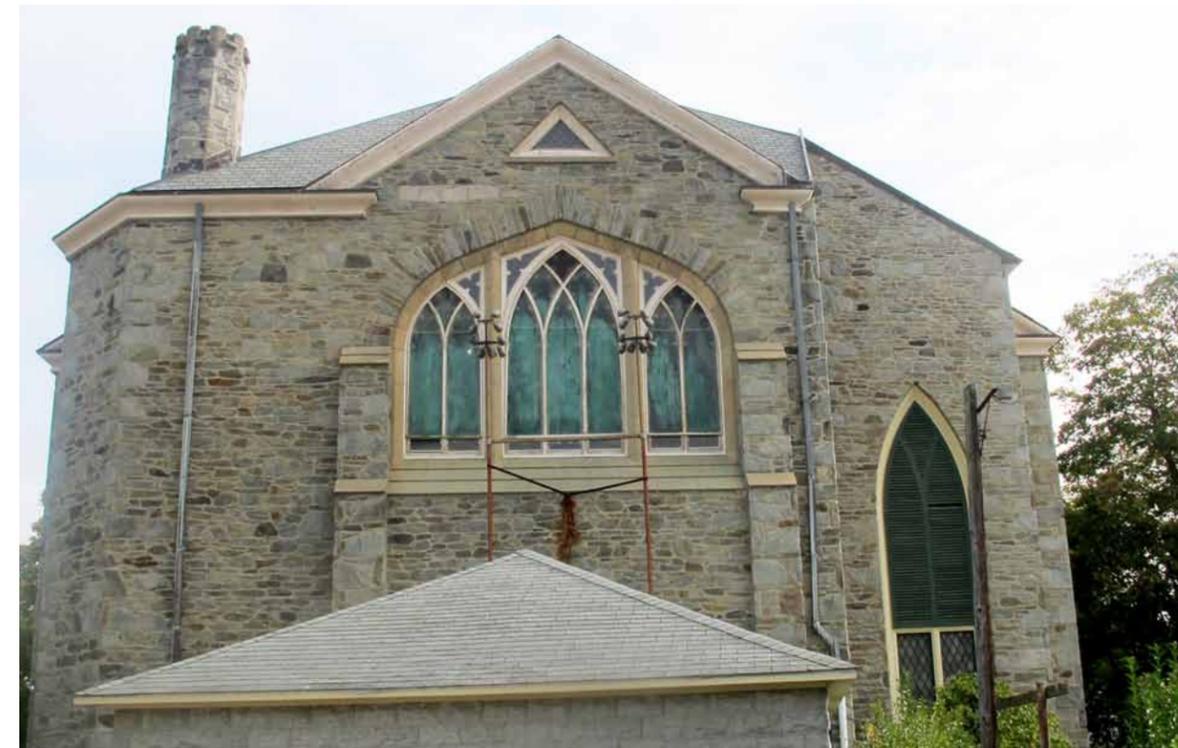
West elevation shows some stone wall rust staining, which needs to be cleaned.

- **3.2.2.4** Allow the remover to stand for three to five minutes before rinsing the area with pressurized cold water of no more than 300 psi. Repeat process as necessary.

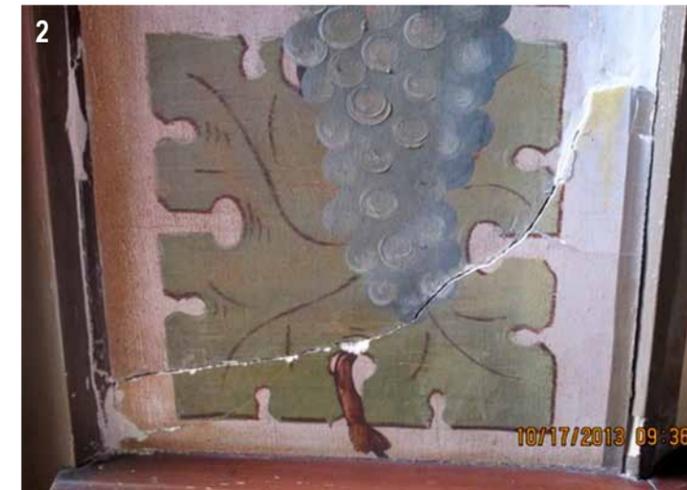
The decorative paint which accents the lancet arches throughout is in good condition. However, the paint on the lower portion of the lancet arch of the windows is deteriorating. The decorative paint in the chancel is in fair condition. The paint in the chancel has suffered moisture damage from a roof leak that has since been repaired. The damaged paint and plaster areas have not been repaired.

1. Areas of paint failure need to be scraped, sanded, cracks filled and surface painted to match existing paint.
2. Cracking and peeling of decorative paint, which needs to be filled and painted to match existing paint.

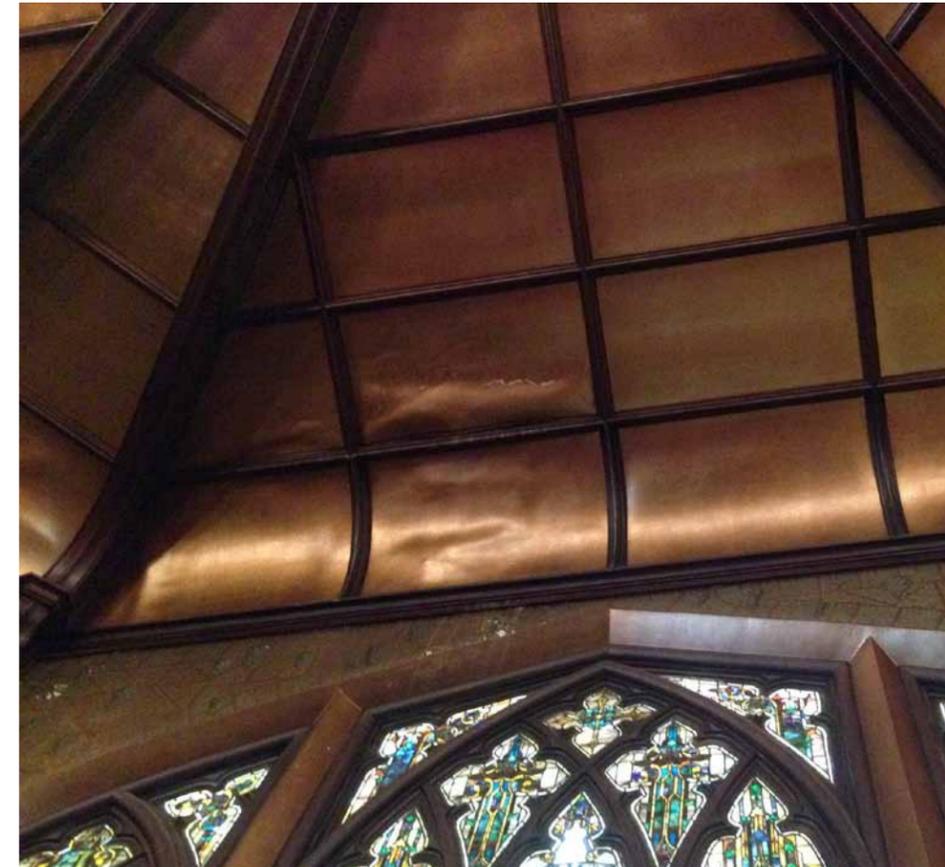
The puckering of the gold leafed, canvas ceiling in the vestry can be seen in the lower left corner.
