Trinity Restoration Inc. Theater Design

393 Broad Street | Providence | RI
Community Partner: Trinity Restoration Inc.

Introduction

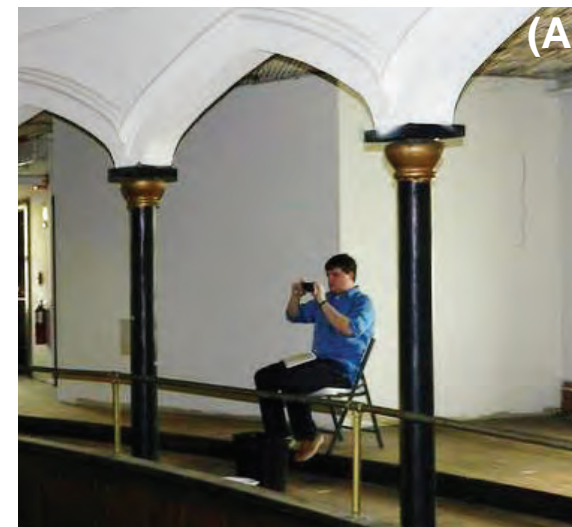
(A) CPC Project Manager, Jake Wheeler investigates the mezzanine site lines.

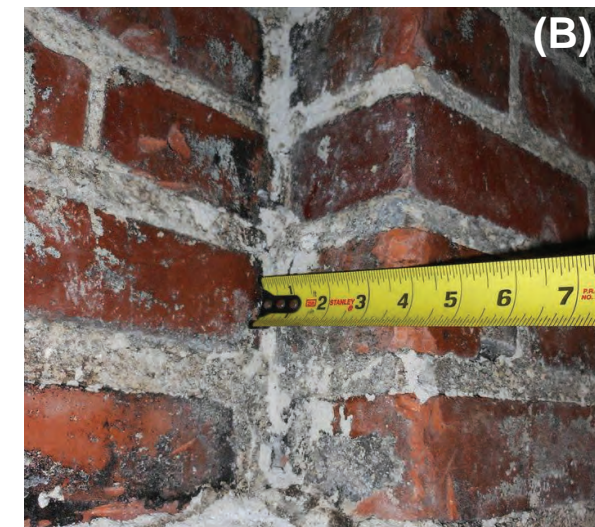
(B) CPC Project Manager, Vincent Lemma, conducts a field measurement.

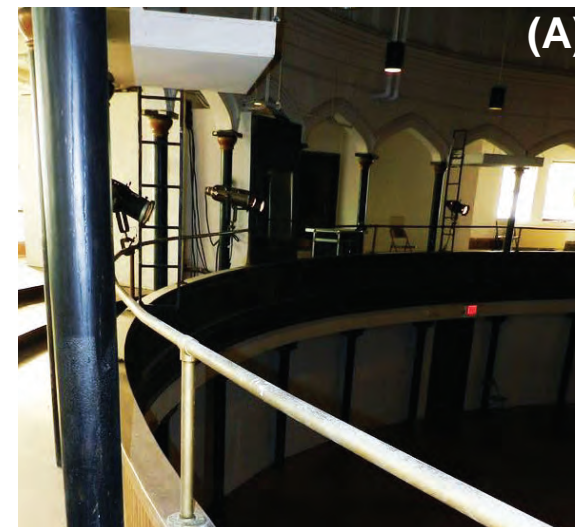
(A) Mezzanine hand rail

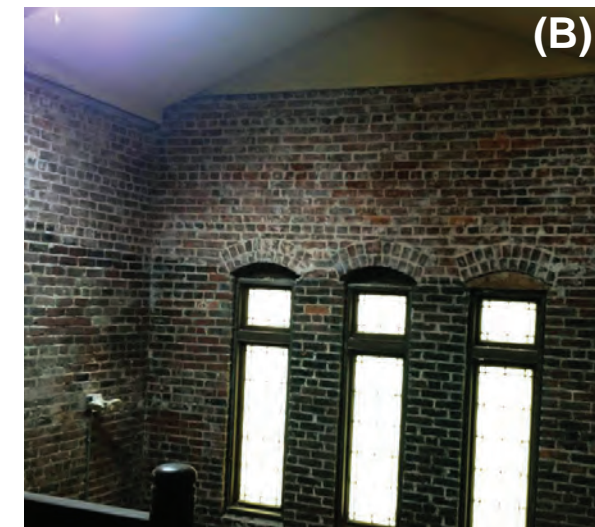
(B) View from stairwell

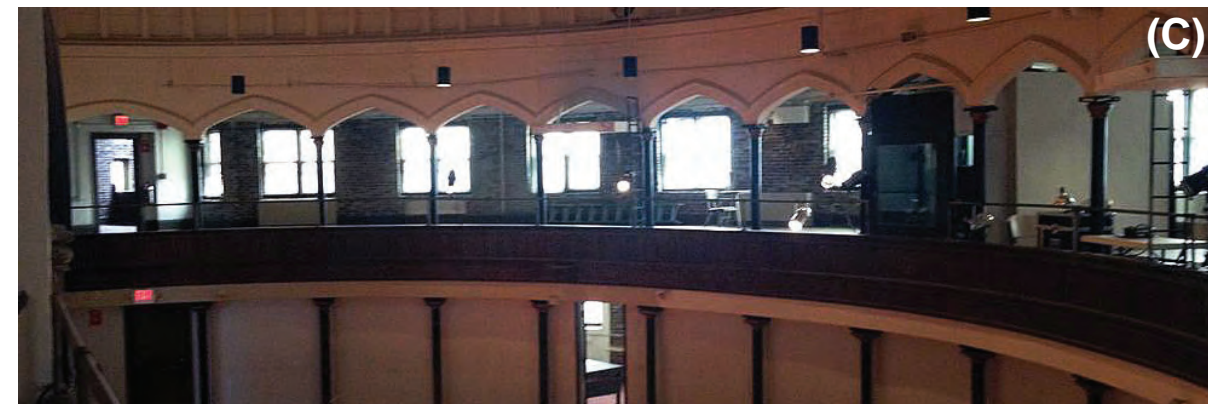
(C) View from Mezzanine

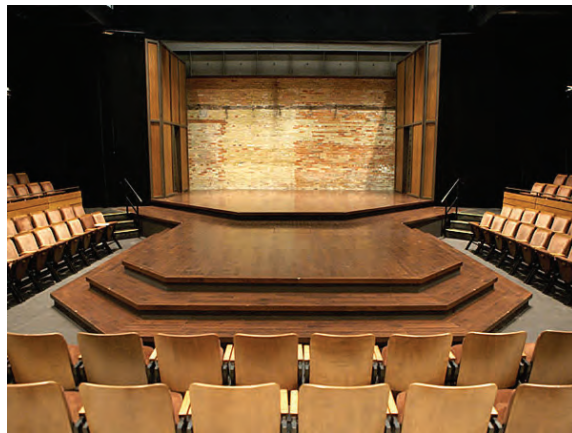
The Marilyn and Charles Baillie Theatre

Located at the Young Centre for the Performing Arts in Ontario, Canada, this building holds approximately 315 seats. The theater is a multi-configurable space with orchestra and balcony seating. It is set up with a proscenium configuration but can be rearranged for other functions.

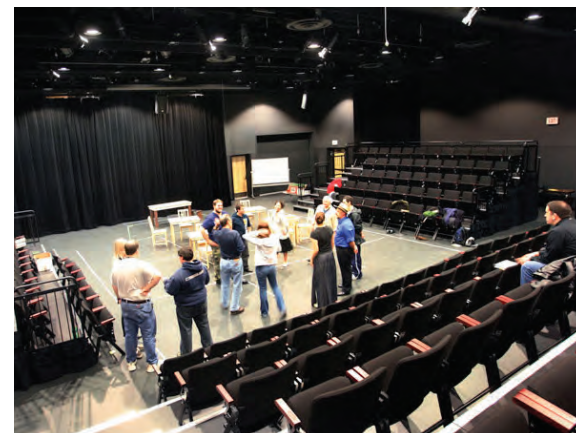
Edmonds C.C. Black Box Theater

Located in Edmonds, Washington, this “Black Box” theater implements a design that accommodates flexibility for seating, stage layout and AV device locations. This approach allows scheduling to become easier since different uses can be set up quickly.

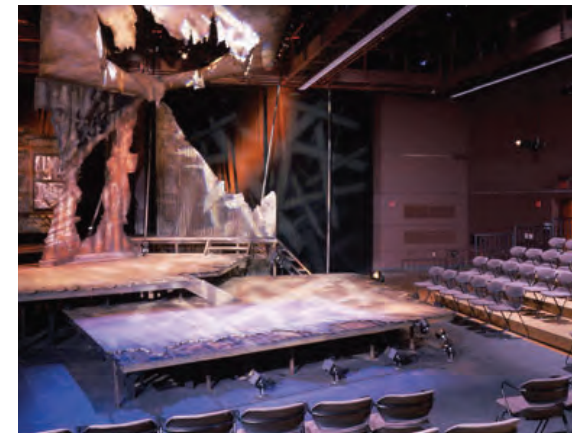
Kogod Theatre

Located at the University of Maryland, this multi-purpose, flexible theater can accommodate various seating configurations for a maximum capacity of 156 people. In addition, a modular stage can be manipulated to suit the needs of individual performances.

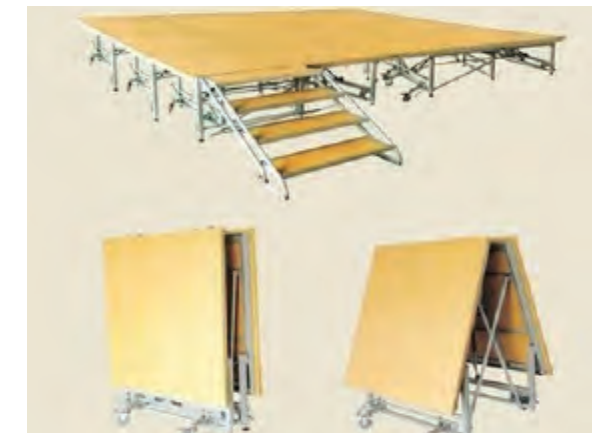
Portable and Modular Stages

There are many stages that can be moved into place using mobile techniques such as wheeled systems. These lightweight systems allow for easy storage. The above system is able to be folded up and rolled to the desired destination. Some lower budget theaters use them as permanent stages.

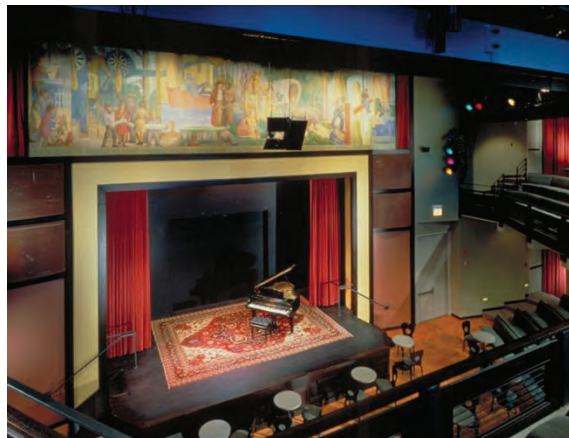
Old Town School of Folk Music

Located in Chicago, Illinois, this renovated library was turned into a 400-seat concert hall with an upper balcony. There is fixed seating on the balcony as well as fixed “bench” seating on the main level. In addition, moveable table and chair sets are placed along the front of the stage to allow for flexibility from performance to performance. During the day, the theater entry doors are opened which allows the space to be used for café seating.

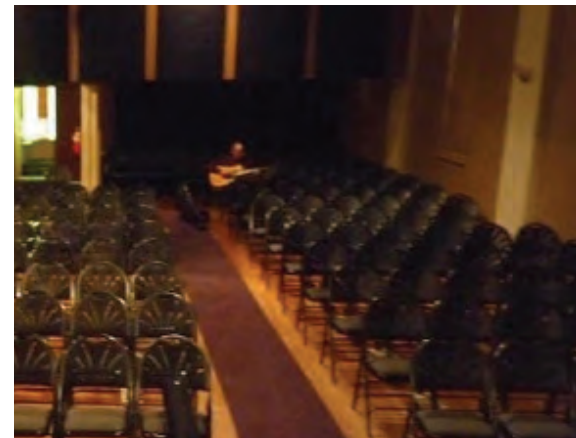
Daniel's Hall, Swallow Hill Music

Located in Denver, Colorado, this folk and acoustic school features a 300-seat performance hall which aims to be as flexible as possible. The fully moveable chair configuration is used to have productions ranging from traditional concerts, dance events, and cabaret.

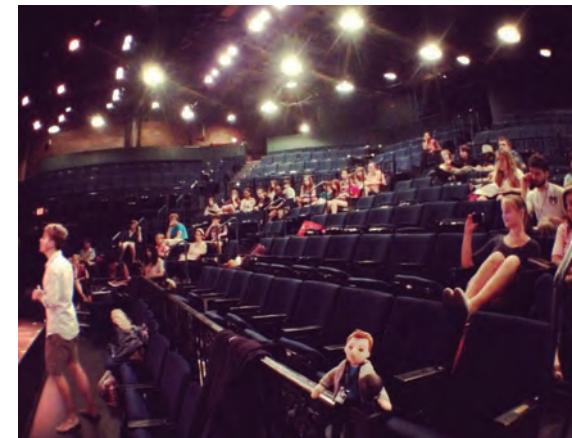
Trinity Repertory Company

Located in the Providence, Rhode Island this historic building houses two performance spaces. The lower level theater houses 286 seats, while the upper performing space holds over 500 seats. The large performance hall offers an assisted listening system so the hearing impaired are not restricted to up-front seating.

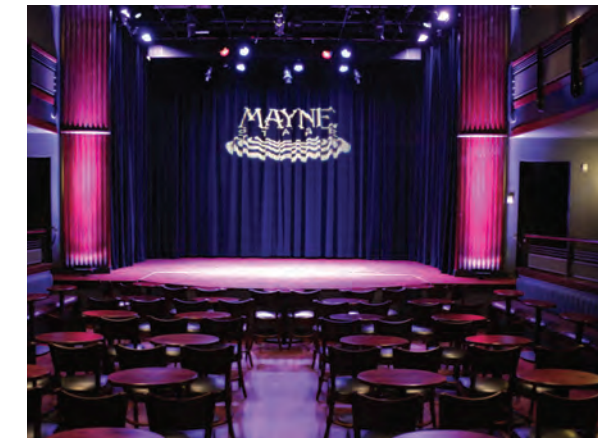
Mayne Stage

Located in Chicago, Illinois, the former Morse Theater, is able to be utilized as two different venue options. The theater can hold a capacity of 220 people when the space is filled with tables. When an event calls for mixed audience seating, 400 people can fit with a mix of standing spaces and additional seating.

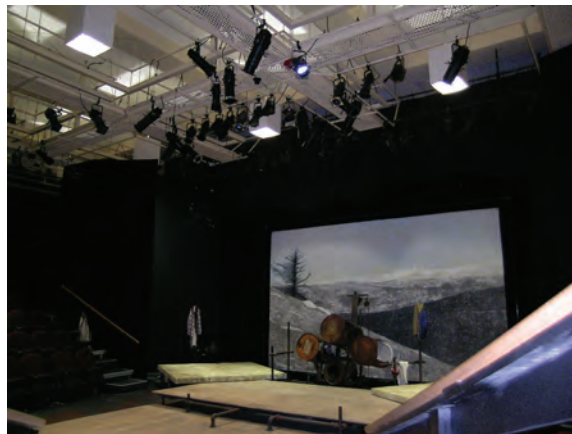
Lost Nation Theater

Located in, Montpelier, Vermont, this hall is known for its versatility. Theater lighting is often laid out in the form of grids. This theater decided to use catwalks for their grid format. To avoid distraction, the catwalks were painted the same color as the ceiling. This approach makes it easy for lights to be altered for different performance types.

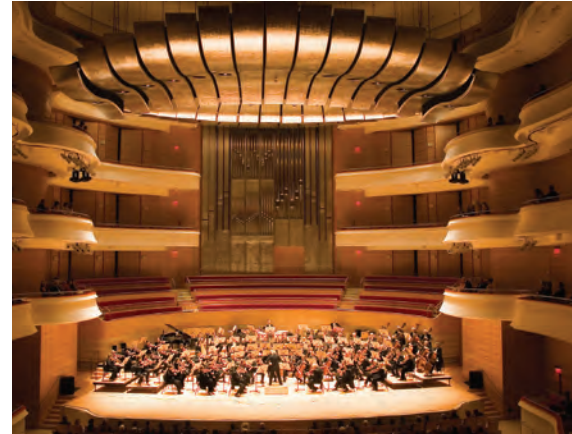
The Renee & Henry Segerstrom Hall

Located in Costa Mesa, California, this building implements a wide variety of LED Lights to achieve dazzling effects. In 2008, this space won an award of excellence for the International Illumination Design Awards. The LED lights wash down the 4' high fronts of the curved balcony. Accent lights, and fiber optics are also used in the lobby before entering the performance space.

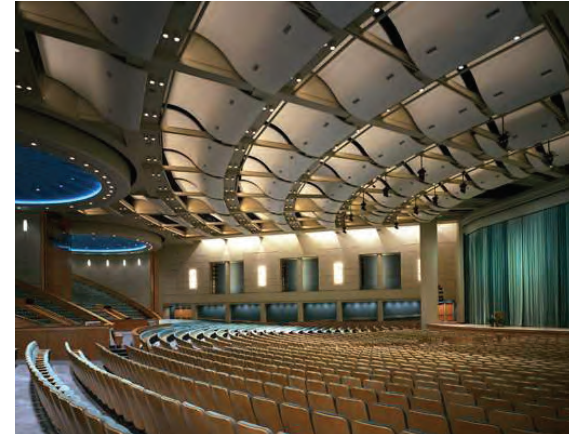
Minneapolis Convention Center

Located in Minneapolis, Minnesota, this large venue is often broken down to accommodate smaller events. The xenon fixtures are secured and accessible from catwalks to allow for quick changes. This lighting is supplemented by 400W quartz (incandescent) down lighting. There large bays are indirectly lighted with surface mounted strip-lights that are concealed behind columns.

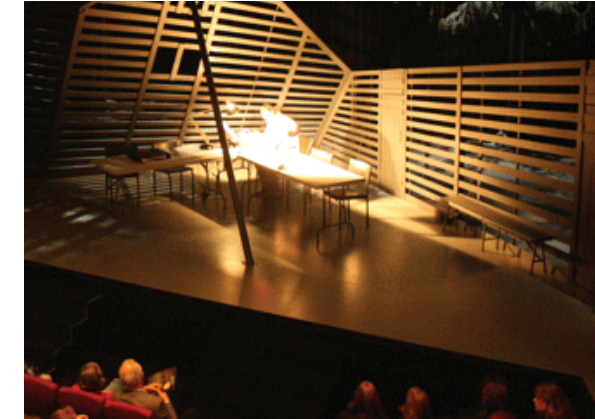
The Queensland Performing Arts Centre in Brisbane, Australia recently completed a major renovation of its 1800-seat concert hall. Since the installation of energy efficient lighting, energy consumption and cost have decreased. The stage lighting, which was once the top energy user, has fallen well behind other common theater units, such as air-conditioning.

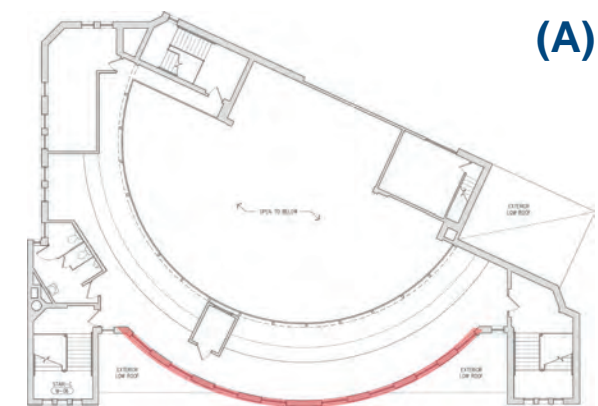
(A) Circular Form: The two walls identified in Diagram (A) and (B) are problem points for the acoustical quality of this theater. The exterior wall on the mezzanine has been built in a circular pattern and the gypsum wall on the second floor is made up of flat sections set up along a circular arc. These concave rear walls create a unique set of problems.

(A) Mezzanine Floor Plan

Problems: (1) Sound travels very quick around the curve of the wall creating a disproportional

amount of sound on the opposite ends of the arc. (2) Sounds that start in front of the curve gets reflected back to a focal point. The location of that focal point moves depending on where the sound is located. As a result, loud refocused echoes are created at the focal point. When heard, the sounds seem to come from a mysterious place. The effects of the curved walls are extremely strong and need to be addressed. One common mistake is over applying absorptive material to the walls. This solves the focal point problem but creates a “dead wall” problem.

Solutions: (1) Apply some acoustic absorptive material at the surface of the curved wall. This will pull the sound to the back of the room. (2) Apply reflective material in a scattered pattern where absorptive material is not implemented. The remaining sounds need to be scattered and reflected in directions away from the focal point. The typical sound scattering device implemented is a curved acoustical panel. This panel is essentially a thin flat plane that is bent to have a reversed curvature to the curve of the wall. This panel will scatter mid and high range sounds. In addition, the panel must also be a bass trap so that the reflecting low frequencies do not focus. (3) An alternative would be to increase the angles and depth of the rear walls. By adding irregular forms and voids, sounds can be

scattered and redistributed throughout the space. This will create a more uniformed acoustical quality to the theater. By mixing the absorption and scattering of sound on curved surfaces, the seating areas can achieve a pleasant acoustical quality. These methods are excellent architectural opportunities and should be integrated into the final design to make a unique trademark for the Trinity Theater.

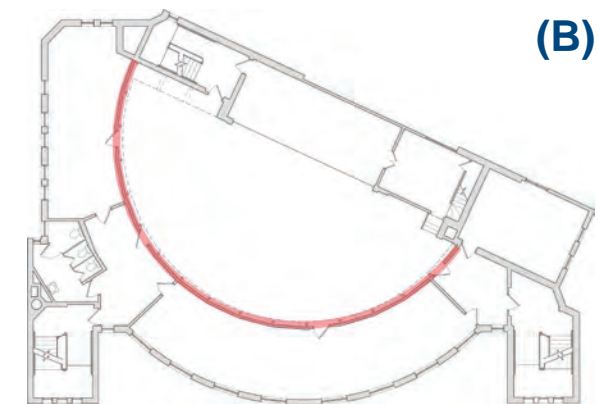
(B) Second Floor Plan

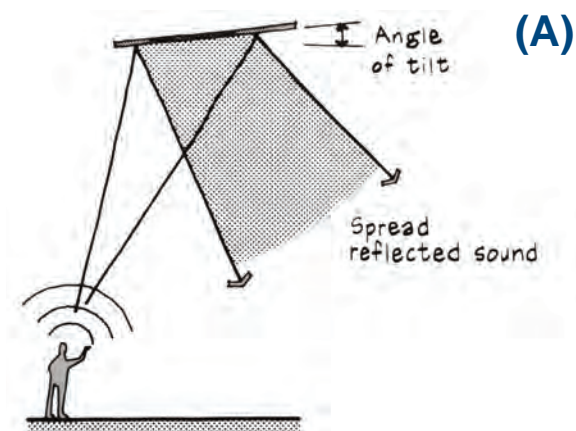
(A) A typical reflector spreads sound. The angle of tilt can be changed depending on the performance or occupancy.

Solutions: (1) Create a reflective shell for the interior of the stage to reflect sounds. The proscenium opening can lead to poor acoustic coupling between the stage and seating area. By lowering the ceiling height of the stage and angling the shell towards the audience, sounds will travel outwards instead of above, behind or adjacent to the stage. (2) Construct a platform that can be set up in front of proscenium stage for specific performances. This can greatly minimize the problems associated with the coupling between the stage and auditorium. Unfortunately, the trade-off is in the elimination of seating. (3) Install acoustical panels in front of the stage from the ceiling. The suspended acoustical panels should be adjustable. Different performances call for different panel heights. By making them adjustable the performer can test the heights before the show. (4) Avoid using the foyer space for seating. Overhanging mezzanines are great for creating extra seating but the space below often has poor acoustical qualities. The sound is usually dull and muffled. By following these measures the large size and ceiling heights can become a strength for Trinity Restoration instead of a weakness.

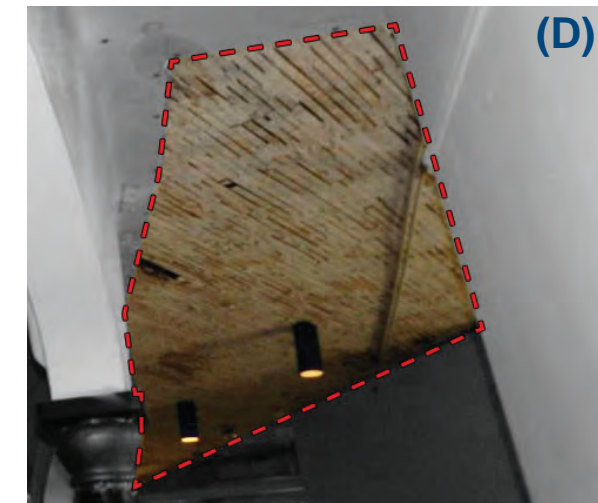
(D) Sufficient mass is necessary to keep desired sound in and unwanted noise out. All penetrations must be properly repaired.

Problems: To provide effective sound isolation the doors, walls, and roof need to be solidly built with sufficient mass. In addition, any penetrations in these variables or through windows must be sealed to keep the desired sound in and the unwanted noise out.

Solutions: (1) Consult a acoustician about replacing your current windows and doors with sound-rated products. (2) Consult a licensed contractor about repairing the building and sealing all voids that could allow leaks to the exterior of the space. Without eliminating sounds leakage, any efforts to improve the acoustics of this space will be under minded.

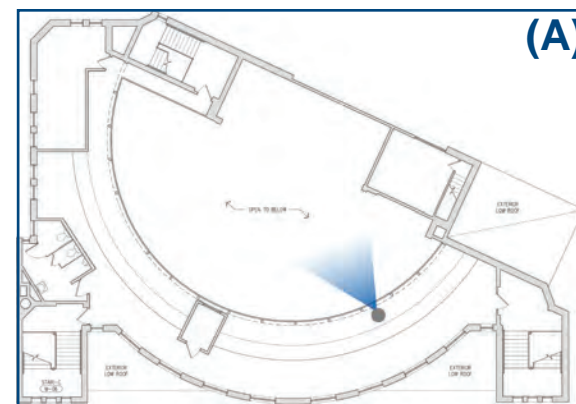
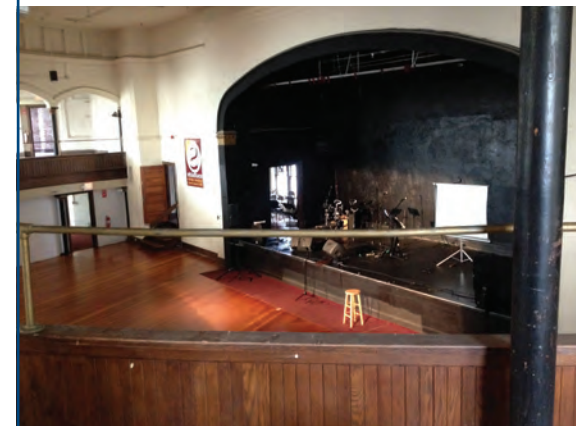
(A) Mezzanine Floor Plan with visual icon indicating view of stage.

Mezzanine Investigation: Visual connection is vital for theater design. Site lines are important design factors that must be kept in mind during the design process. The final design must create a built environment and a circulation that does not obstruct any views. The column arrangement and handrail position on the mezzanine will force a rigorous design approach to create seating with desired site lines. The current condition of the mezzanine has two levels but there may be a possibility to increase higher seating capacity by adding another seating section.

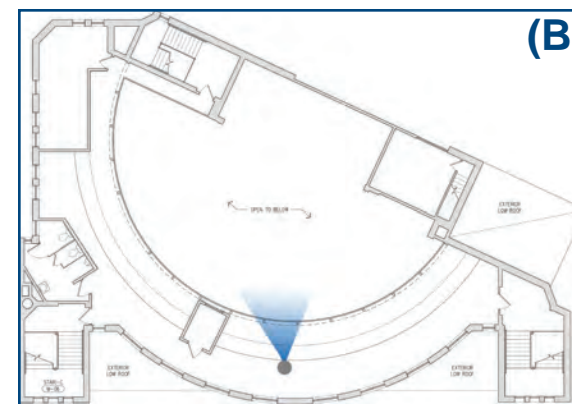
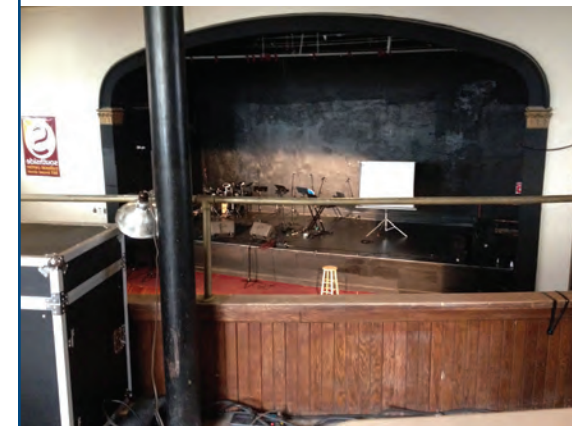
(B) Mezzanine Floor Plan with visual icon indicating view of stage.

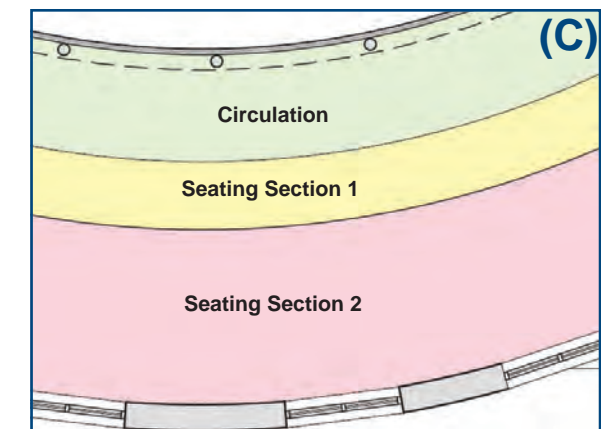
(C) Diagram showing current seating arrangement and the a typical stadium seating section.

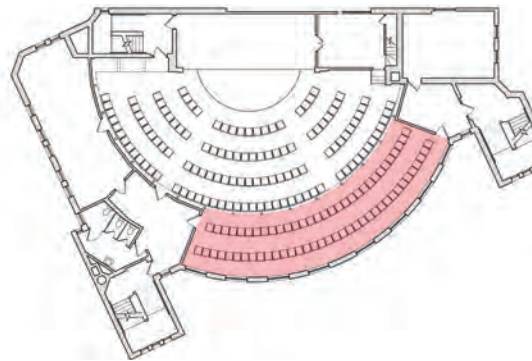
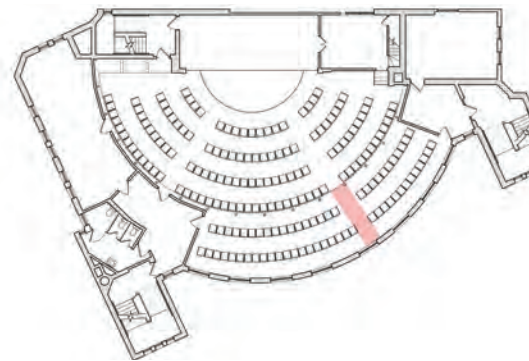
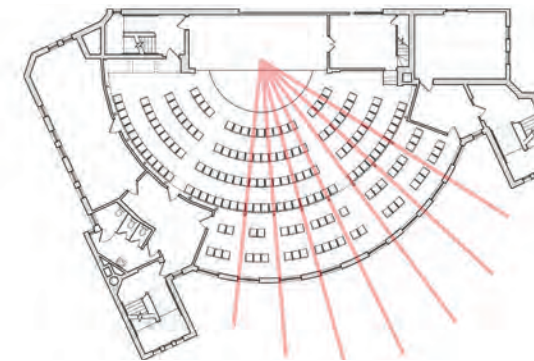
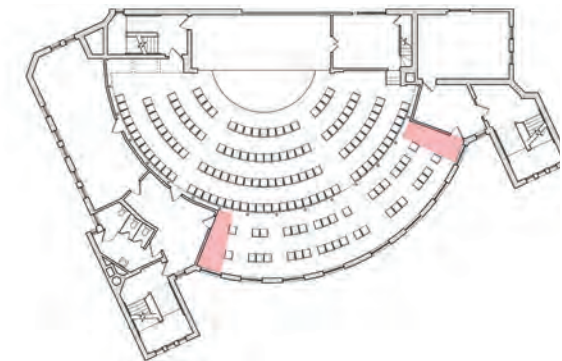
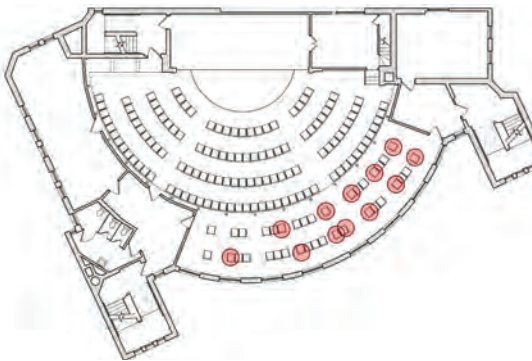
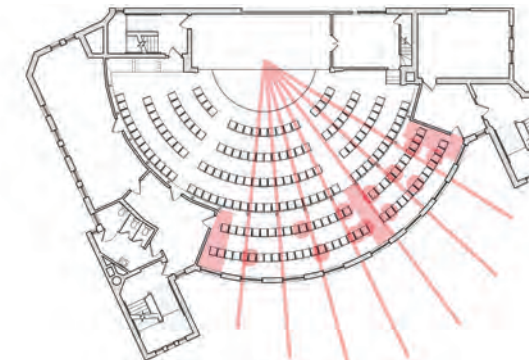
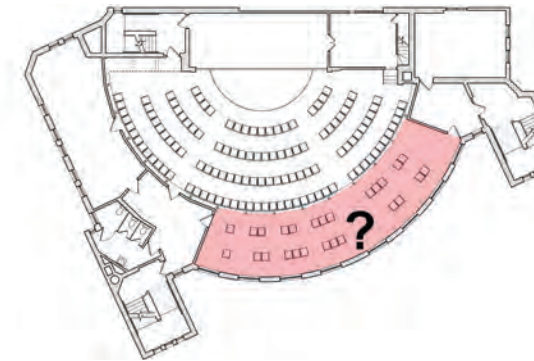
1 - Select space

2 - Remove seats for main aisle

3 - Remove seats due to columns

4 - Remove seats for side aisles

5 - Remove seats due to poor site lines

6 - Check results against project objection

7 - Evaluate situation

Corridor Investigation: The space below the mezzanine has the possibility to hold many programs. One possibility is to open the space up as an extension to the theater seating. The CPC investigated the site lines in the space and concluded that the seating would not be able to hold a large amount of seats with high quality views. If TRI does pursue connecting the two spaces, the CPC recommends utilizing the space for unconcentrated seating. This style would allow for group seating options.

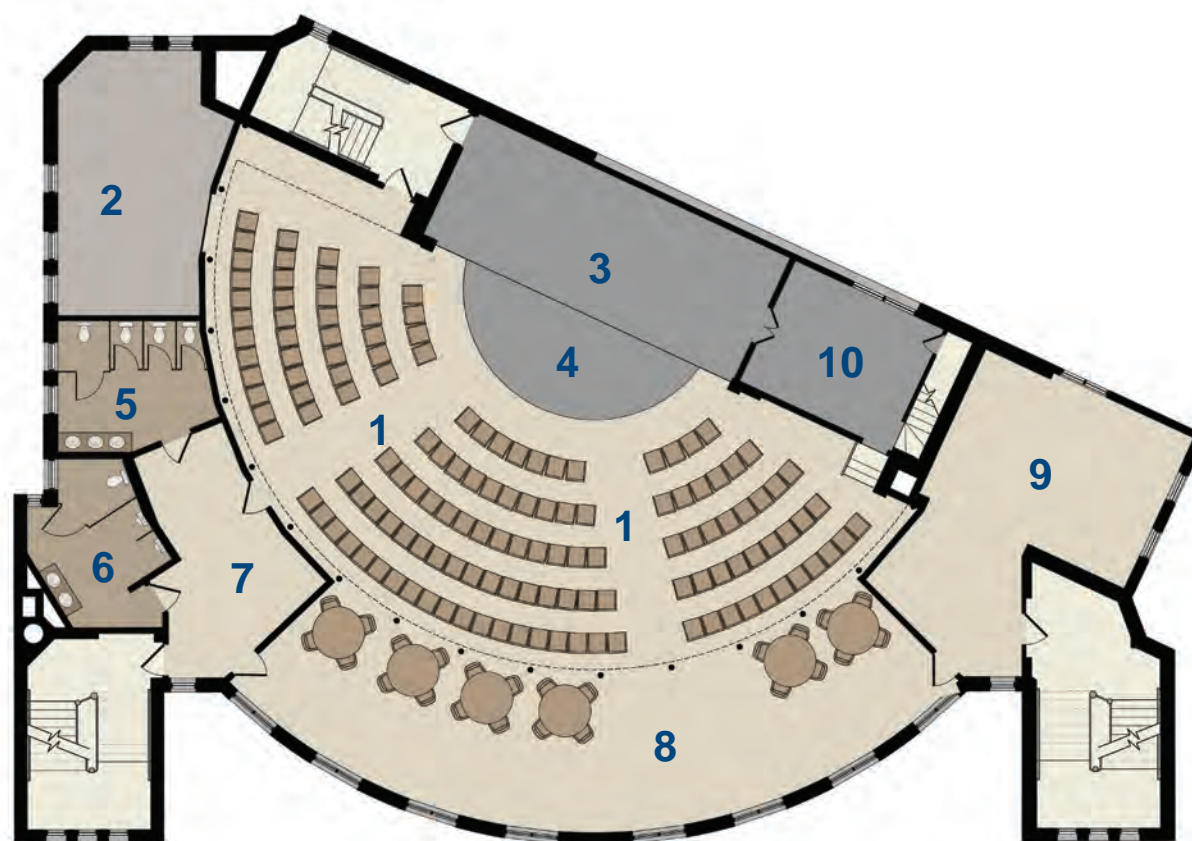
Second Floor

1 - Seating Area	6 - Men's Bathroom	11 - Unisex Bathroom
2 - Storage	7 - Foyer	12 - Control Room
3 - Stage	8 - Flexible Space	13 - Seating Area
4 - Stage Extension	9 - Sales	14 - Storage
5 - Women's Bathroom	10 - Side Stage	15 - Changing Room
