WASHINGTON SQUARE REHABILITATION STUDY

February 3, 1995

CONSERVATION TECHNOLOGY GROUP

WASHINGTON SQUARE REHABILITATION COMMITTEE
NEWPORT BEAUTIFICATION AND CONSERVATION COMMISSION

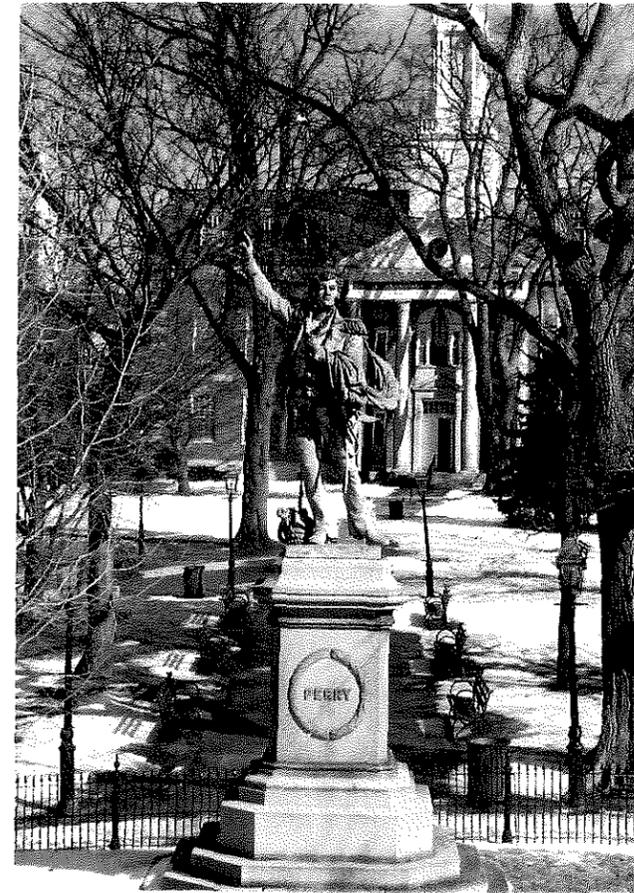
West elevation of Perry statue

Bronze surface characteristics were examined from a bucket lift. The surface is characterized by casting flaws² (see photo plate 5-3), deleterious corrosion patterns (see photo plate 5-4), and dirt³. Examination of the upper horizontal surfaces indicated heavy pitting; examination of the lower surfaces indicated nascent erosion channels. This pattern is typical of bronze monuments with poor resistance to natural elements. No evidence of a ferrous armature or other galvanically interactive material was discovered during examination.

The surface of the statue is in very poor condition. It is extremely important that the statue be cleaned, chased, repatinated⁴, and buffered with BTA⁵ in microcrystalline wax. Heavy pits on horizontal surfaces should be power washed and chased to prevent deleterious hygrophilic chlorides from forming and exacerbating corrosion. The statue should also be cleaned and rewaxed on an annual basis.

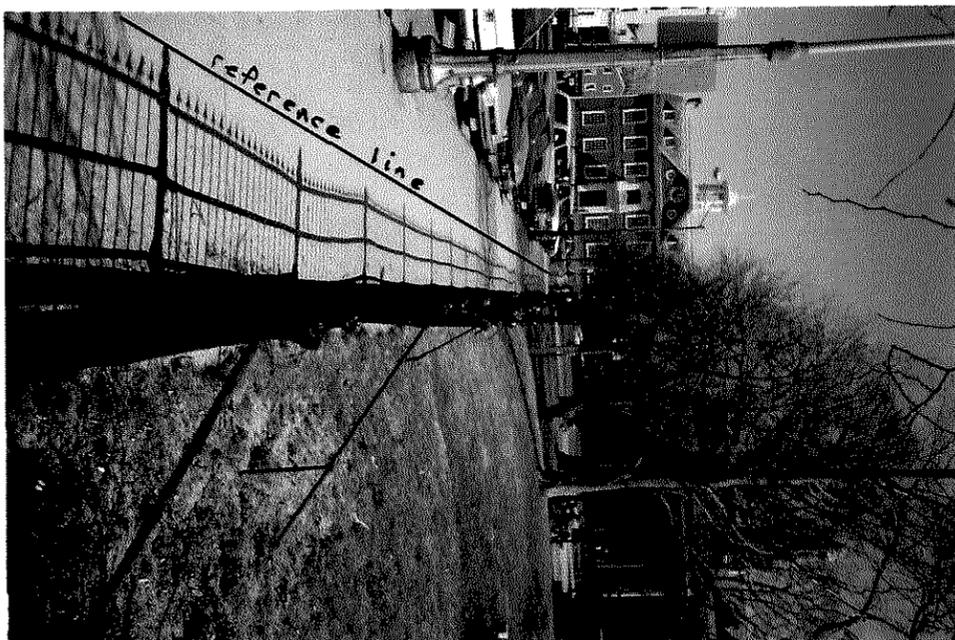
Typical section

The fence is in poor condition (see photo plates pages 9 and 10): total alignment is deformed as the curbing has shifted and due to vandalism and automobile accidents; several sections are missing; many of the posts are missing elements; and many picket sections are deformed or missing elements.

During the last "restoration", the entire south border was set in concrete. This concrete mount, which often rises above the lower rail, has veritably destroyed much of the fence so that it is no longer restorable. Oxidation has destroyed many of the posts: A restoration mount technique utilized galvanically incorrect materials which have exacerbated rust perforation. Condition details listing begin on page 9.

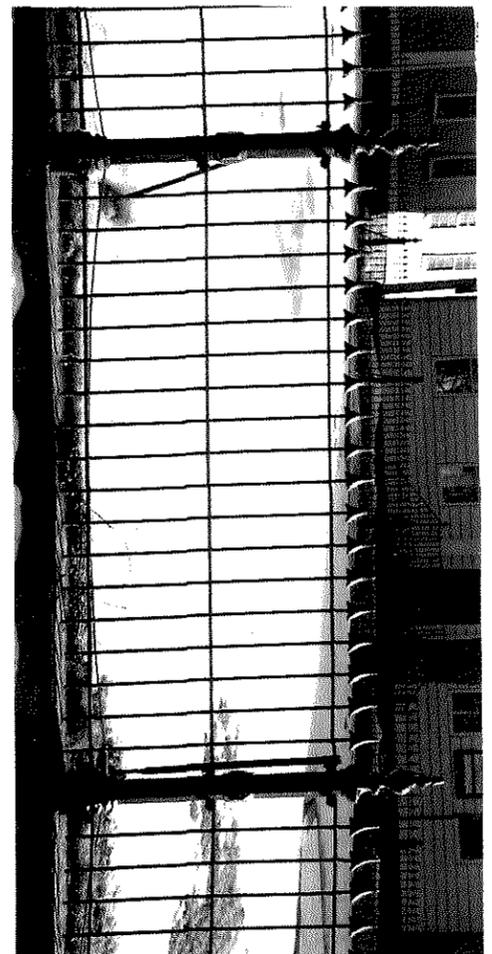
Typical post damage and deformation

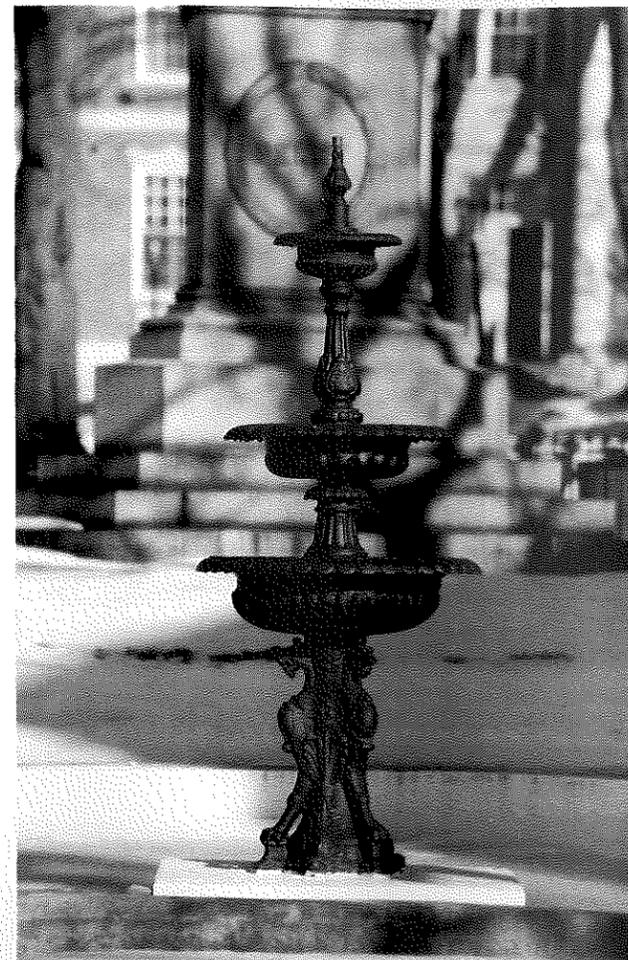
West elevation of fountain

Condition The fountain was reconditioned by Mr. John Isham in 1991 and remains in excellent condition.
