Coddling Farm Barn

Reuse and Rehabilitation
Feasibility Report

Academic Partner:
School of Architecture, Art
and Historic Preservation

Fall 2013

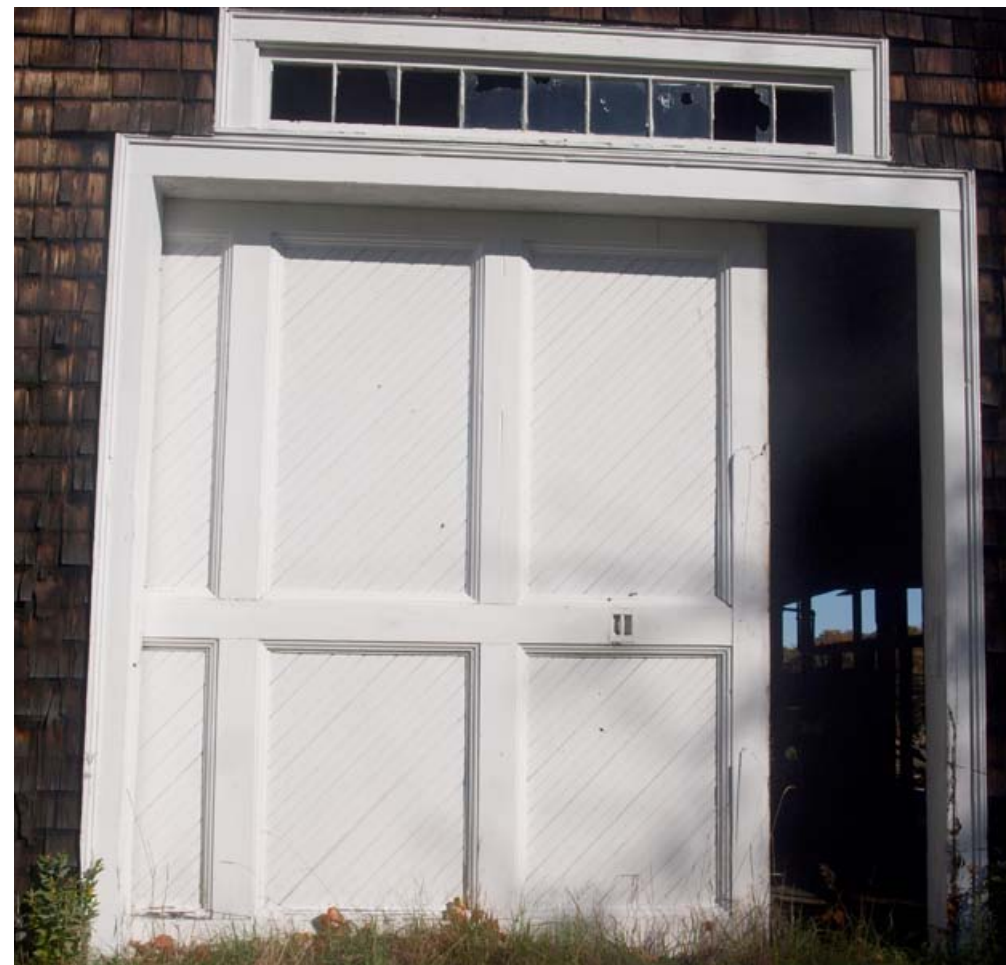
13.1. Existing Conditions: The barn has four different types of exterior doors. The south elevation contains two doors: the primary sliding barn door and a regularly dimensioned solid door that com-

plements the design of the sliding door. Both of these doors are in fair condition with some weathering of the paint. An access door to the dairy washout room on the west elevation is the most decorative and includes a glass window, however, the wood is badly damaged as the result of vandals. Temporary patching has been attempted. All of the exterior door trim on the first floor level is in good condition. Three doors once existed at the foundation level. They have been pulled off of their hinges, and only two are extant on the site. They are laying on the ground in very poor condition.

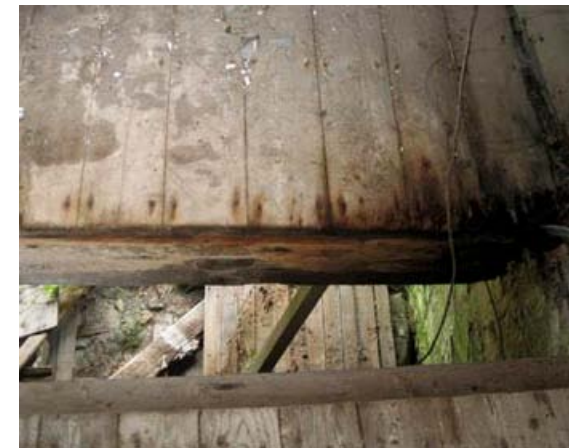
16.1. Existing Conditions: The wood floor on the first floor is in poor condition due to rot, bio-growth, wear and structural failure. The wood flooring on the loft level is in good condition with a few holes of both natural and manmade causes.

- **16.2.1.** The entirety of the wood flooring on the first floor will be replaced in kind in terms of material and dimension. This must be done to create an even floor level and continuous

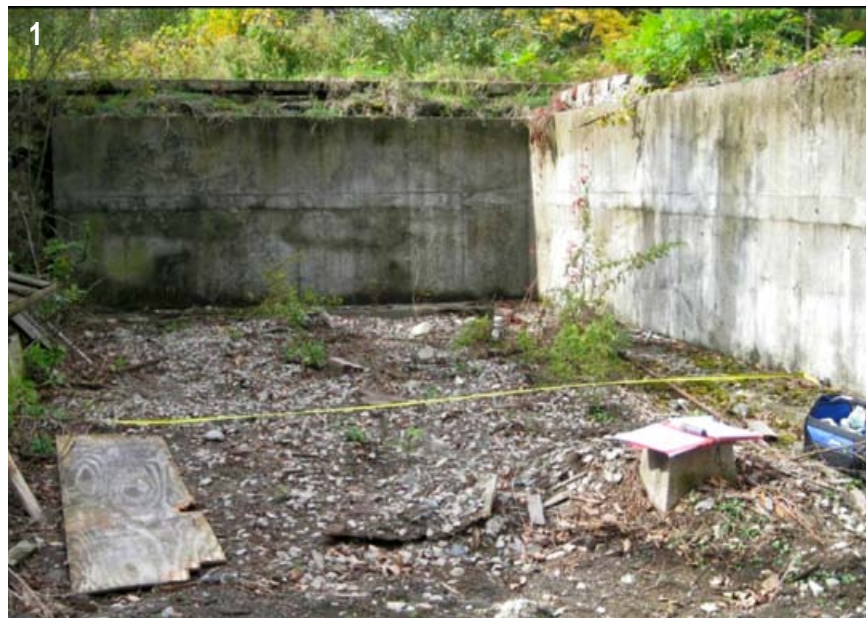
19.1. Existing Conditions: The retaining wall at the rear of the foundation is in fair condition with some bio-growth from moisture exposure. This wall was added to reinforce the original fieldstone foundation.
