The Fuller Farmstead

Reuse and Rehabilitation
Feasibility Report

Academic Partner:
School of Architecture, Art
and Historic Preservation

Community Partner:
The Barnstable Land Trust,
Barnstable, MA

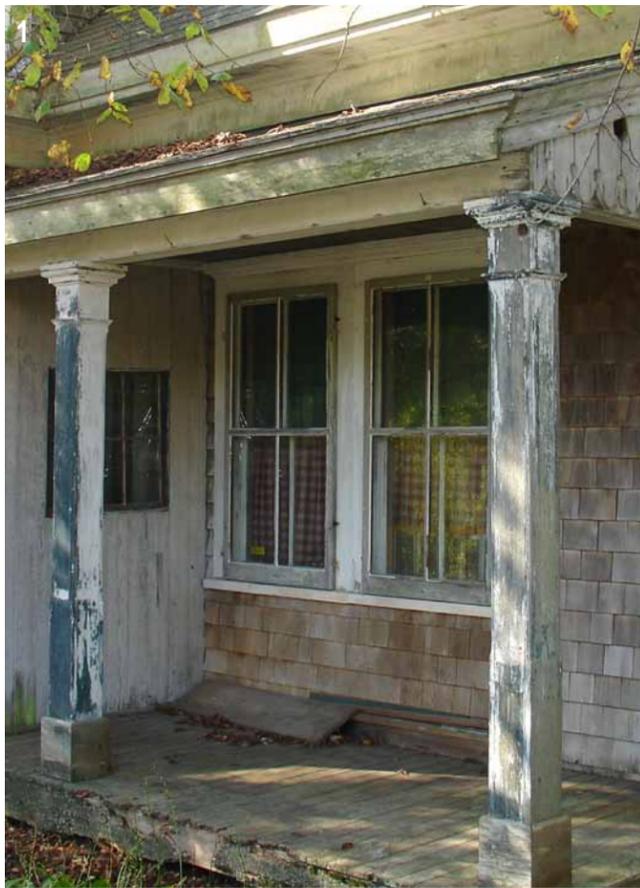
- Northeast pillar has holes approximately 1.5 inches in diameter.
- South porch failure to solitary porch post, sill and floor.
- South porch roof sags and pulls away approximately five inches from the structure.
- Porches have missing floorboards.
- Porches have enclosed entrances.

- Reattach south porch to main structure.
- Replace porch sills with dimension lumber.
- Remove “chicken coop” entrance on east and south porch.
- Rehabilitate porch columns.
- Reattach/fabricate original porch ornamentation.
- Replace floors with similar wood planks.
- Stain/paint trim same as exterior.

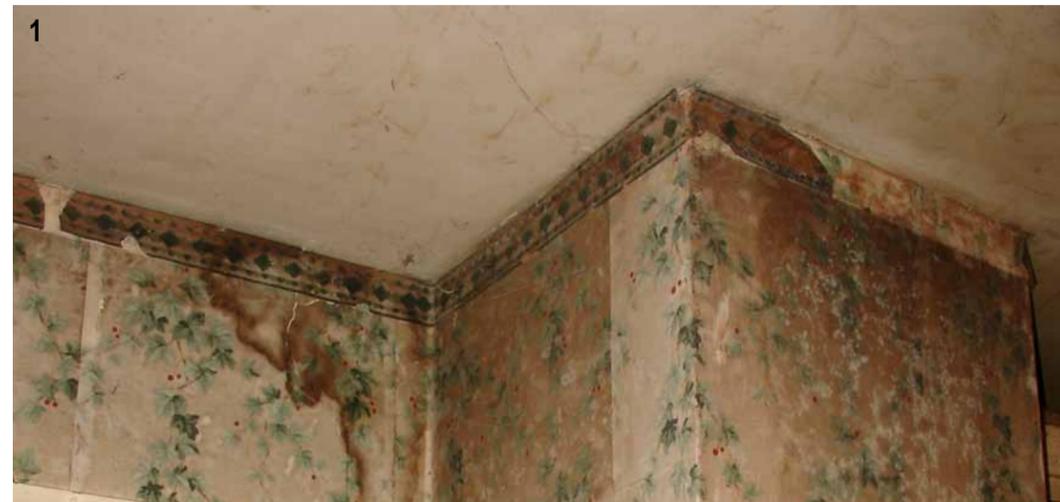
- The ceiling and walls, with the exception of the north kitchen, show extensive cracking and multiple repairs to the plaster.
- Ceilings exhibit calcification and peeling of the paint over an estimated 80% of their surface.
- Walls have multiple layers of wallpaper, which has separated from the plaster in many areas.
- Ceiling in almost all rooms shows past history of water staining and cracking of the plaster.
- Northeast corner of the kitchen shows serious water damage. There is evidence of current interior water damage that has detectable moisture.

1. Walls have multiple layers of wallpaper; some areas exhibit water stains.

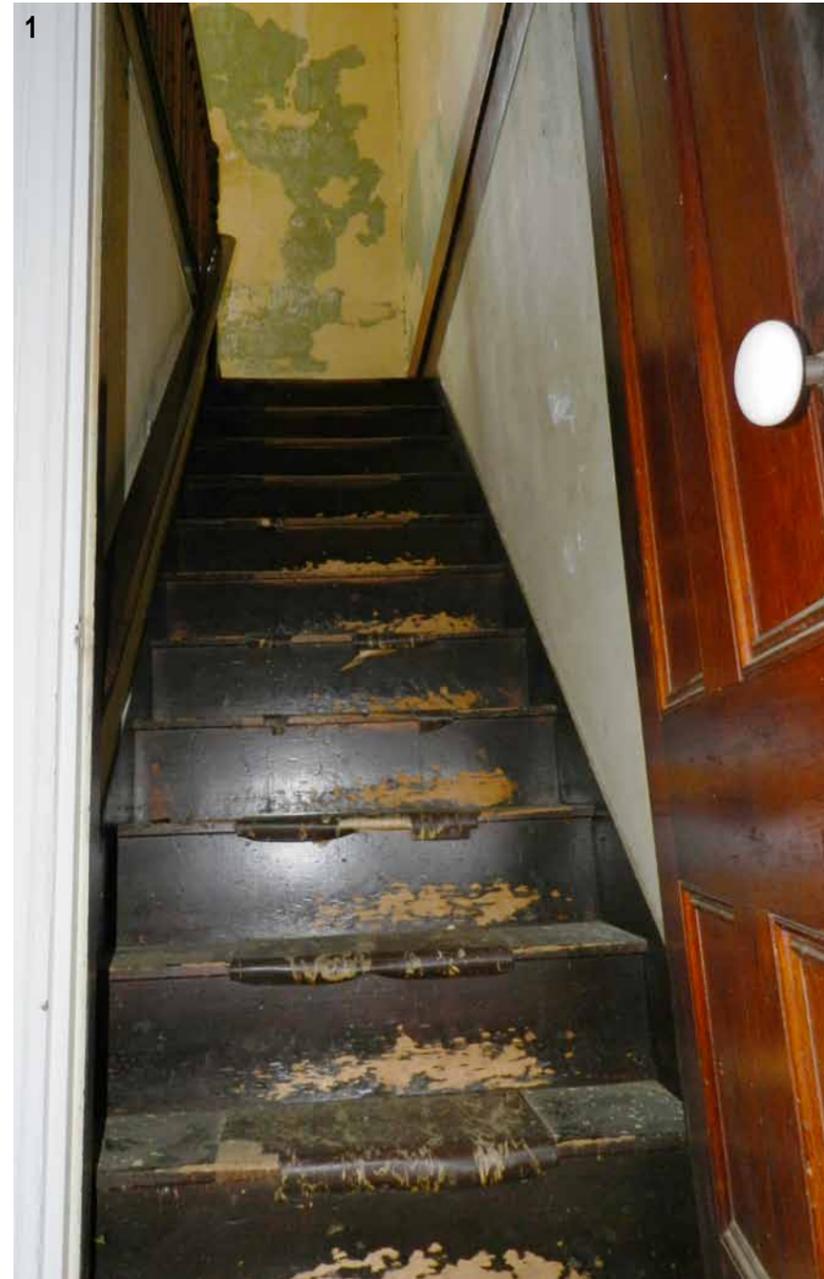
- There are 12 steps from the first floor to the second floor.
- Discoloration of the floor varnish indicates there were once treads on the steps.
- The staircase has a wraparound banister with two different style railings that create a pattern.
- The banister is in excellent condition.

- The staircase has one newel post and a hand-rail; both appear to be in good structural condition.
- Stairs are constructed of wood planking.

1. Main staircase on first floor shows discoloration.

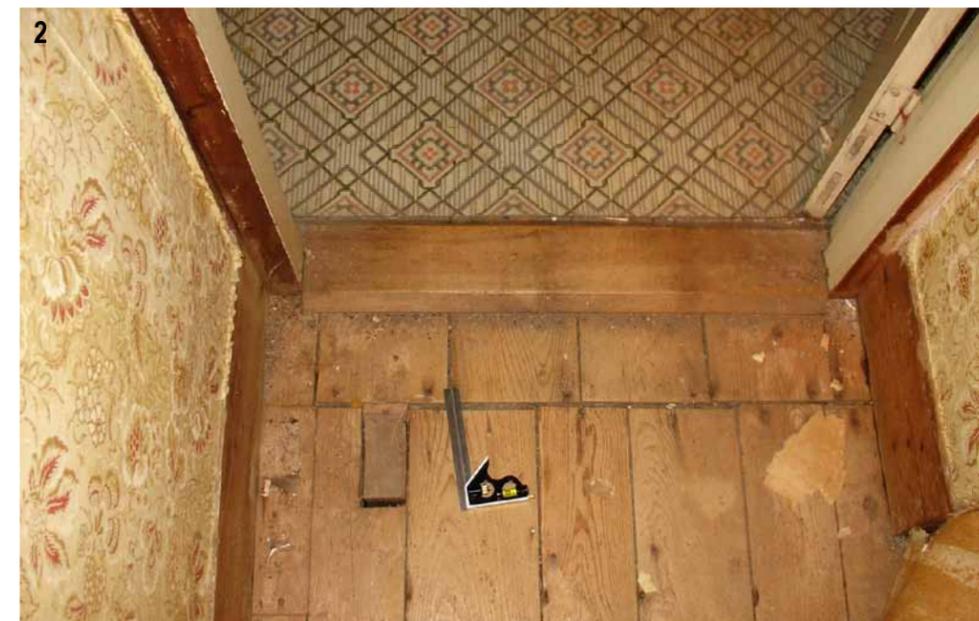
- Interior of the structure is comprised of wood plank floors.
- Floors have been layered with various forms of coverings, including: carpet, paint, linoleum and varnish finishes.
- Unfinished natural wood planks lie underneath the coverings; they appear to be in good structural condition in the areas investigated. All coverings on the first floor will need to be removed in order to fully assess condition of the natural wood planks.
- On the second floor, coverings are in poor condition and need to be removed.

2. Unfinished wood planks with secondary floor covering above.

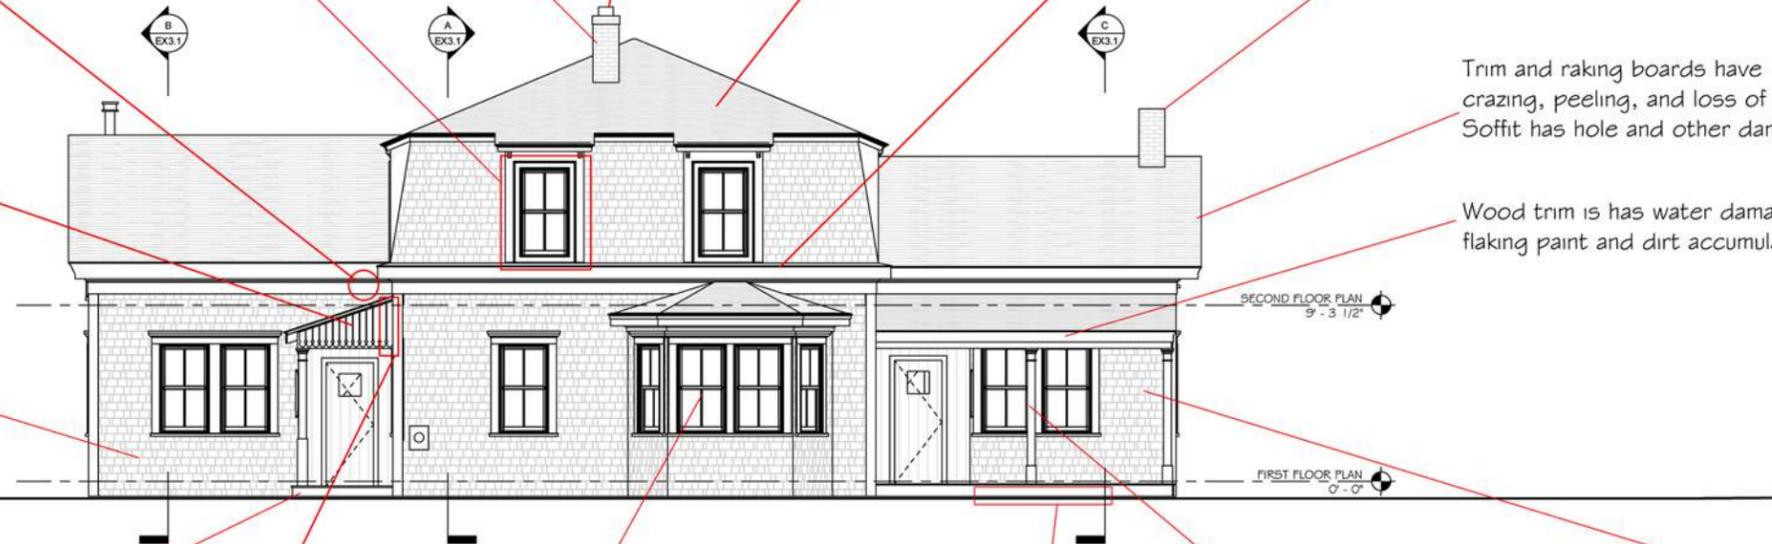
Sheet Title: EXISTING CONDITIONS EAST ELEVATION

Cedar shingle siding is recent.

Decking weathered & is not supporting load.

Storm Windows have rotting frames. Many also have crack panes of glass. Not weather tight - some barely attached. Typical.

Wood band board and decking has water damage, bio. growth and is significantly decayed. Typical.

Wooden porch posts are weathered, damaged, have failing paint and separating joints. Typical.

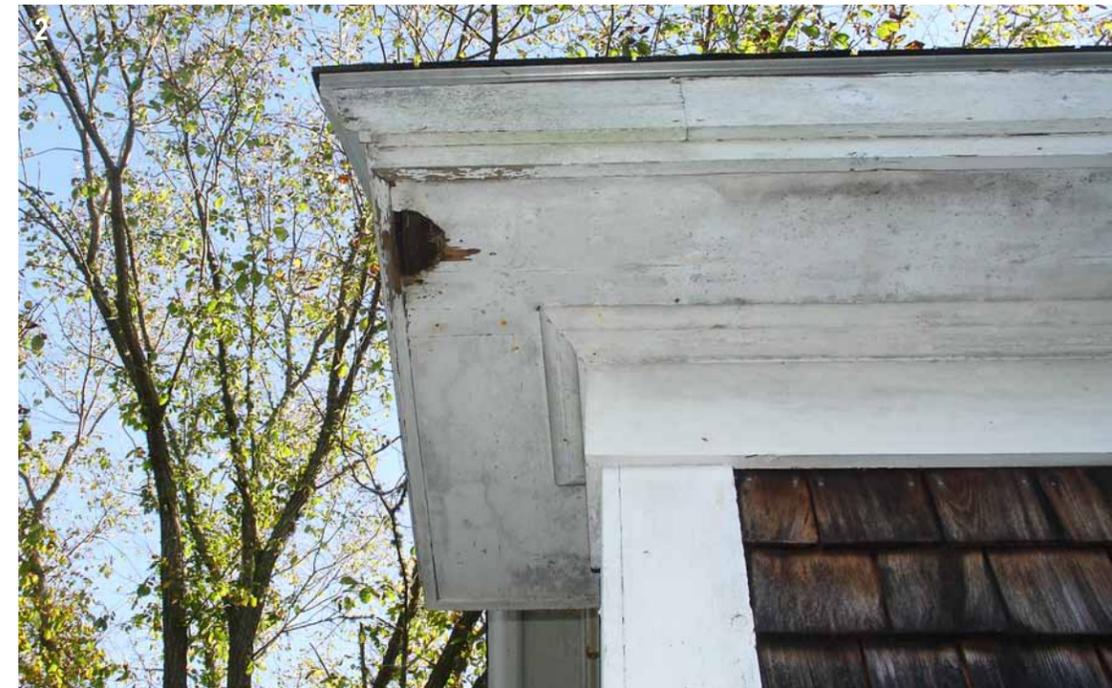
2. Animal nesting holes to be sealed.

- If section has more than 20% rot, remove the damaged portion, attach new material with replacement wood – either salvaged or new.
- Seal all animal nesting and bird holes with Dutchman Patch.
- Remove loose, flaking or checking paint by removing surface edges. Using two coats of primer, apply a white final coat with latex satin finish paint.
