Mathewson Street United Methodist Church

Reuse and Rehabilitation
Feasibility Report

Fall 2012

The Roger Williams University Community Partnerships Center

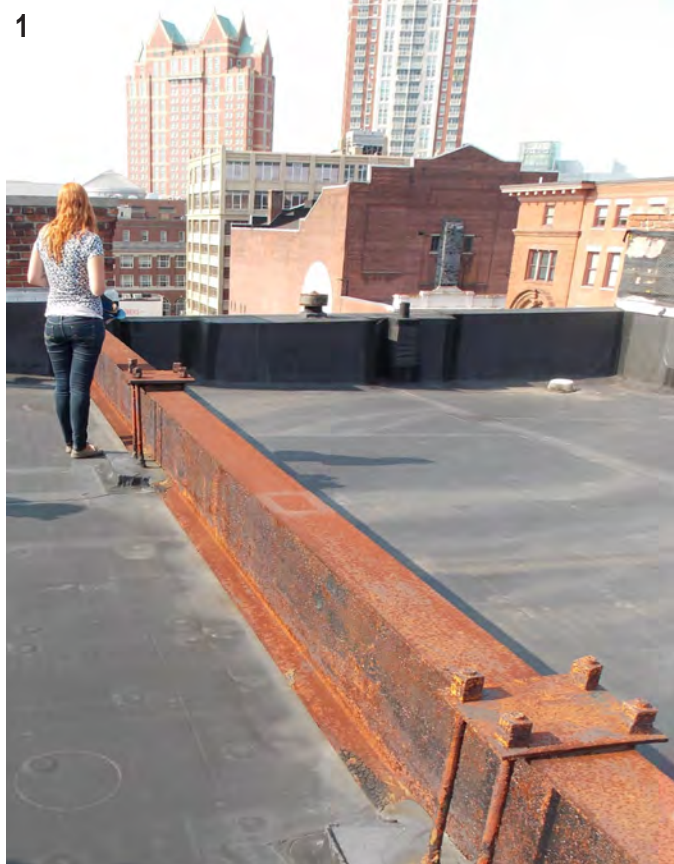
The steel wide-flange beam on the roof is in fair condition, but it exhibits significant oxidization and rust. The beam is open to the elements and

this exposure is causing corrosion. (Photo 1) Continued deterioration could have an adverse effect on the structural integrity of the building.

1. Corroded beam on roof could affect structural integrity of the building.

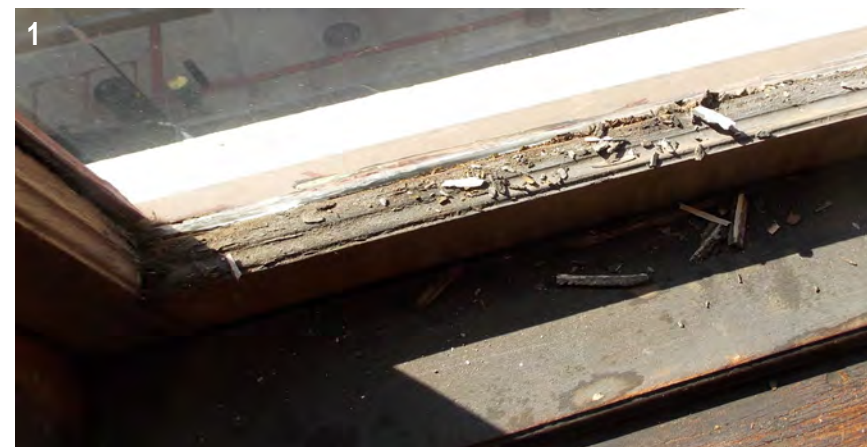
1. Windows exhibit deterioration in rotting wooden mullions, loss of putty and pervasive peeling of paint.
2. Floor moisture and asbestos tile deterioration in the basement.

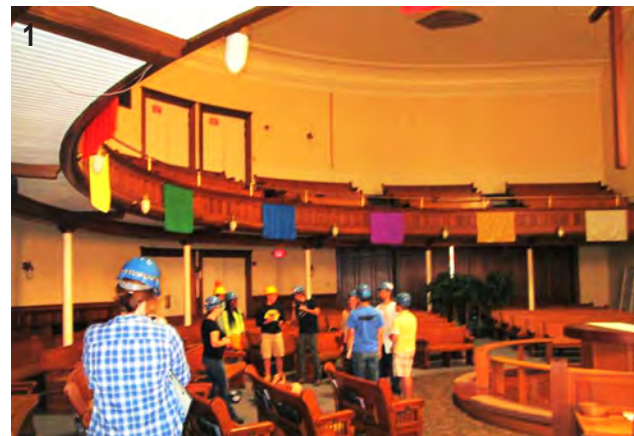
Sanctuary Wall Opening:

POOR CONDITION

The historical opening in the sanctuary wall is currently closed, cutting off the connection between the sanctuary and the adjacent room off of the balcony. It appears that these changes were made in the 1980s, and metal studs and sheetrock were used to close the opening. A restored wall opening without a partition would not meet current building code requirements. While drawings and photographs of the historic opening exist, adequate documentation for the historic opening is lacking.

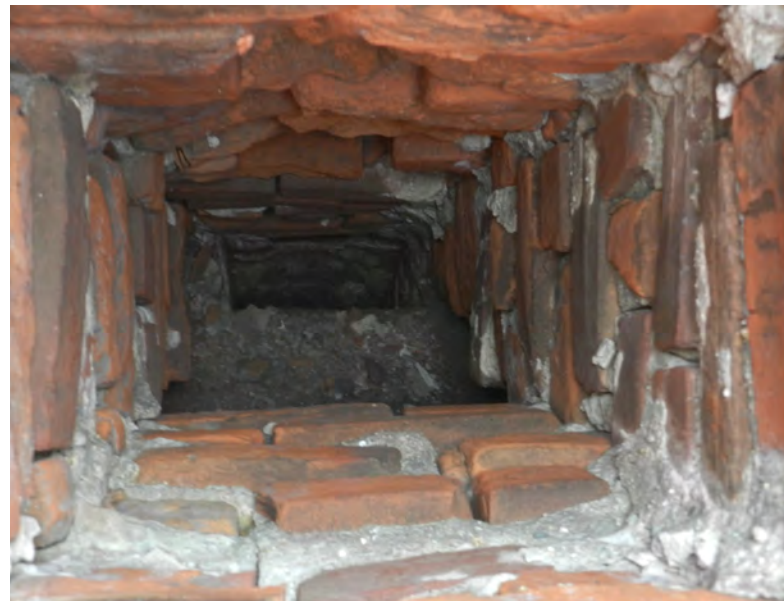
West Chimney

- **Problem:** The westernmost chimney is a simple brick chimney that is not highly adorned apart from a four-course corbelled chimney cap. The chimney is not character-defining and is not a prominent feature of the structure. It is failing due to severe mortar degradation. As a result, the bricks are dangerously loose. Nothing secures the bricks from falling and causing injury.

- **Solution:** The chimney will be adequately documented and then removed and capped below the roof membrane, which will be extended to cover the area the chimney occupied to prevent moisture penetration. Impact will be the removal of a historic feature that is severely deteriorated, not character-defining and not prominent to the appearance of the building (nor particularly visible prior to the demolition of the adjacent building).

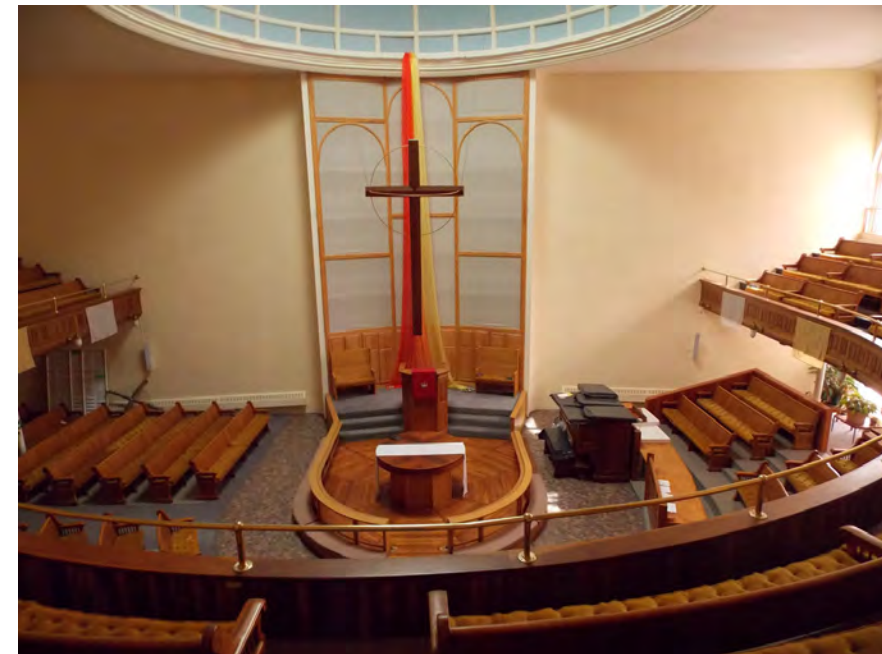
Balcony Railing: The handrail on the sanctuary balcony does not meet minimum height requirements of 42 inches for public buildings.

Removal of the non-historic prayer railing will allow easier access to the altar. The balcony railing will be raised to meet code requirements.
