# FASAD: First Floor Existing Condition Report

October 30<sup>th</sup> 2015

## Report Summary

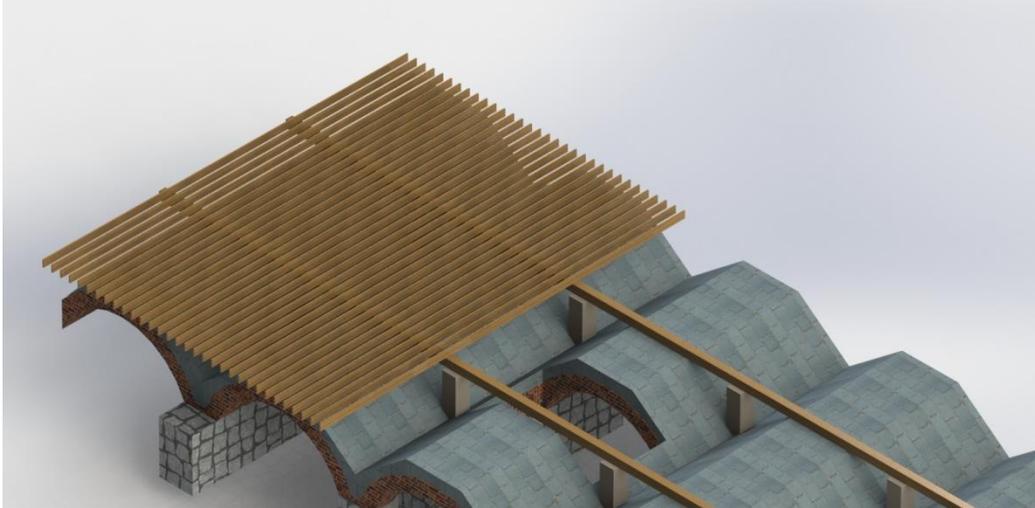
**Comments/Descriptions:** The timber floor joists (wood type unknown) run the width of the Southwest Barracks. The joists 2"x12" are spaced 16" on center and function as the structural supports for the second floor structure (see Figure 5). Three joists were used to span the width of the Southwest Barracks, flushed faced as shown in Figure 6. The interior joists span the distance between two main span girders that run the length of the Southwest Barracks. These joists are nailed in place and notched to fit into the main girders. The exterior joists connect from the exterior walls to the main span girders.

Figure 6: The image shown is a screenshot of a 3D model of the first floor structure. Shown are the 2"x12" joists at 16" on center. Note that that it takes three joists to span the width of the southwest barracks. The joists are currently set as flushed faced with no overlap.

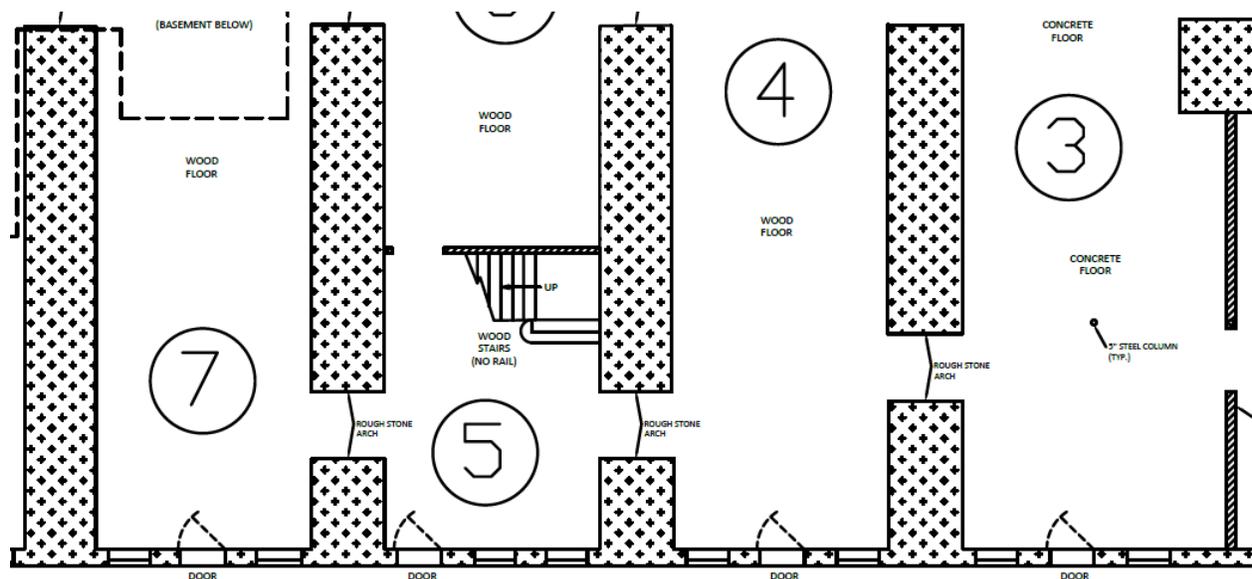
**Comments/Description:** There are five rough arch doorways on the first floor. These rough cut arches were cut out of the masonry piers supporting the masonry and brick archways in order to allow access and flow between each room on the first floor. These rough cut arches are on the northern side (interior Fort wall) and shown in Figure 17, below. The arches are typically 10' high at the peak, 6' wide and 5' deep. It appears these doorways were an afterthought and chipped away after creating the jagged stones. The finishing is shown in Figure 13. There is no masonry top to these arches either.

Figure 14: The photo is a screen shot of as built drawings for the Southwest Barracks. Note that the rough stone arch ways are called out and connect the rooms together.

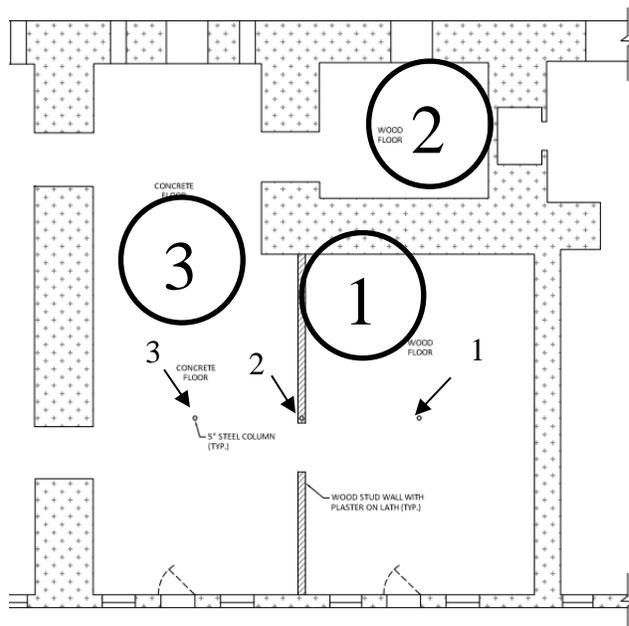
**Comments/Description:** There are only three columns in the first floor. These columns are located in rooms 1 and 3 (Figure 16 below), with one of the columns located in the wall between the two rooms (Figure 17). The columns support the main span girders which support the load of the second floor. The columns are all in poor condition which is attributed to significant oxidation and deterioration. The columns also may not be sufficient for meeting modern building codes, especially if the second floor was to be used as an event space in the future. Column number 3 is currently not supporting any load as it is not currently connected to the main span girder located above. Column number 3 is also effectively rotted out at its base as well which leads to major concerns regarding the other columns located throughout the structure.

Figure 16: This is an AutoCAD drawing of the locations of the columns in the first floor of the Southwest Barracks.
