Liberty Street School

Reuse and Rehabilitation Feasibility Report

Community Partner:
Town of Warren, RI
Fall 2012

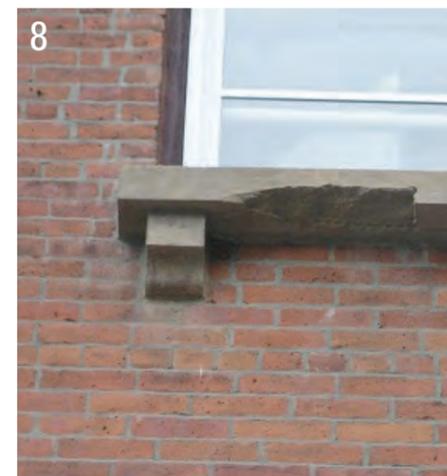
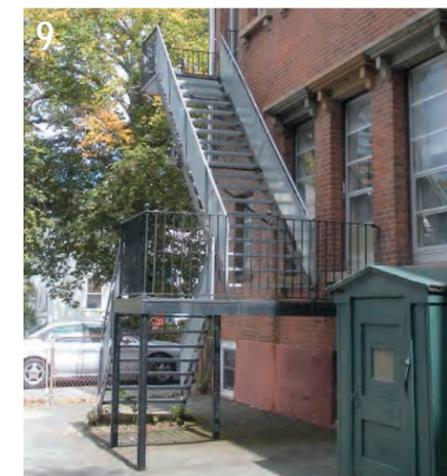
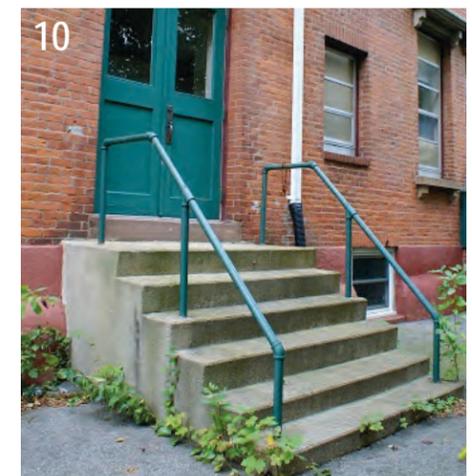
There is lead paint on the door surround on the north elevations. The paint is currently failing in many places (Photo 5). The wood window hoods have lead paint on them. The lead paint is failing and some of it has weathered off (Photo 6).

All of the exterior walls are brick masonry walls with a brownstone foundation. In areas where there is poor drainage from the roof, biological growth and environmental staining have covered areas of the brick masonry and brownstone foundation (Photos 2 and 3). There is a brownstone inscription of "Public School. 1847." above the north elevation door. There are areas of lettering as well as some of the brownstone window sills and sandstone window hoods that have spalled (Photos 7 and 8).

There is one iron fire escape located on both the east elevation and west elevation (Photo 9). These iron fire escapes are beginning to rust. In addition, the fire escapes do not meet current fire codes as proper means of egress from the building. There are metal railings for each of the three sets of steps leading to the first floor (Photo 10). These railings are also beginning to rust and do not meet building code as a proper railing height.

The windows on the east and west elevations that were added circa 1910 received window hoods that matched the sandstone hoods of the original ones. These wood window hoods are in good to fair condition. There are areas of rot and paint failure on some of the hoods (Photo 6). The wood door surround on the north elevation is in good condition, only having paint failure (Photo 5).

The brownstone foundation needs to be cleaned and repainted. The proper method of cleaning would be water washing with a non-ionic detergent. The combination of a soaking with a low-pressure or medium pressure water source and the scrubbing of the non-ionic detergent on the affected area, with a soft-bristled brush, will clean the brownstone. The brownstone foundation should have the paint removed (where

there is paint). The areas of spalled brownstone on the foundation, as well as the window sills and the letters above the main entrance, should be reformed with a mortar-like product and then repainted to create the appearance that the brownstone is still in one piece. The newly formed mortar-like product should match the intact brownstone in color and texture. The brick needs to be cleaned on all elevations. The discolored and dirty brick can be cleaned through a combination of a soaking with low-pressure or medium-pressure water and scrubbing of a non-ionic detergent (alkaline cleaner) on the affected area with a soft-bristled brush. The stained brick (from "runoff" of the metal from the main brace attaching the fire escape to the building) can be cleaned with a poultice (consisting of an absorbent material/clay powder mixed with a liquid solvent to form a paste) which can be put on the stain. To repoint the bricks, particularly on the west elevation where water damage has caused a loss of mortar in a vertical line down the elevation, the mortar in the areas surrounding where there is mortar missing should be analyzed to determine the content. Then old mortar should be removed to a minimum depth of 2 to 2.5 times the width of the joint. A new mix of the mortar should be made and installed by filling in the joints where the mortar was missing or removed.

It is recommended that the iron fire escapes on the east and west elevations be removed because they do not meet current fire codes as a proper means of egress from the building. The metal railings should also be removed and replaced with railings that meet current building code with a proper height.

The hoods above the windows on the east and west elevations need to be fully evaluated by a woodworker to see if the level of deterioration is repairable. If the hoods are past the level of repair, the shape, size, and turnings can be replicated with wood. Any of the wood window hoods, old or new, will need to be repainted, as some of the paint on the older hoods has failed. The wood door surround is at risk of deterioration, but does not seem to be rotted and is currently in good condition. The lead paint has failed and should be removed and repainted. The soffit is at risk of deterioration because of poor drainage. There has been no observation and access to the roof to determine if there are leaves blocking the openings for the gutters, but detached downspouts have caused poor drainage and likely buildup of water on the roof. The soffit is one of the character-defining features of the Italianate building and should be restored, if the architectural feature is not too far deteriorated. If there is too much deterioration, the new wood should be constructed to fill in where deteriorated wood was removed. When completed the wood should match the removed wood in size, shape, and appearance.

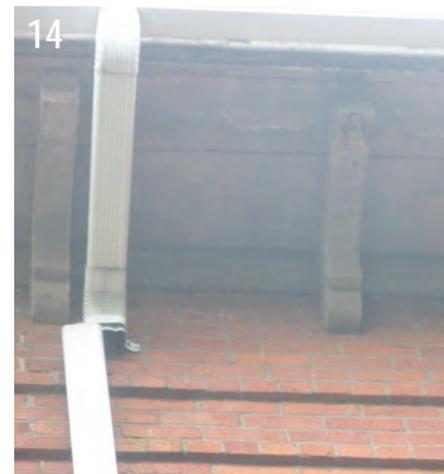
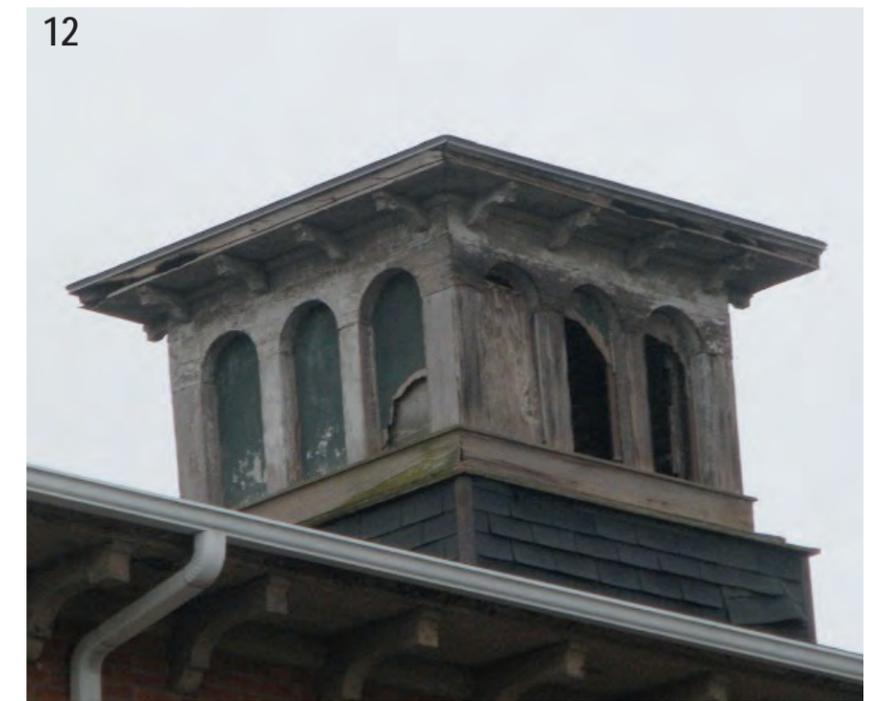
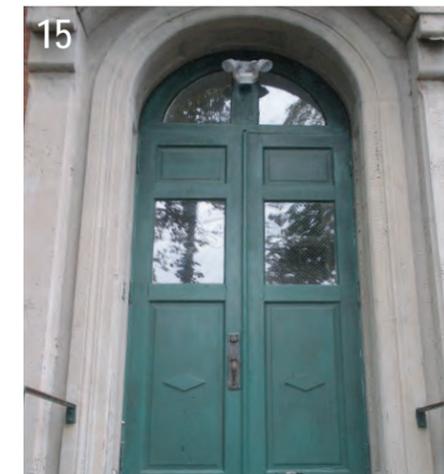
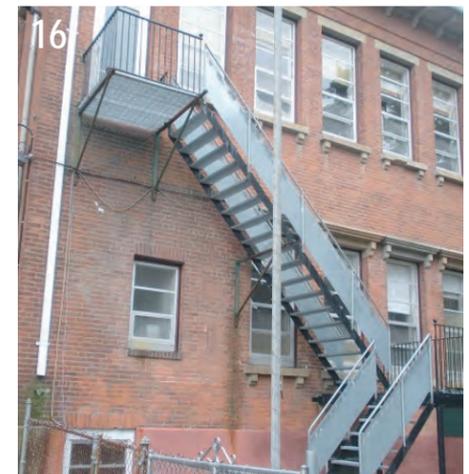
The soffit is another architectural detail made of wood. The soffit is in fair to poor condition. Much of the wood has rotted or is in danger of rotting, seemingly because of poor roof drainage (there is currently no safe access to the roof to examine the condition of the soffit and the drainage system) (Photo 11). The wood cupola is also in fair to poor condition. Much of the wood appears to be rotting (Photo 12). It is difficult to determine the exact condition of the cupola because the only way to see the cupola is walking west down Liberty Street or while walking along Main Street (perpendicular to Liberty Street), and there is currently no safe access to the cupola to examine the condition.

The roof is currently covered in asphalt shingles. There is currently no safe access to the roof to examine the condition of the shingles, but there are multiple shingles that have become detached from the roof boards and fallen to the ground. The current drainage system is in poor condition. There are many areas where the aluminum gutter has detached from the wood soffit, leaving a space for water to pour down off the roof (Photo 13). Many of the aluminum downspouts are disconnected from the aluminum gutters (Photo 14). Many of the aluminum downspouts also were connected to the sewer leaders, which are now capped with cement (Photo 4).

There are currently seven entry door openings into the building. The bulkhead doors, leading to the basement, are located on the east and west elevations. They are wooden doors of approximately five feet in height (Photo 9). These doors are in good to fair condition and are in working order. The doors have some areas of paint failure. There are three sets of doors to enter to the first floor, one on each the north, east, and west elevations (Photos 10 and 15). Each of these sets of double doors is wood doors with glass openings in sections of the top half. These doors are in good to fair condition and are in working order. The doors have some areas of paint failure. There are two metal doors leading to the second floor from the iron fire escapes on the east and west elevations (Photo 16). These doors are in good condition and are likely in working order. All of the windows on each elevation are aluminum windows that were likely added to the building circa 1950 (Photo 16). The windows appear to be in overall good condition and are likely in working order.

There are currently electrical wires (for the electricity of the building) attached to the north elevation, which detract from the historic character of the building (Photo 16). There are also exterior spot lights and electrical conduit located in multiple places throughout the building. The lights and conduit detract from the historic character of the building as well (Photos 15 and 16).

The cupola is at risk of deterioration because of lack of care. The only access is in the attic (there is currently no safe access to the cupola to examine the condition.) The cupola is one of the character-defining features of the building and should be restored, if the architectural feature is not too far deteriorated.
