St. Mary's Parish House

Reuse and Rehabilitation
Feasibility Report

Fall 2013

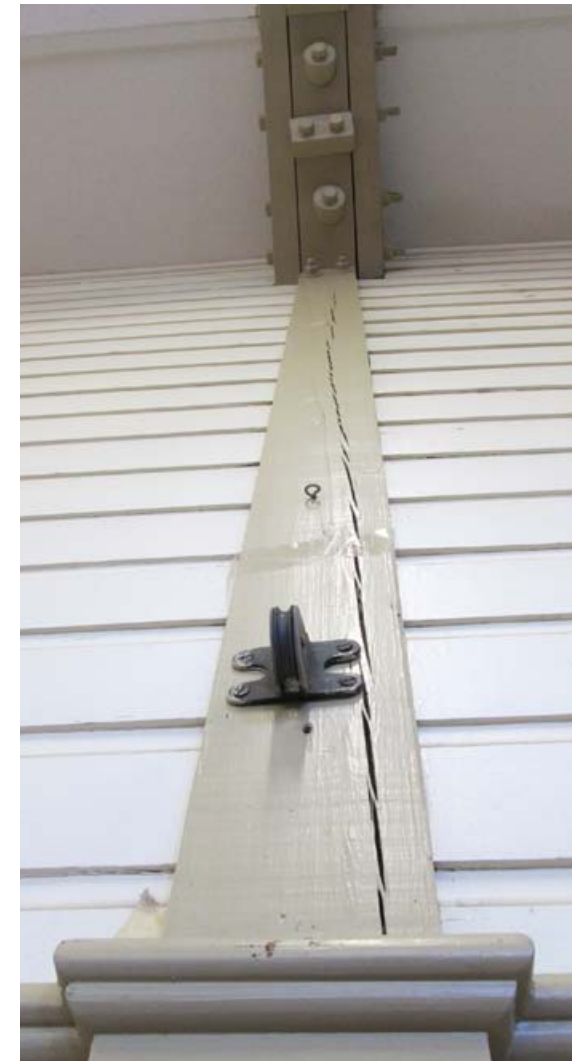
The structural piers in the gym are splitting vertically, which happens over the lifetime of many species of wood. This seems to be allowing weight to still be transferred downward because this member is in compression. These cracks do not appear to be new and there is no apparent rot or structural instability upon visual inspection from the floor.

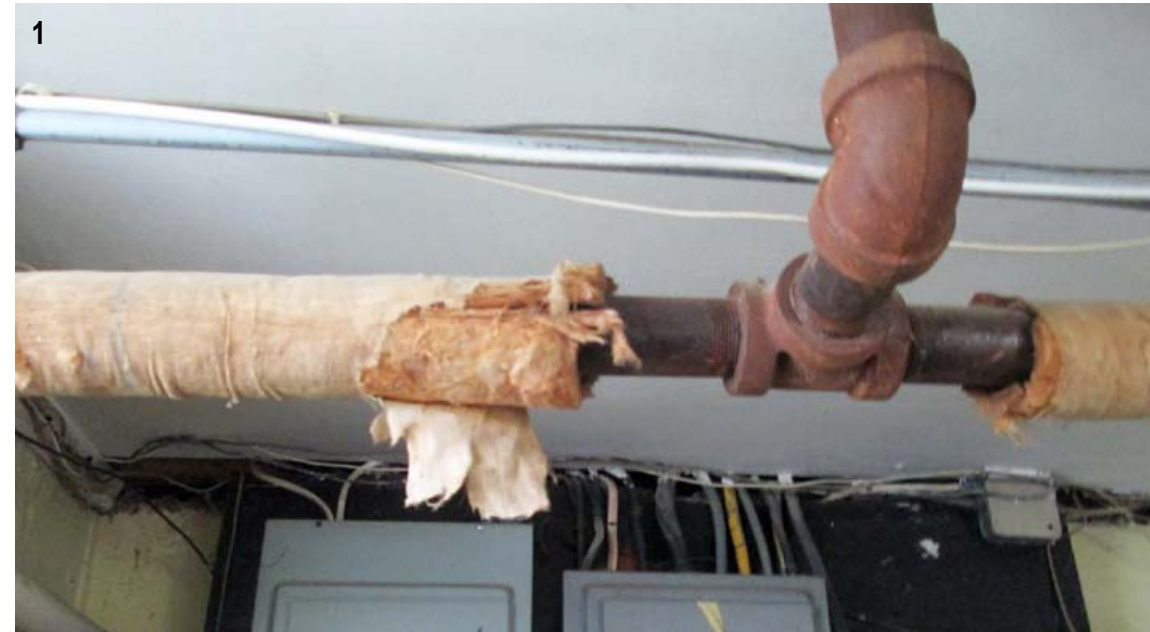
Basement Pipes: Fair Condition

There are no visible issues with the pipes themselves, however, the pipes in the basement need rewiring as the insulation is significantly deteriorated in most places.

1. Basement pipes need to be rewired for insulation.

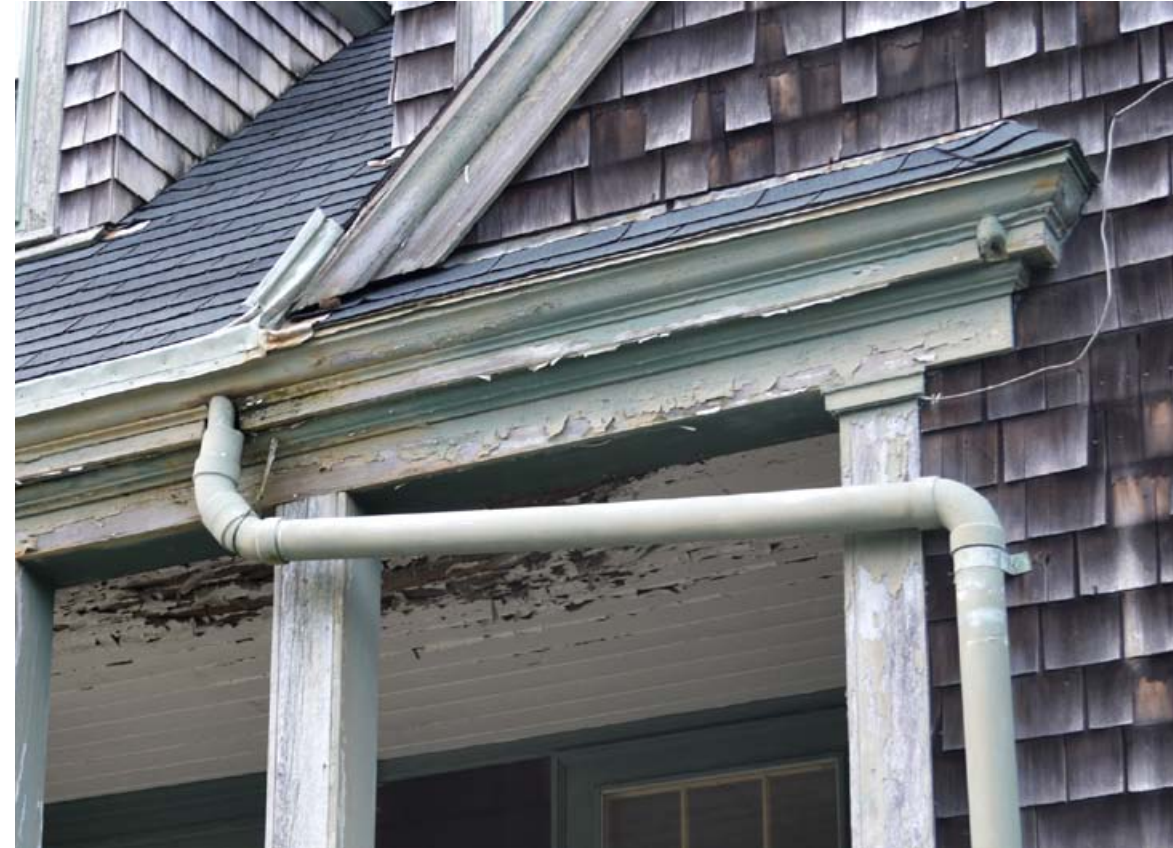
- **Problem:** The exterior of the cornice is slightly deteriorated, showing signs of weathering

and cracking. There is paint loss and chipped paint throughout. Additionally, the cornice contains internal wooden gutters lined with copper. These gutters are in poor condition, with the copper lining deteriorating and the wood beneath rotting. They are undersized for the large roof of the parish house.

- **Solution:** Replace the original wood gutters with wider aluminum gutters with a historic molding profile that approximates the existing profile. Retain the existing molding beneath the gutter where possible. Areas of rot must be

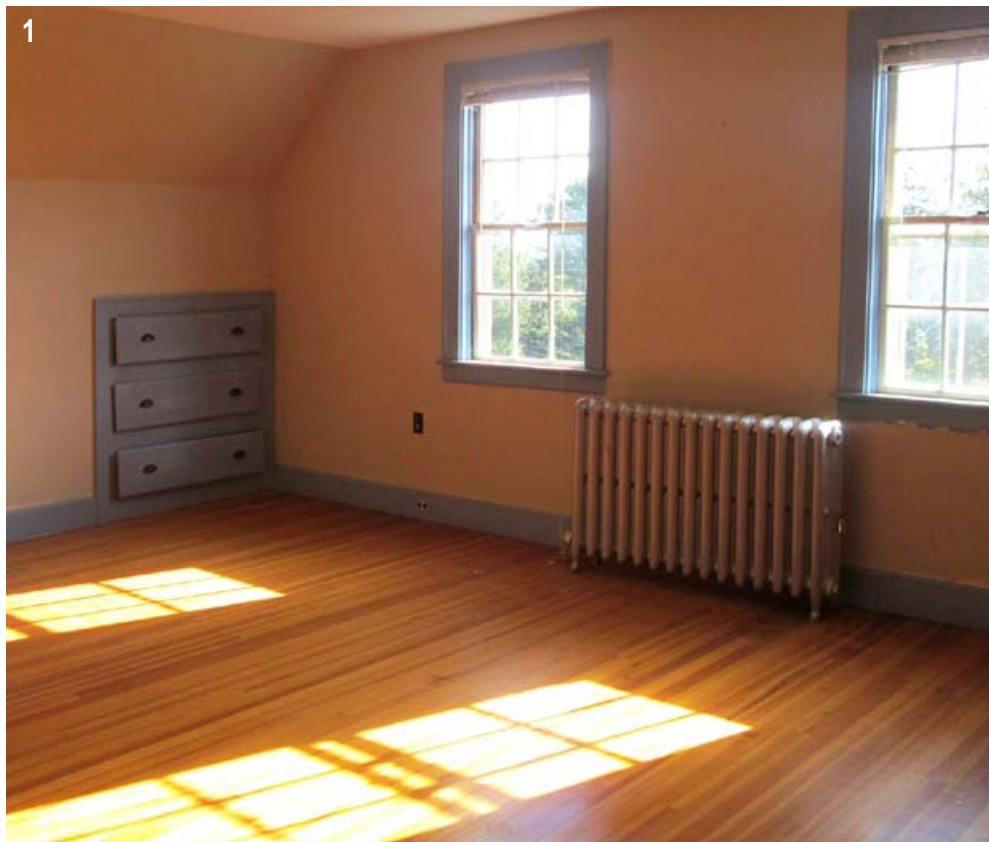
Plaster Finishes

- **Problem:** Plaster condition varies throughout the structure. The plaster is in generally fair condition throughout the first floor, with some holes, missing plaster and hairline cracks. The plaster textured finish on the walls in the upstairs classrooms and particularly in the stair hall is in poor condition, including cracking, bulging and separation from the walls in some areas.
- **Solution:** The plaster shall be retained and repaired. Holes shall be patched with new plaster that matches the historic material in color and texture. Areas of plaster that are bulging shall be reattached to the lathe using mechanical fasteners or chemical adherents.

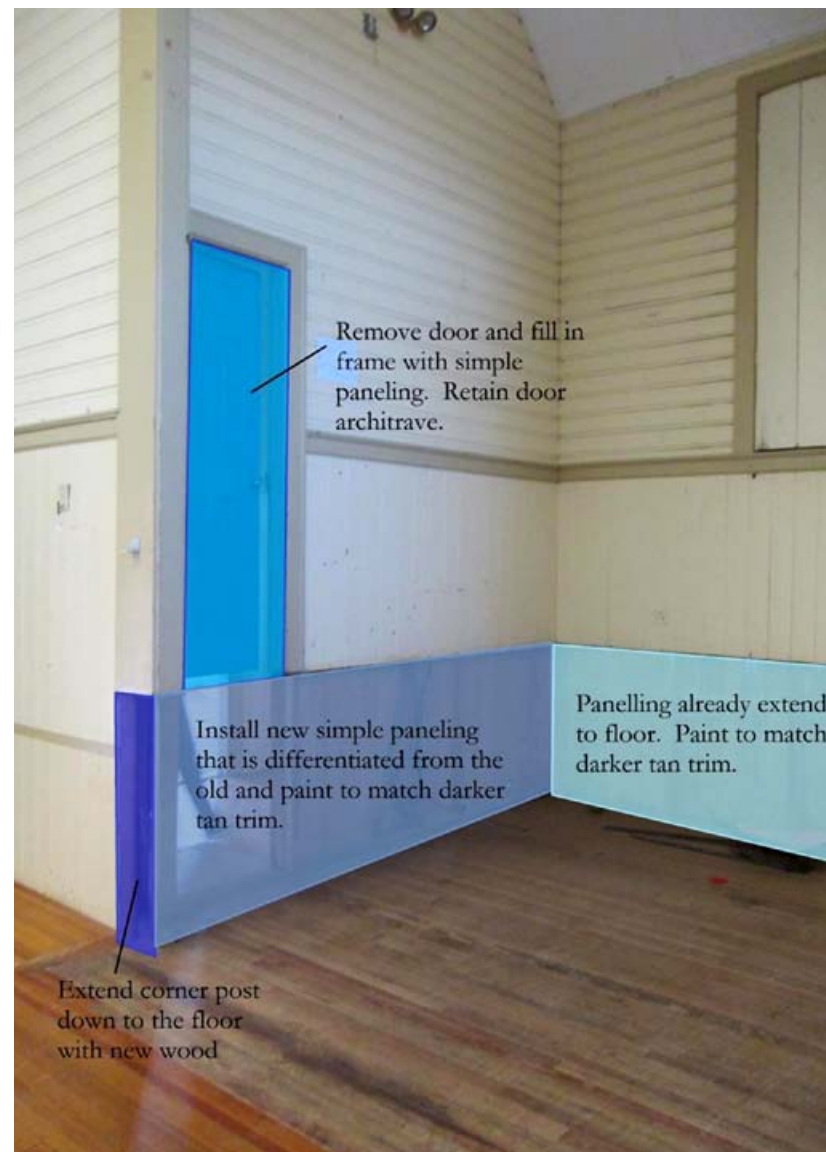
Stage Area

- **Problem:** The wood panelling on the walls of the gymnasium is in good condition, despite some loss of paint in a few places.

Some areas exhibit bulging, scratches or deterioration. However, the stage was recently removed, leaving the wood panelling under the former stage unfinished (back wall) and non-existent (side walls).

- **Solution:** See above solution for repainting surfaces. The stage area will be refinished in a way that recognizes the space that the stage formerly occupied. The door architraves will be retained and non-historic doors will be replaced with simple panels to indicate the former location of the doors. Additionally, the unfinished side walls will have panelling that matches the existing vertical panelling installed, but hung horizontally to differentiate it from the original panelling. The new panelling and the existing unpainted panelling on the back wall will be painted the same colour as the door architrave and trim to further preserve the memory of the stage area.

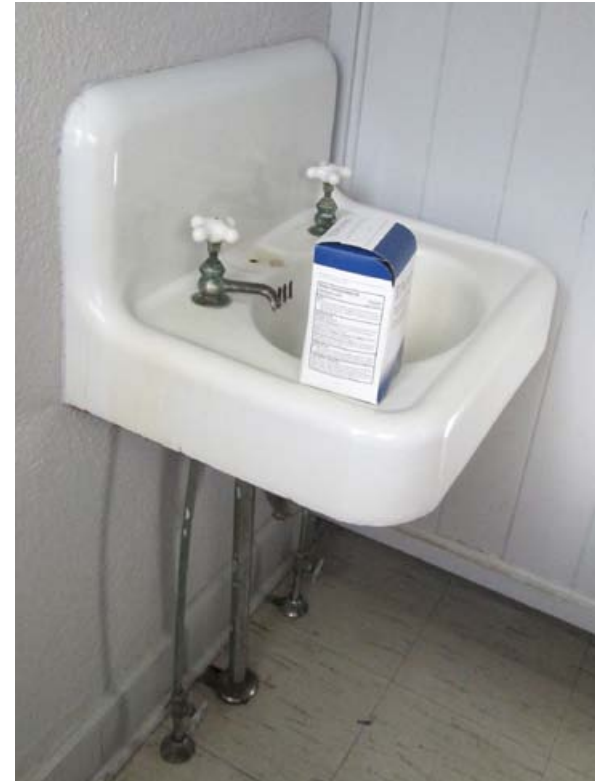
Bathroom Fixtures

- **Problem:** Bathroom conditions on the first and second floors are functional but are showing signs of age and deterioration. They will not be of sufficient size for the desired new program of the building.

Bathroom fixtures need to be updated and additional bathrooms built to accommodate increased occupancy.

- **Solution:** Bathroom fixtures on the first and second floor of the original structure will be replaced with updated fixtures. Bathroom fixtures in the school addition will remain as-is until demolition. Additional bathrooms will be incorporated in the design of the new addition to accommodate the desired occupancy of the building.
