# The Baptist Church in Warren

Rehabilitation and Preservation Report

Fall 2013

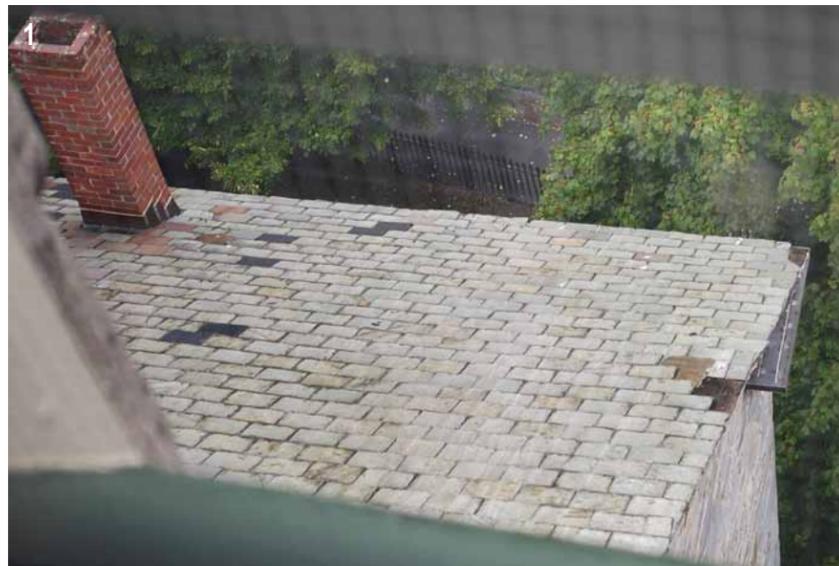
The roof covering the church's tower is bi-colored with grey and red slate forming a striped pattern. Overall, the roof is in fair condition, however, the slate shingled areas are in need of repair. Many slates are missing or hanging by one hanger. This is a failure of the hangers, which only last about a hundred years. These hangers are probably made of brass or copper, since they were the leading hangers of the 1840's. The copper ridge cap looks to be in fair condition, however, after 100 years of service, the roof is showing inevitable signs of age. The framing for the tower roof is in good condition and shows no visible signs of water damage or rot associated with insects or environmental effects.

The gable roof of the main structure is covered in green slate. Overall, the main roof is in poor condition. The existing slate roof was installed over a wooden shingled roof. The condition of the wooden shingles is unknown and could be a cause of the roof's poor condition. As with the tower roof, slates are sliding out of position, which could be caused by failing ferrous fasteners. Certain slates are exhibiting breakage, which could be the result of impurities in the slate. Numerous dark-colored slates show prior maintenance; yet there are missing slates throughout. The copper ridge cap is in good condition. Recently, Renaissance Roofing of Woonsocket, Rhode Island replaced over 400 slate tiles on the main roof.

1. A view of the roof from the tower window. The dark patches are missing slate shingles.
2. The tower roof, showing the red and grey slate striped pattern of the tiles.

- **1.2.1** Replace broken, cracked and missing slates with new slate material. New slate should match the size, shape, texture and weathered color of old slate. Assess the condition of slates sliding out of position; salvage sound undamaged slate and re-hang with copper fasteners.
- **1.2.2** Slide new slate into place and hold in position with one nail inserted through the vertical joint between the slates in the course above and approximately one inch below the tail of the slate two courses above. To prevent water penetration through the newly created nail hole, a piece of copper with a friction

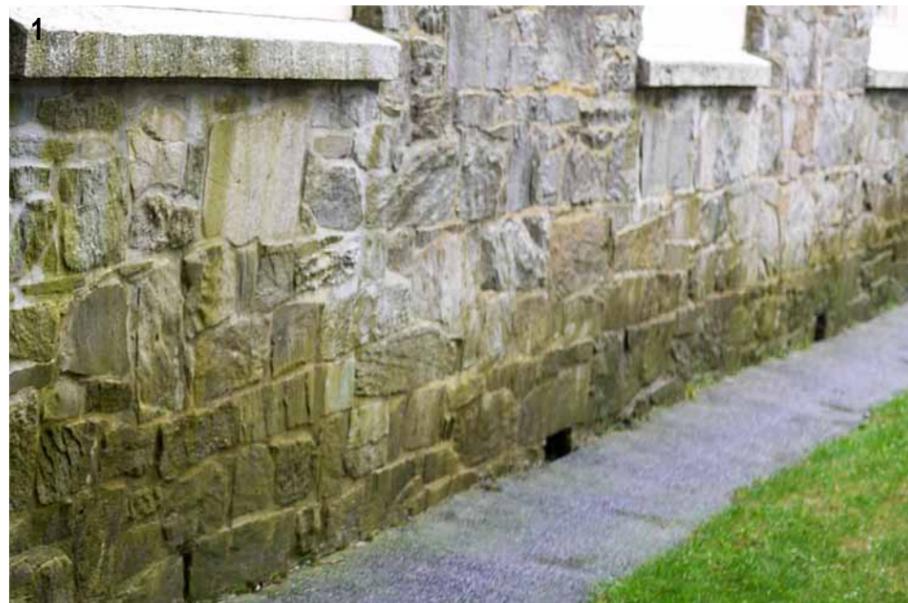
The church is composed of a monolithic, load-bearing, granite-ashlar block. There is no differentiation between the exterior wall and foundation. There is green organic growth along the lower portion of the south and north elevations. Under the windows on the western façade, there is a crack forming in the mortar. Overall the exterior granite and mortar pointing are in good condition. The granite exterior recently underwent restoration.

1. Drainage holes along the base of the north facade show mildew growth from water damage.

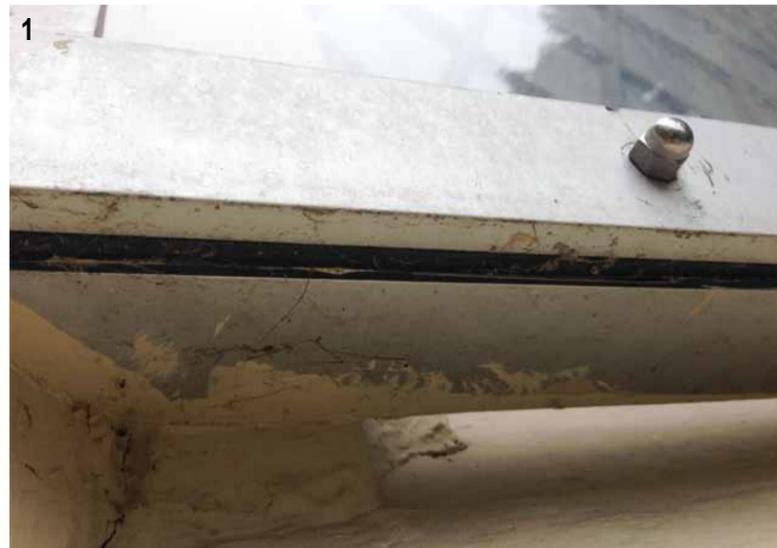
alligating. The bond between layers has broken due to inter-coat paint failure. This allows exterior moisture to penetrate the surface cracks, causing the wood to swell and deeper cracking to take place.

The window glazing is failing. This process has become exacerbated due to the storm windows. The storm windows are not properly ventilated, causing a micro climate within the space between the storm window and the wooden window. This micro climate is causing the paint and glazing to peel away.

1. The northeast window, located on the east façade, has an opening that traps moisture in the cavity between the window and storm window.

2. The doors on the northern entrance exhibit paint peeling and rot at the bottom.

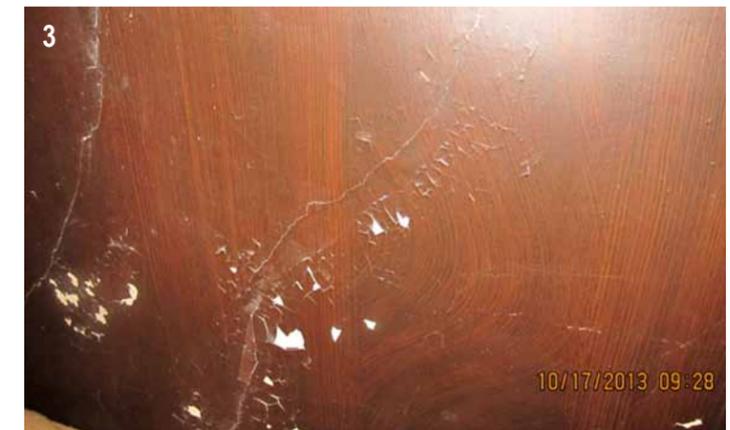
Overall the plaster in the sanctuary is in good condition, however there are a few sections throughout that are deteriorating or cracking, especially in the northwest and northeast corner of the building. The chancel also has plaster issues due to the roof leak. Overall, there are no sections where the plaster is completely detaching from the substrate.

Faux wood graining can be found throughout the sanctuary on doors, door casings, pews and wood paneling. On the mezzanine, overlooking the sanctuary, the wood graining is applied on plaster to mimic wainscoting. Sections of the wood graining show failure, especially in areas applied to the plaster.

2. Cracked plaster walls in the sanctuary.

3. Faux wood graining shows failure throughout the church.

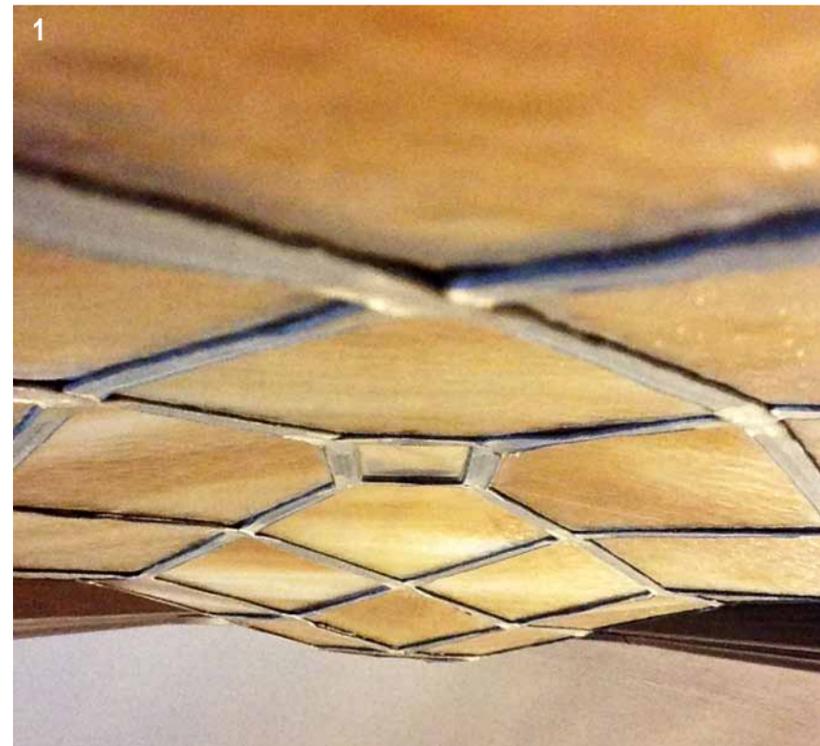
There is leaded glass throughout the sanctuary. It is found on the doors leading into the sanctuary from the front entrance. It is also found in a wooden partition separating the front entry into the sanctuary. The sagging of the lead and glass is an indication that the structural integrity of the lead support is beginning to fail, but the lead came has not failed to the point of breakage or dislodging the glass. On the western and eastern elevation, the stained glass windows are in need of re-caming.

The carpeting in the main sanctuary is heavily stained by water damage with sections worn through to the backing. The finishes throughout the rest of the building are all stable and do not require any necessary replacement at this time.

1. A pronounced view of the stained glass bowing of the doors leading into the sanctuary.
2. The carpet shows signs of water damage.

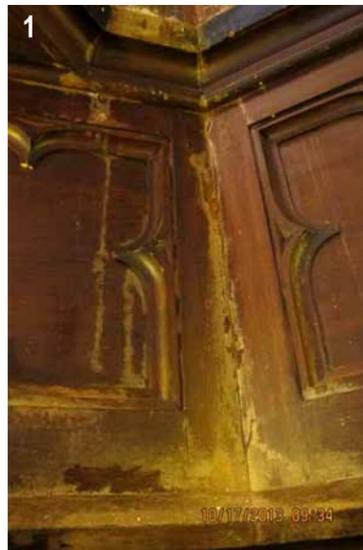
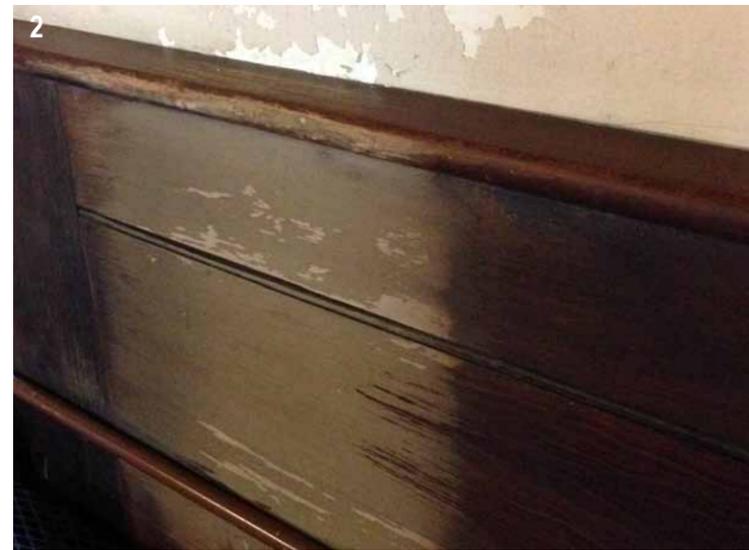
The finish to the wood paneling in the chancel has suffered damage due to the water leak; however, there is no noticeable damage to the structure of the wood. Overall, the wood in the chancel is in good condition.

The faux wood graining throughout the sanctuary can be found on doors, door casings, pews and wood paneling. On the mezzanine overlooking the sanctuary, the wood graining is applied on plaster to mimic wainscoting. There are sections of wood graining that are failing, especially in areas applied on the plaster.

1. Water damage to chancel woodwork requires repair.
2. Faux finished wood graining has worn away in some areas.

- **1.2.1** Onsite collection of finish samples and laboratory analysis of surface treatments must be undertaken to assess appropriate finish, glazing material and stain color.
- **1.2.2** Sand areas where water damage has occurred to remove finish and expose bare wood. When the finish has been removed, bleach the entire stained surface with a solution of oxalic acid if wood is stained dark.<sup>9</sup>
- **1.2.3** Stain bare wood to match existing stain.
- **1.2.4** Prepare existing finish surrounding treated area with sandpaper grit-220.
- **1.2.5** Re-finish the wood paneling to match existing finish throughout.
- **1.2.6** All materials and shop drawings required for work in this section shall be subject to approval by preservation consultant and the architect based on submittal of product information, samples and supporting material.

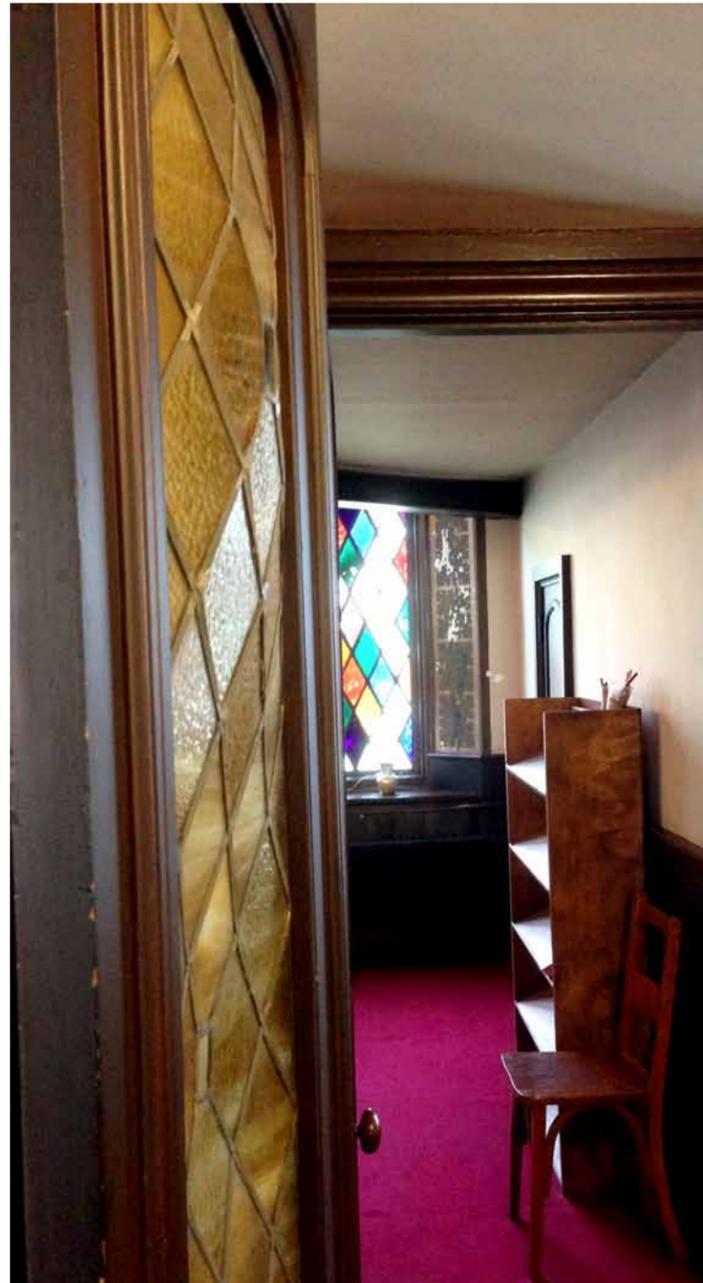
There is leaded glass throughout the sanctuary. The sagging of the lead came and glass is an indication that the structural integrity of the lead support is beginning to fail. The lead has not failed to the point of breaking or dislodging the glass.

The stained glass window in the door is bowing due to failure of the lead comes.

- **1.2.1** If window is sagging or bulging more than 1½” out of plane, it has reached the point where it should be removed from the opening to be flattened out.
- **1.2.2** Record location of each section prior to removal to ensure section is reinstalled in original location.

- **1.2.3** The window must be allowed to flatten over a few weeks in a horizontal position. This will minimize stress on the solder joints and glass. A moderate weight and controlled heat will help coax the window back into its original plane.
- **1.2.4** Once the window has flattened, additional support should be added as necessary. It is crucial to consider the original design so the new support bars do not intrude on important window features.
- **1.2.5** Reinstall windows.
- **1.2.6** All materials and shop drawings required for work in this section shall be subject to approval by preservation consultant and the architect based on submittal of product information, samples and supporting material.<sup>11</sup>

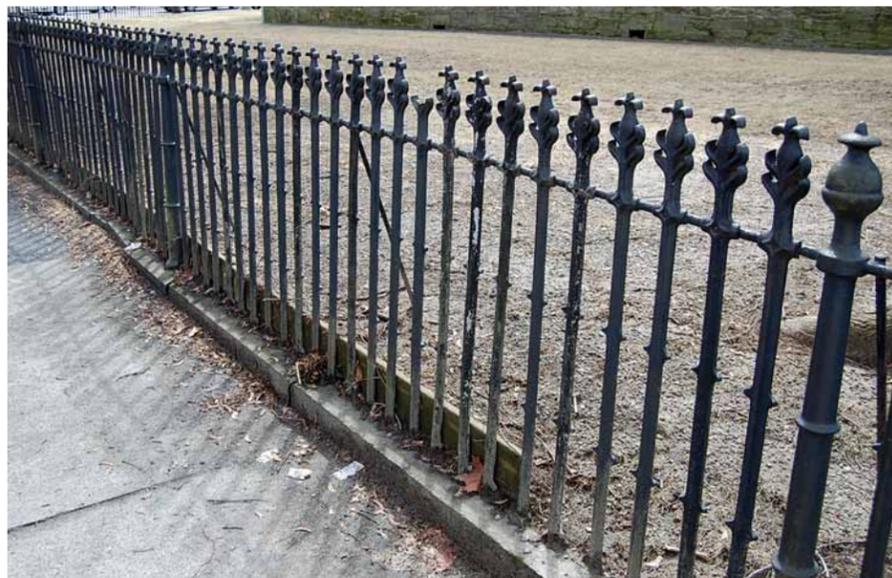
Skirting the perimeter of the church property on Main Street and Miller Street is a decorative cast iron fence and looks to be original based on historic photos, with about 75% of the original material still existing. Some missing pieces of the

original fence have been replaced with similar pieces that do not detract from the overall aesthetic of the fence, except for some issues with the protective finish. There are still some missing and broken pickets, and many of the footings are heaved. Overall the fence is in fair condition.

The cast iron fence is original to the church with about 75% of the original material still existing.

**1.2 Rehabilitation Plan:** Maintain and protect finish.

- **1.2.1** When there is extensive failure of the protective coating and/or when heavy corrosion exists, the rust and most or all of the paint must be removed to prepare the surfaces for new protective coatings
- **1.2.3** Local environmental regulations may restrict the options for cleaning and paint removal methods, as well as the disposal of materials.
- **1.2.4** Hand scraping, chipping and wire brushing are the most common and least expensive methods of removing paint and light rust from cast iron.
- **1.2.5** Before removing paint from historic architectural cast iron, a microscopic analysis of samples of the historic paint sequencing is recommended.
- **1.2.6** Thorough surface preparation is necessary for the adhesion of new protective coatings. All loose, flaking and deteriorated paint must be removed from the iron, as

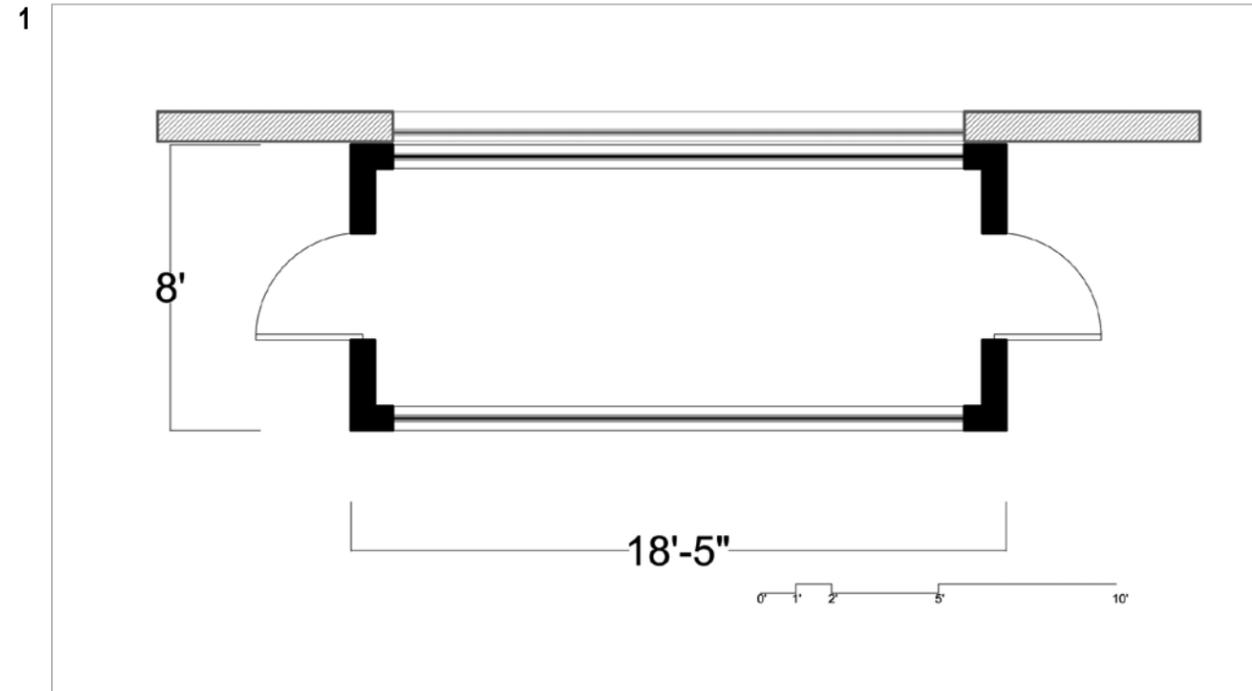
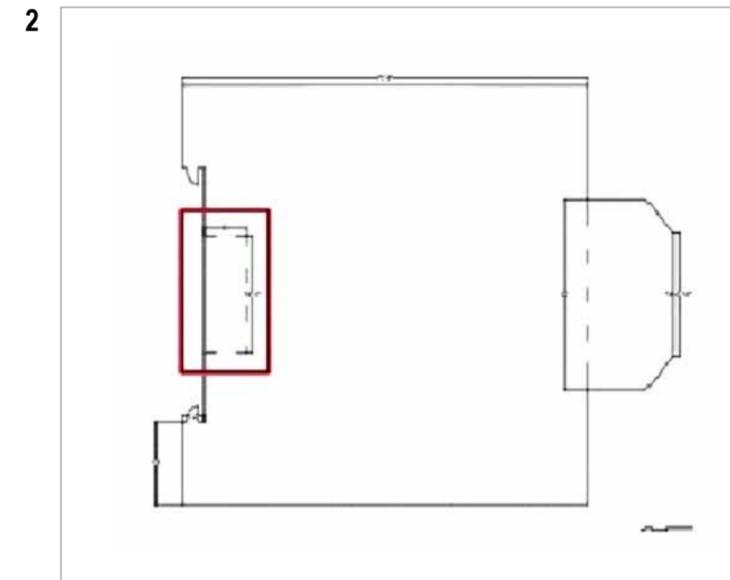
The church wishes to have a cry room installed. We are suggesting the installation of a modular or prefabricated room that could easily be broken down if necessary and does not significantly impact the fabric of the church interior.

1,2. Design and location of a new addition for a cry room. The modular or prefabricated room could easily be broken down if necessary.

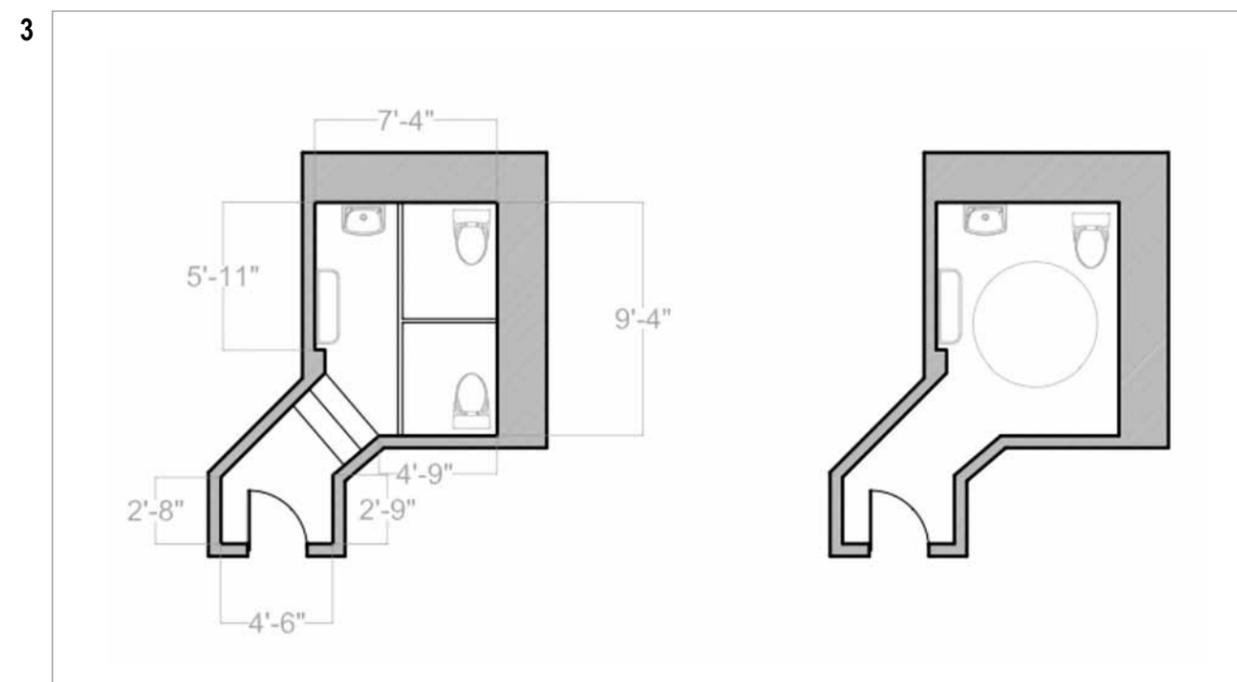
stair from the basement to the sanctuary main floor is handicap accessible. The bathrooms are currently inaccessible. The current bathroom at the southwest corner of the church currently has two stalls and two steps to enter the lavatory. The church wishes to make this facility ADA compliant. To facilitate the installation of an ADA compliant bathroom, it is necessary to remove all partitions of current stalls, existing toilets, the sink and any wall fixtures.

3. Existing and revised ADA-compliant bathroom design.

Once demolished, the bathroom will be an empty space. The floor will be raised to create a flat entry into the room. All plumbing and systems can be located beneath this platform. The room itself will be a single stall with the toilet installed at the southwest corner of the room, grab-rails at the south and west walls. The sink will be installed along the north wall in order not to block the entry or impede the necessary area around the toilet (60 x 59"). All changes must abide by State of Rhode Island and Providence Plantations Rehabilitation Code for existing buildings and structures – Chapter 10 Accessibility – and the Town of Warren Department of Building and Zoning. Accessibility must meet the 2010 ADA Standards for Accessible Design.
